RV Inspection Report

**Inspection Date / RV Model:
Newmar Superstar 4065 2023**

**Pierre Fortin
5753 Highway 85 N Lot 8511
Crestview, Florida, 32536**

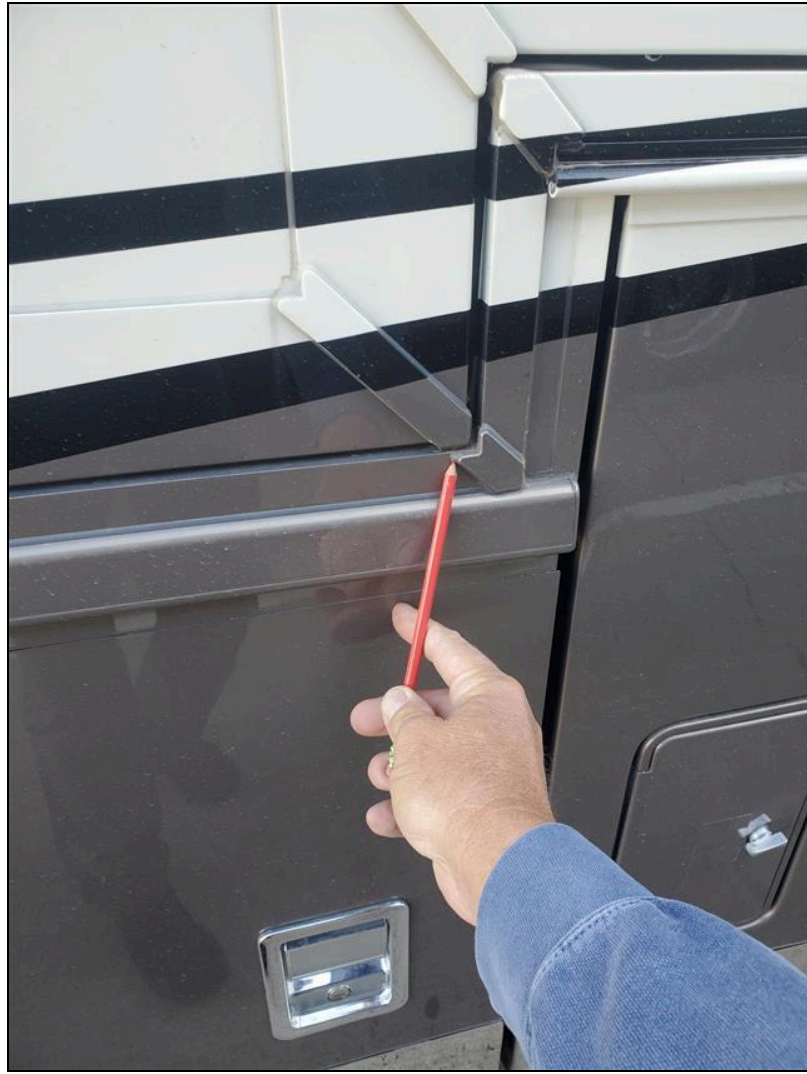
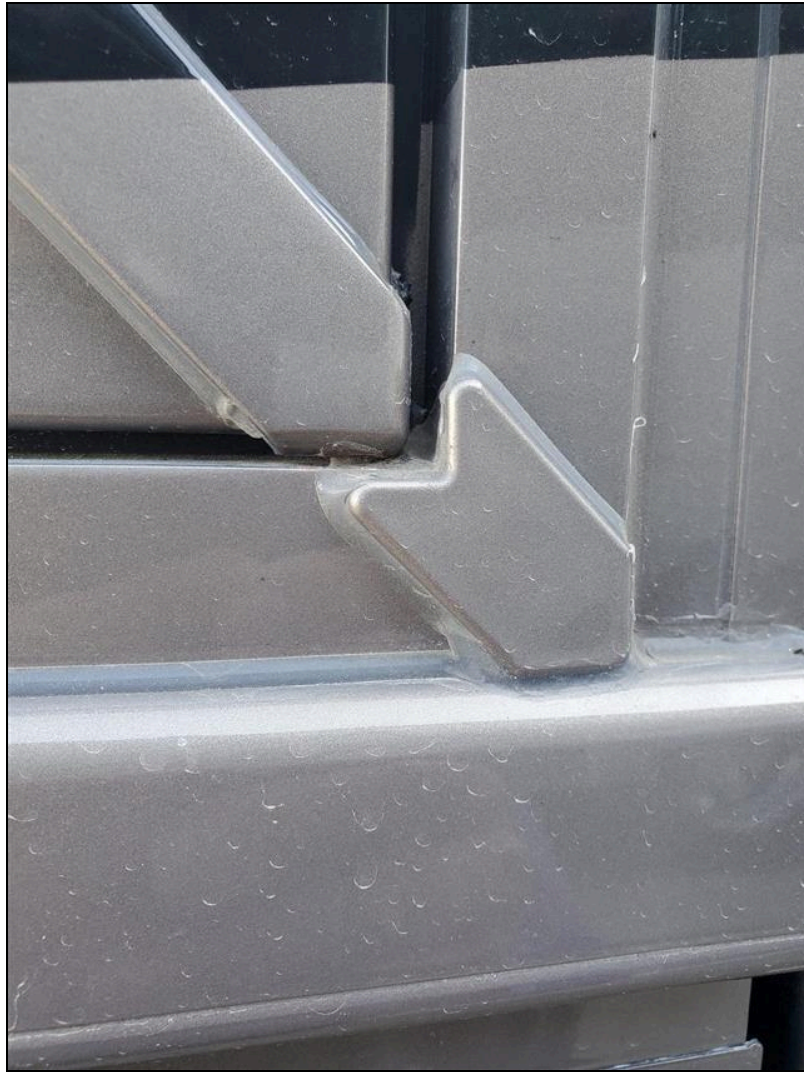
(2) Same with front of trim rubbing on the frame

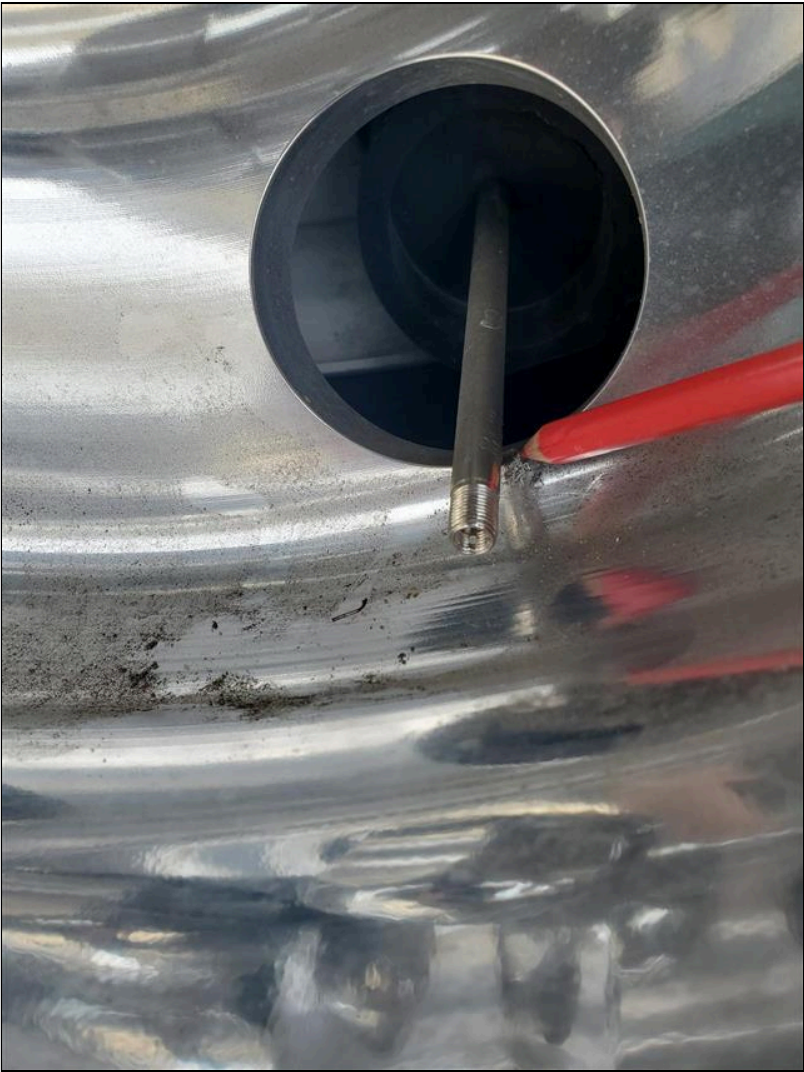
8.0.B Tire Condition

Valve stem extension is worn out and started to scuff the wheel as well

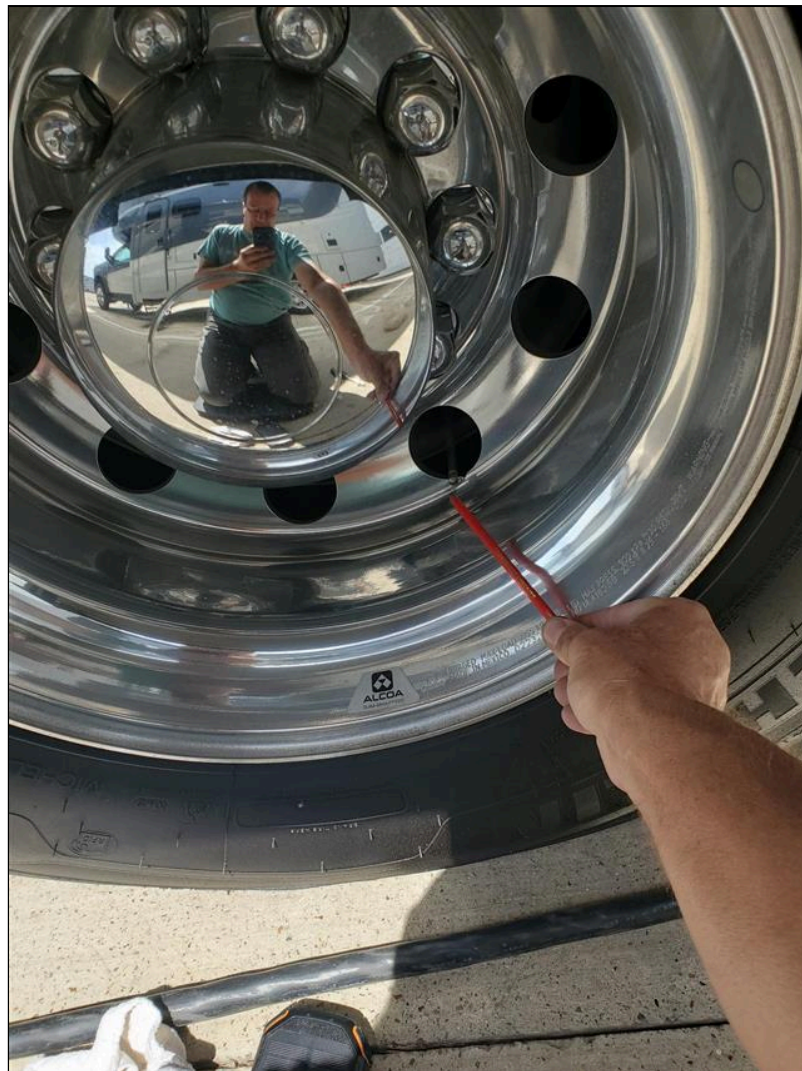
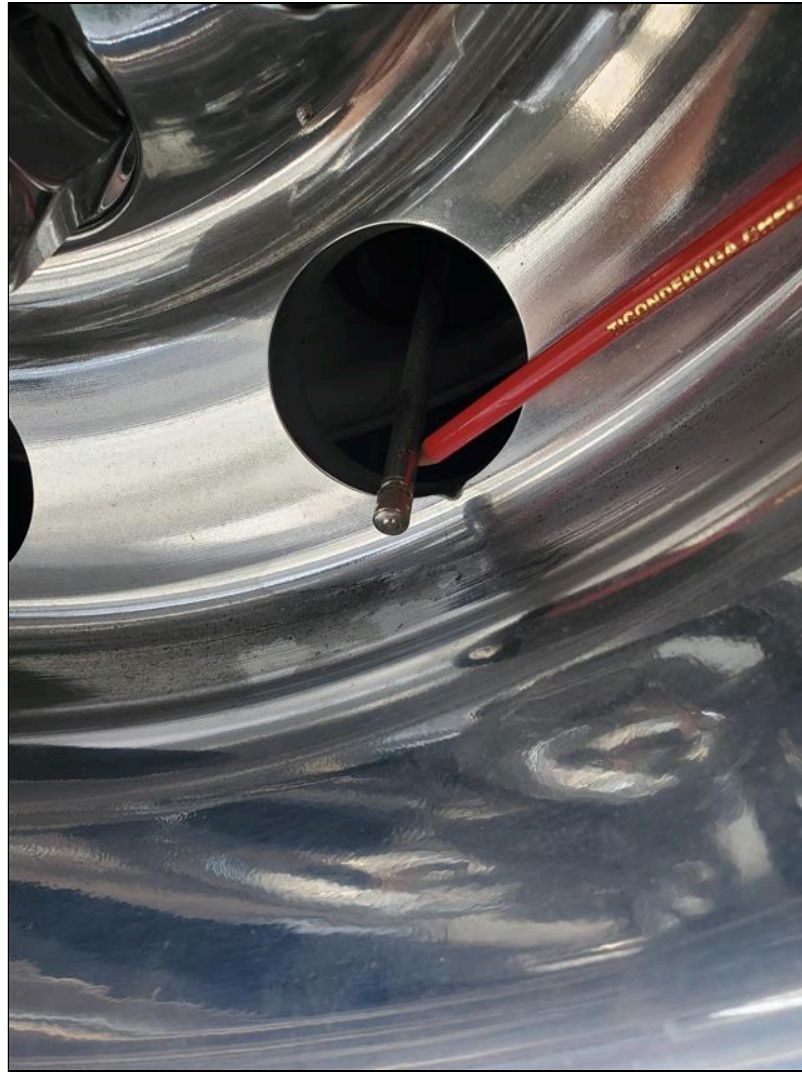
8.0.E Tire Condition
Poor

Valve stem extension is worn out to to the point of having scuffed the wheel itself

+ Valve stem extension is worn out to the point of having scuffed the wheel itself

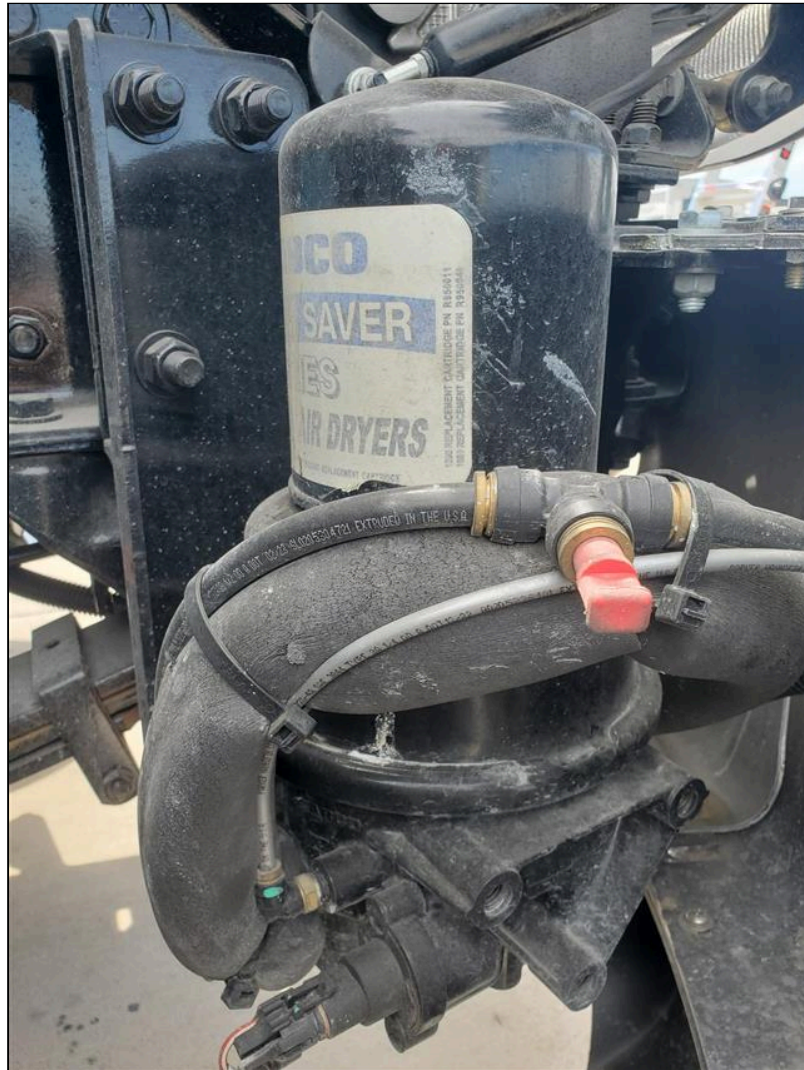
We couldn't verify age on cartridge or maintenance last performed.

We Recommend to verify when last Service was Performed

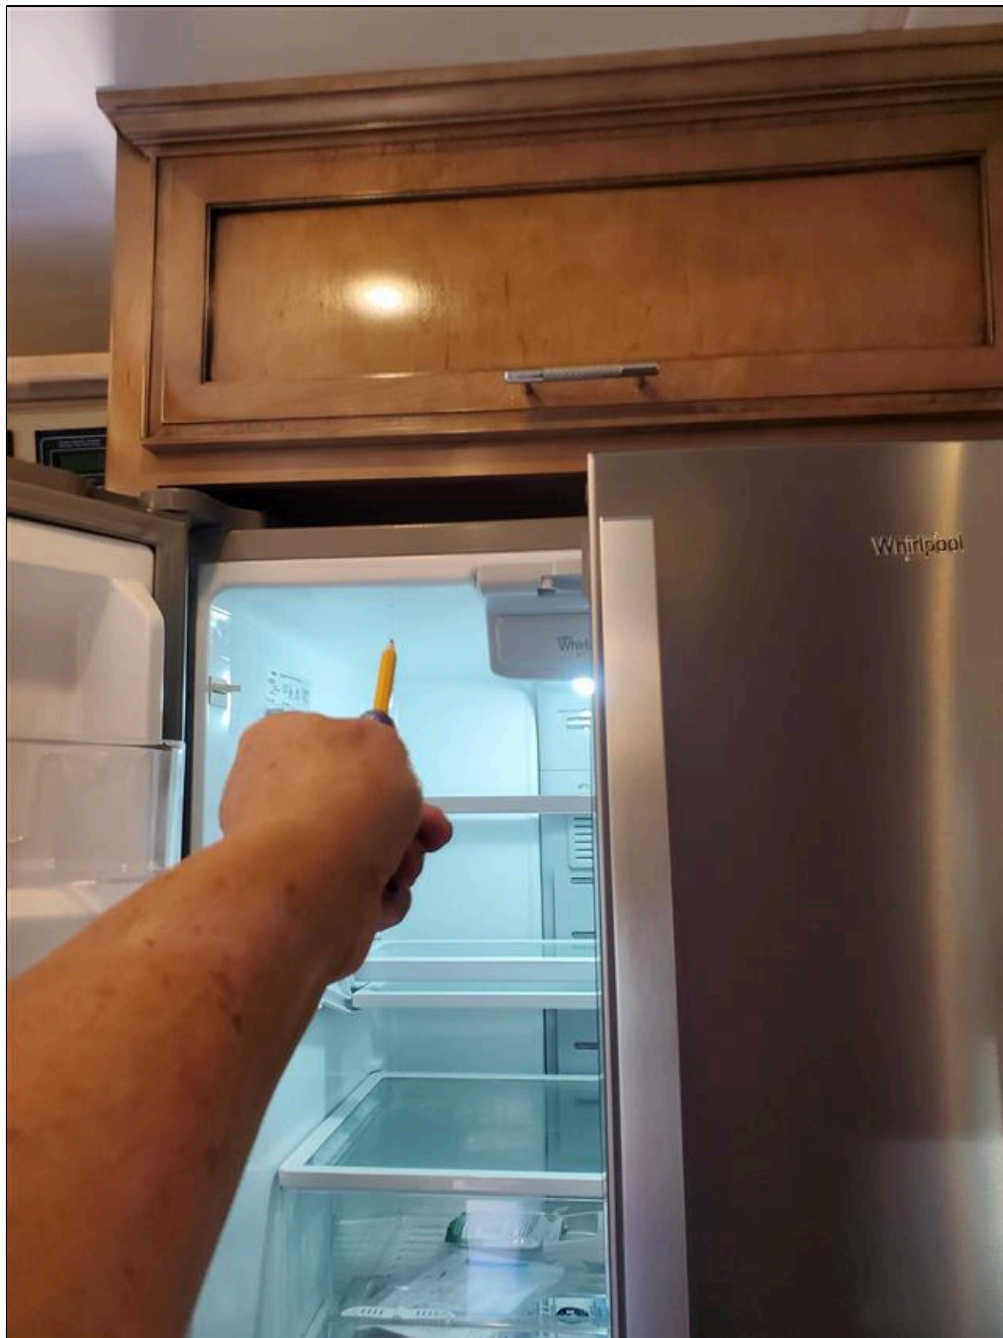
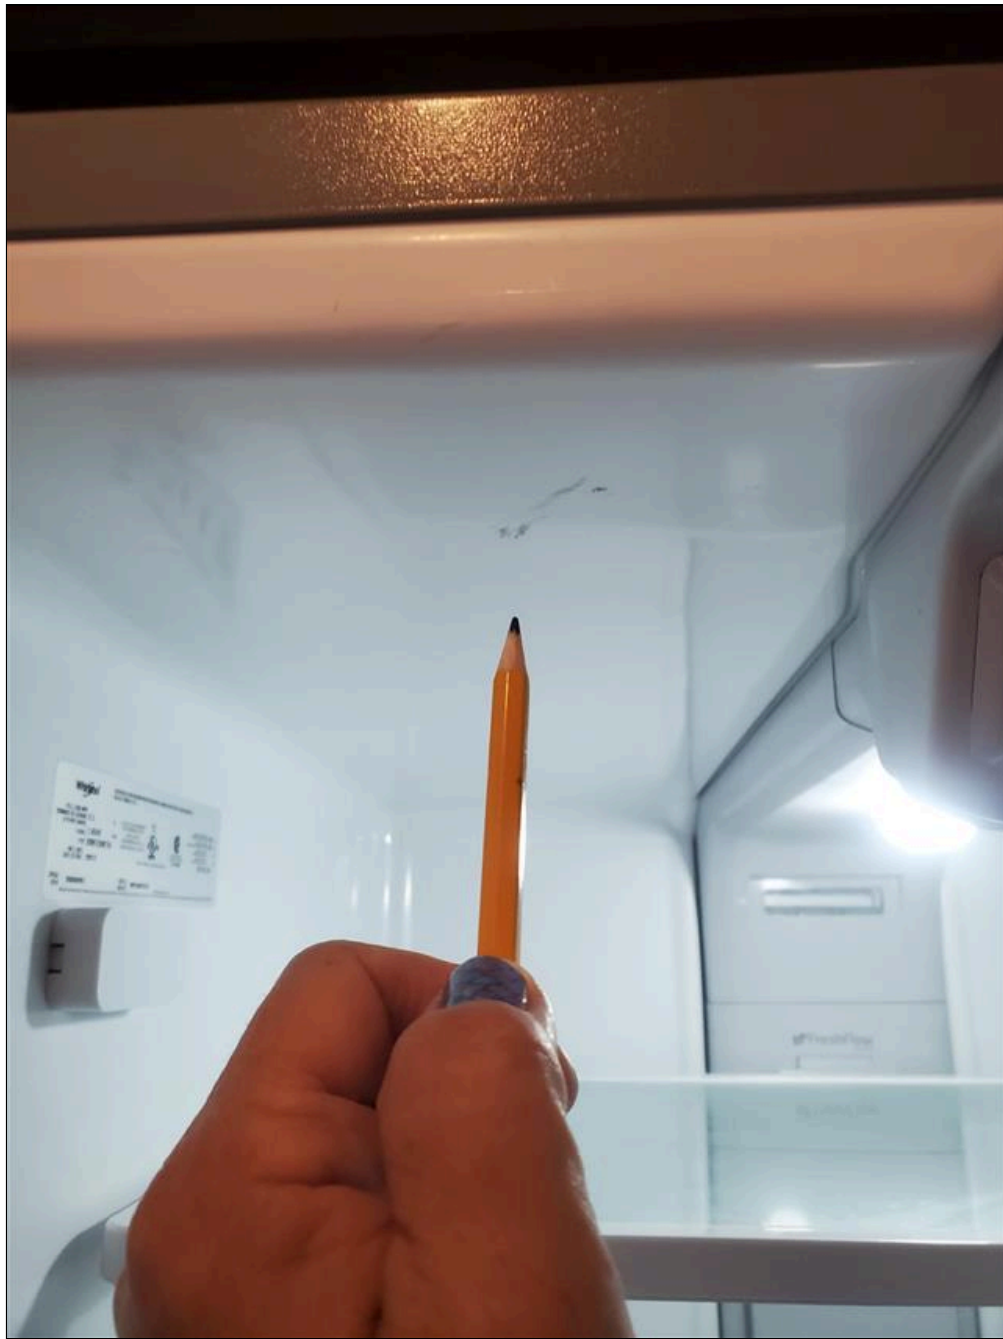
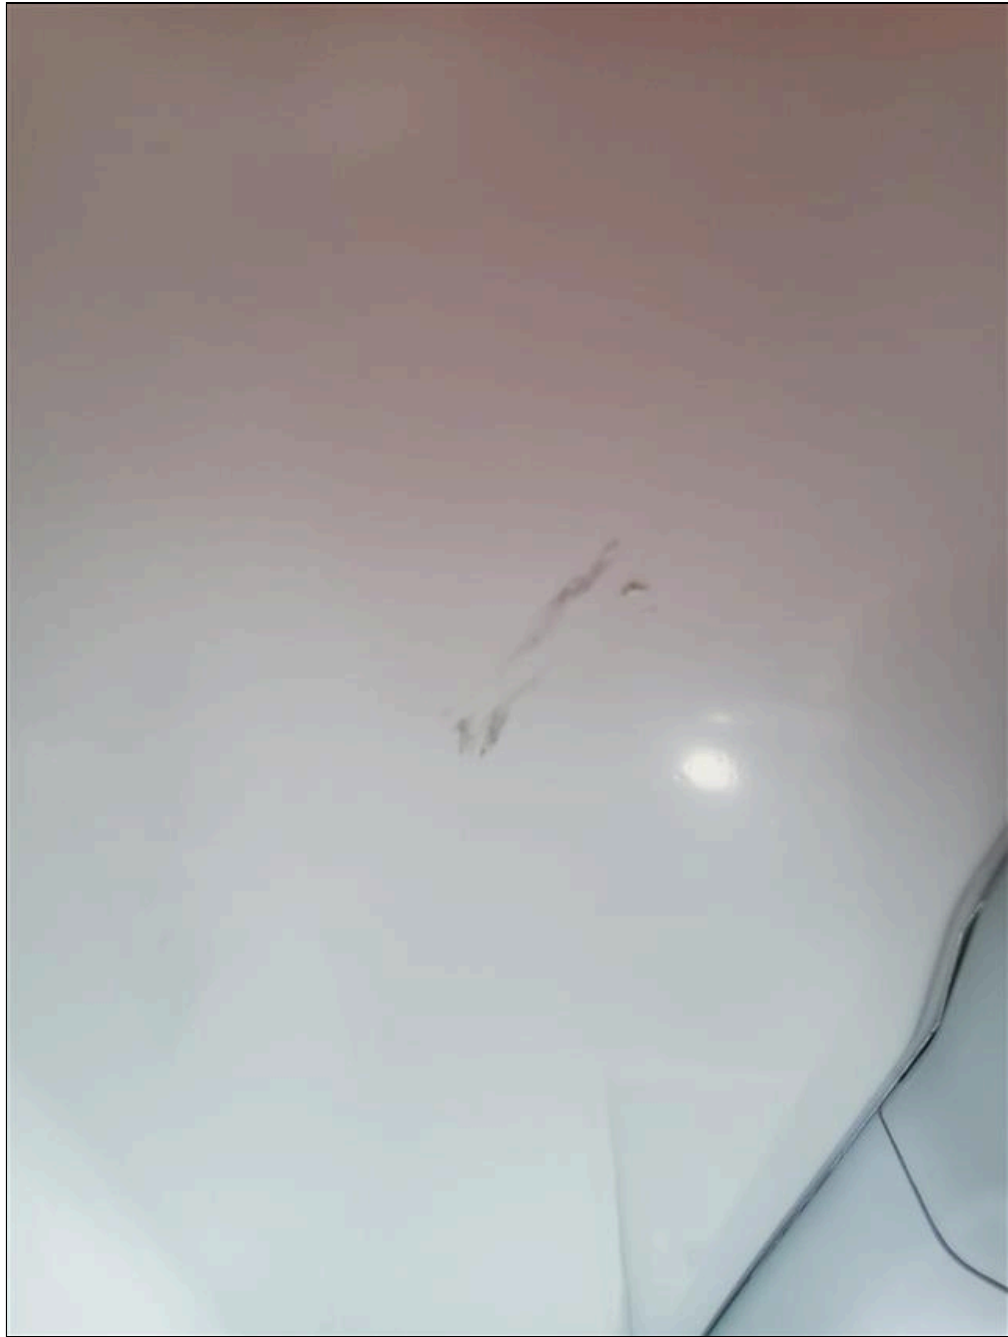
- 🔧 (3) Residue was observed on surface of the walls
- 🔧 (4) Residue was observed on surface of the walls

👁️ (3) Residue was observed on surface of the walls

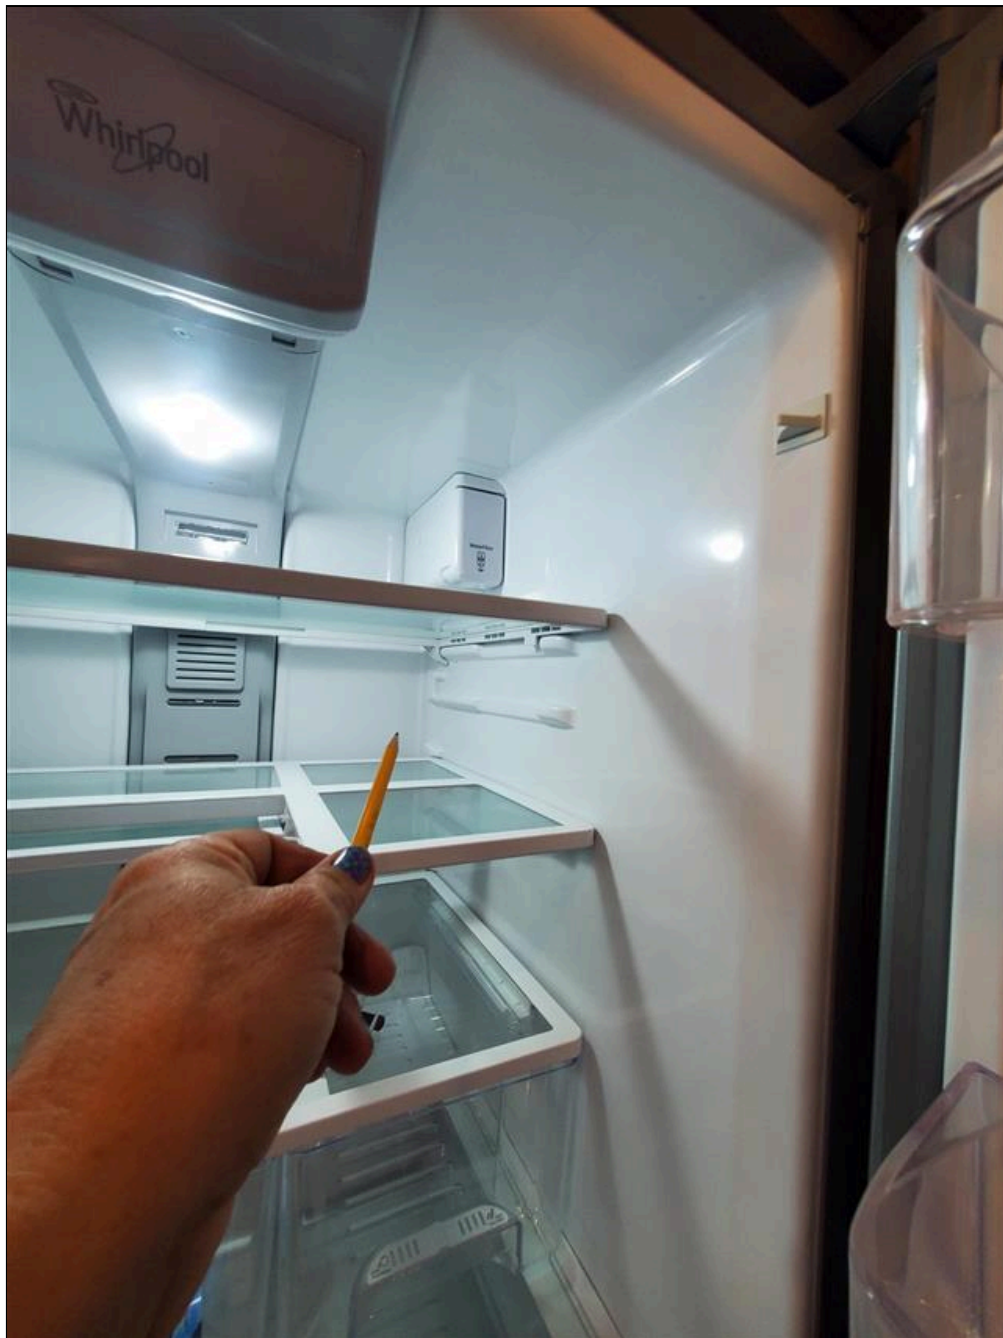
🐛 (4) Residue was observed on surface of the walls

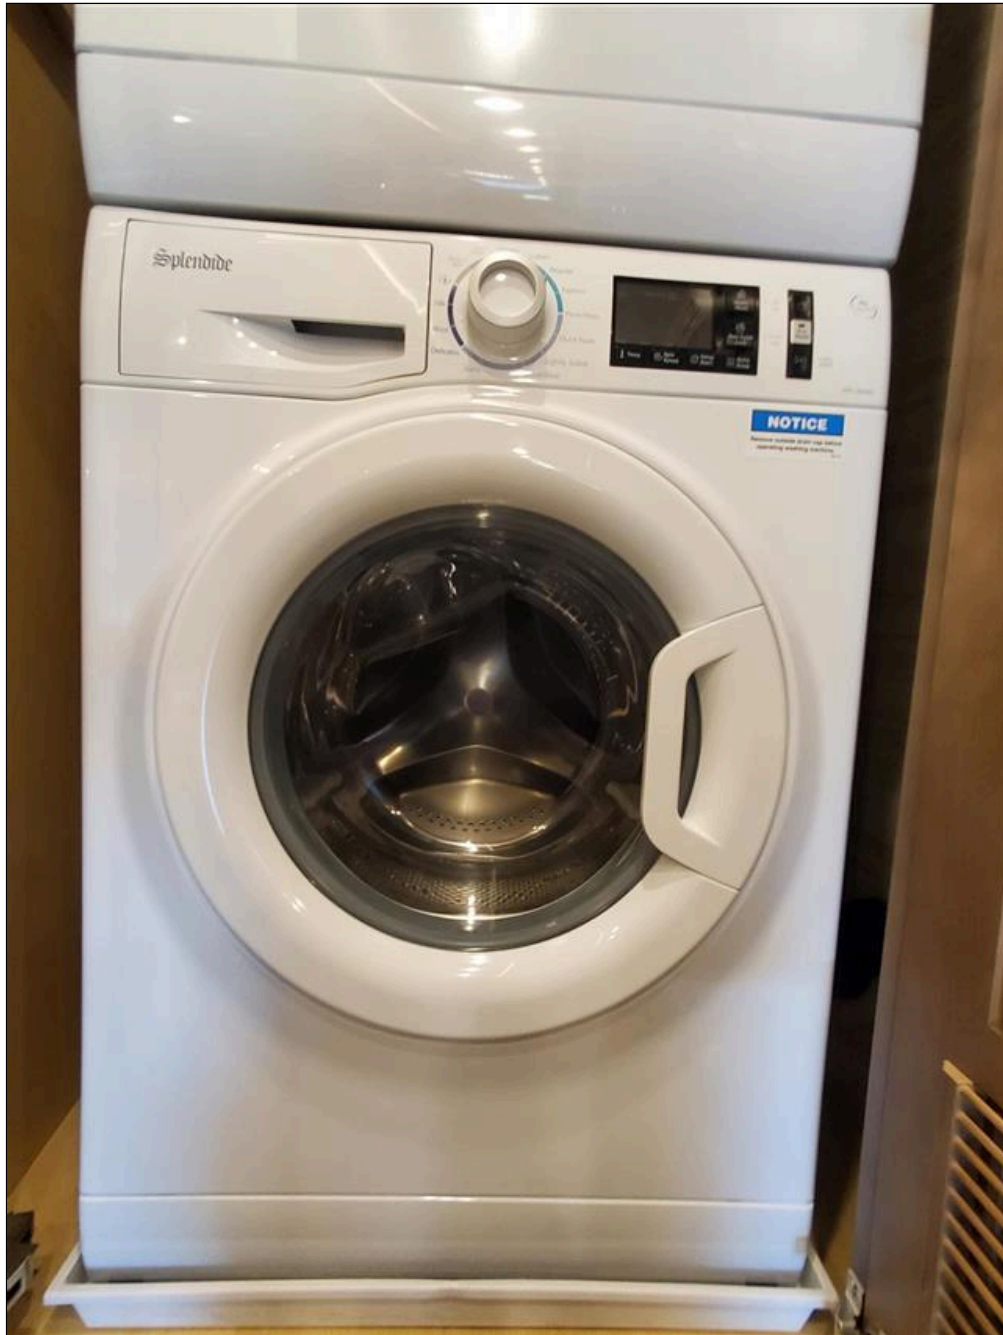
17.4 Washer / Dryer - Condition

Washer Doesn't Operate as Intended and Requires to be Addressed.

F8 E1 code is Displayed

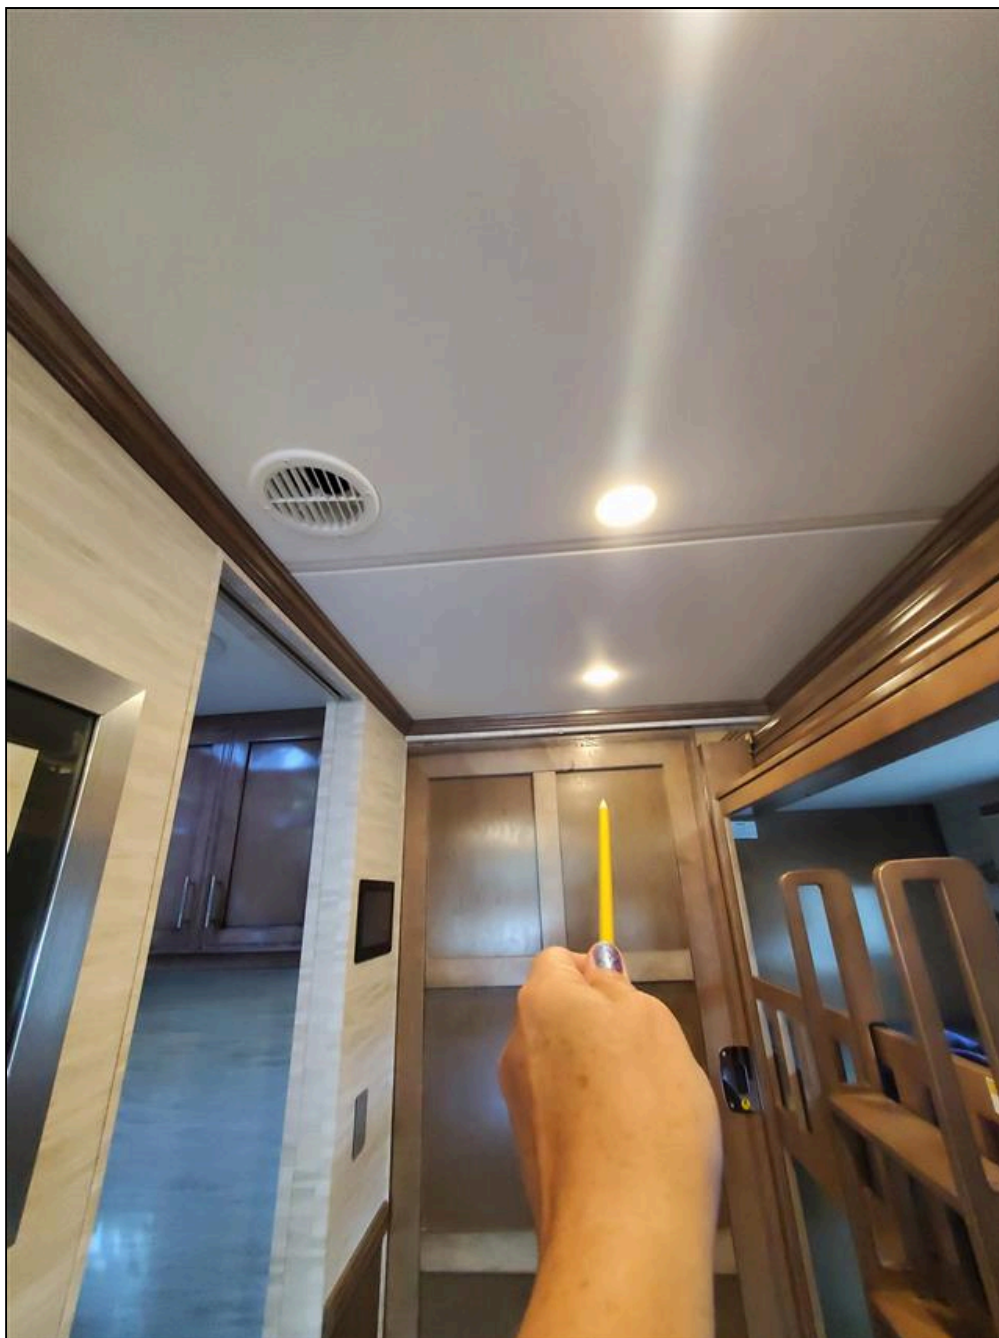
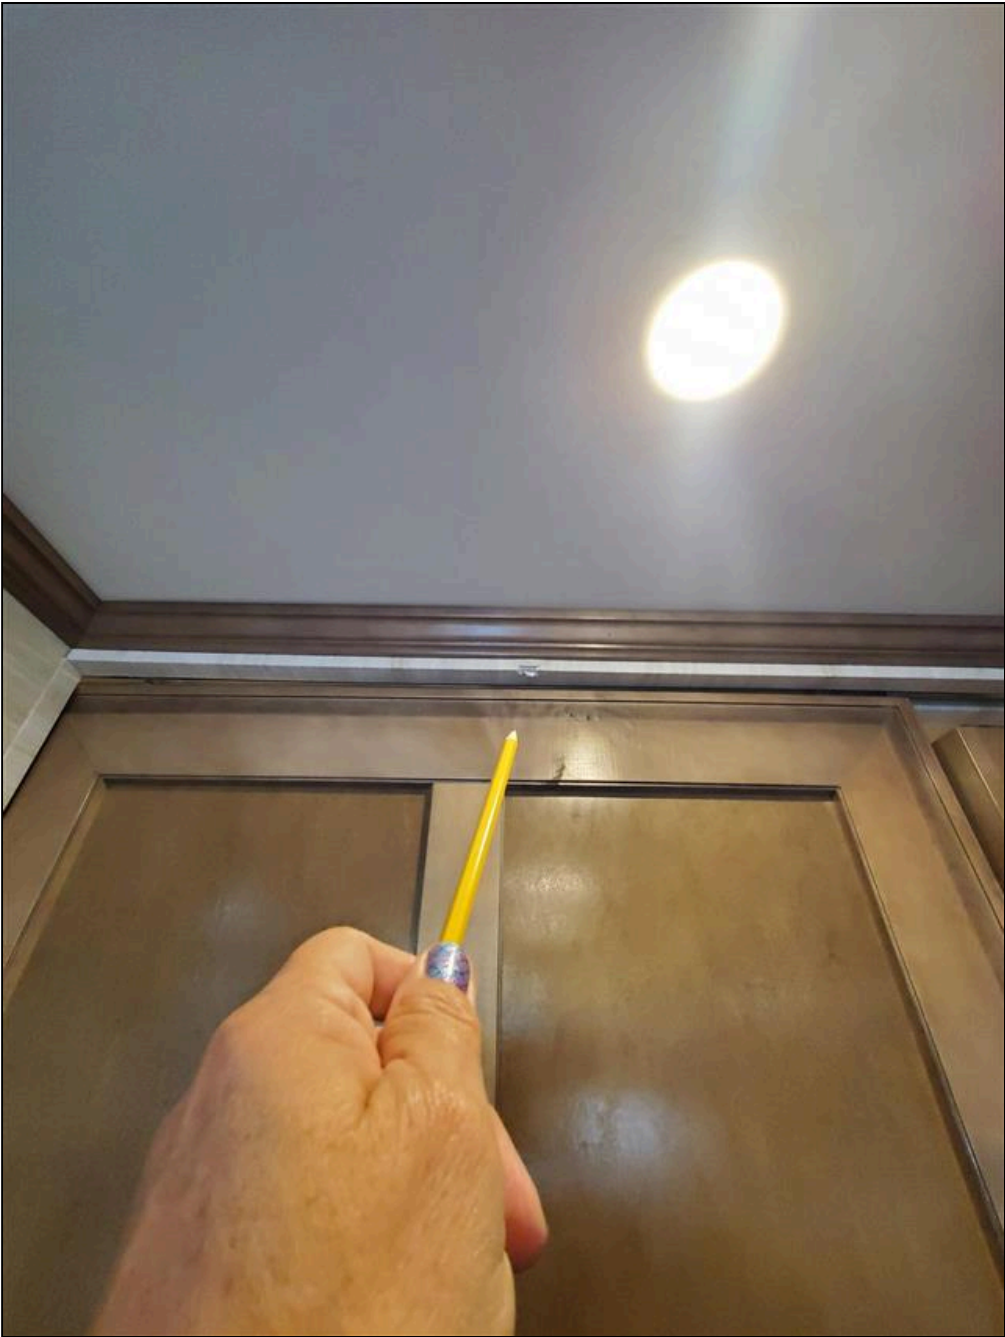
19.20 Walls - Wallpaper Wrinkles, Residue or Damage

(1) Wallpaper Tear(s) were Observed

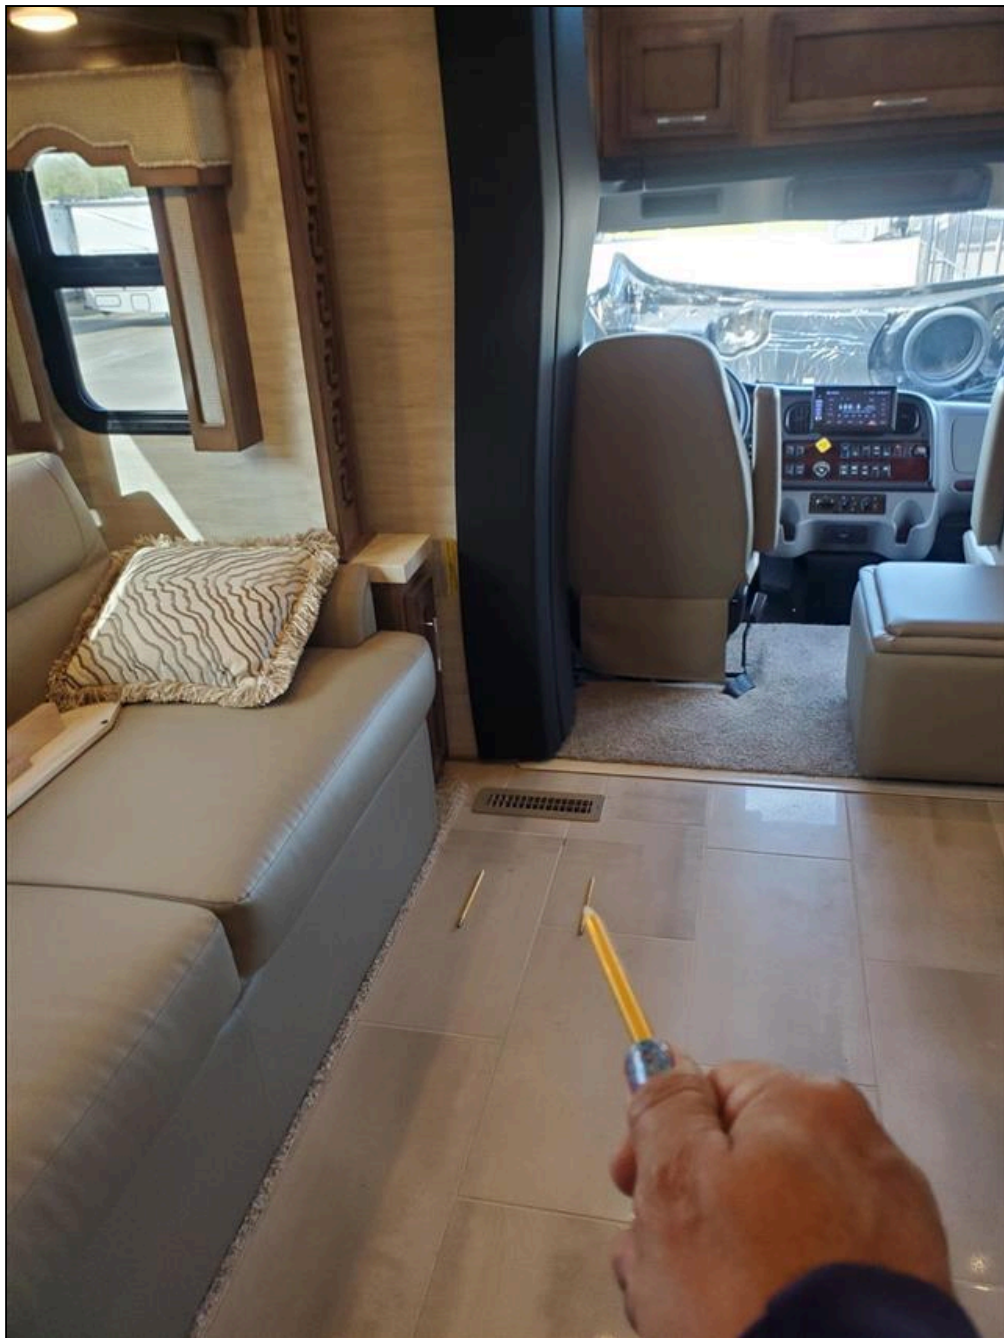
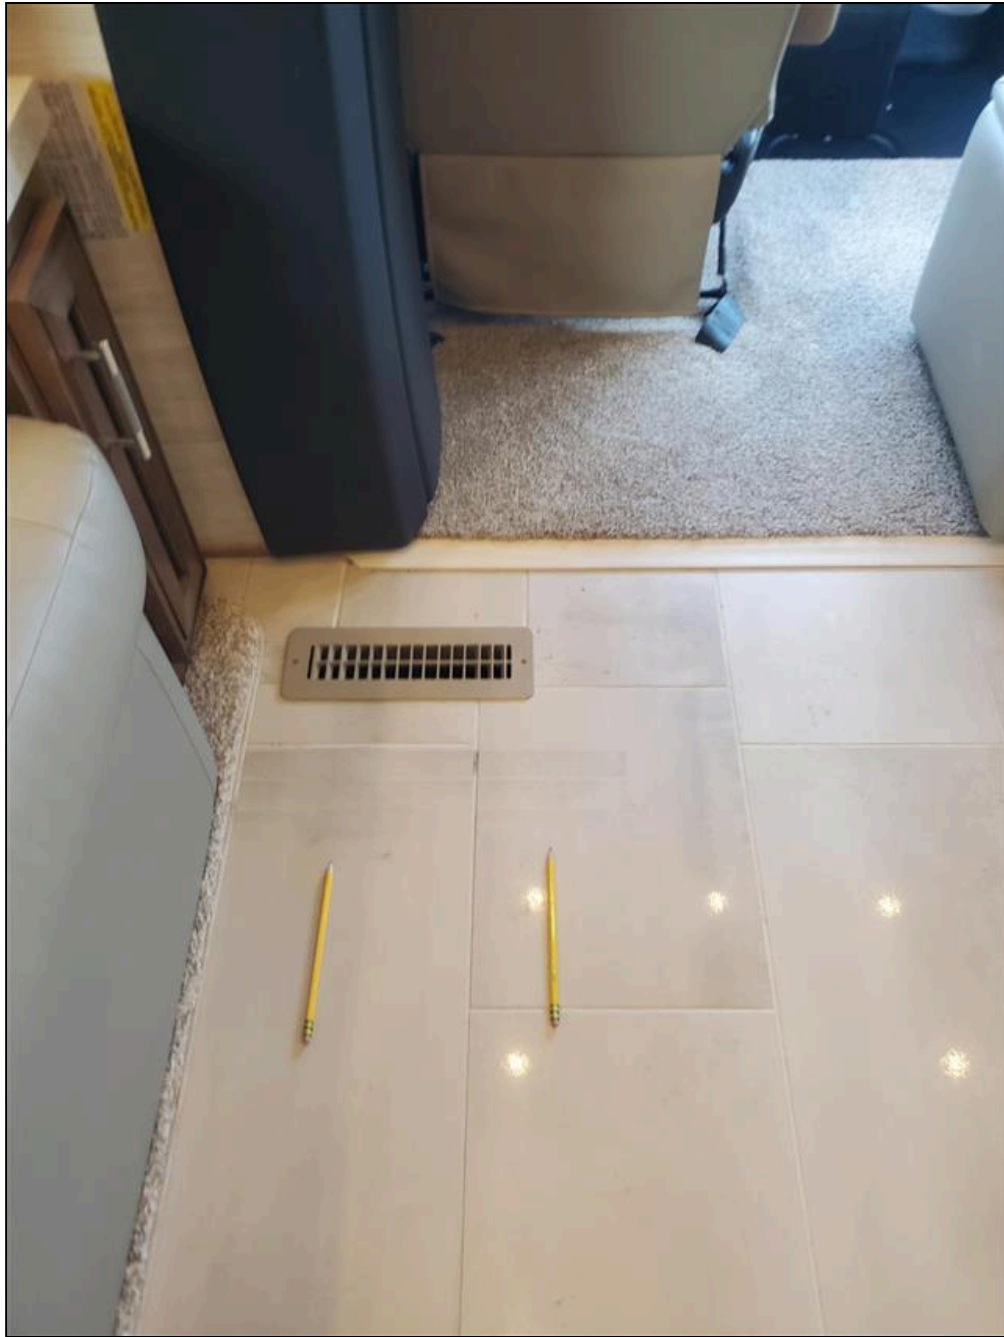
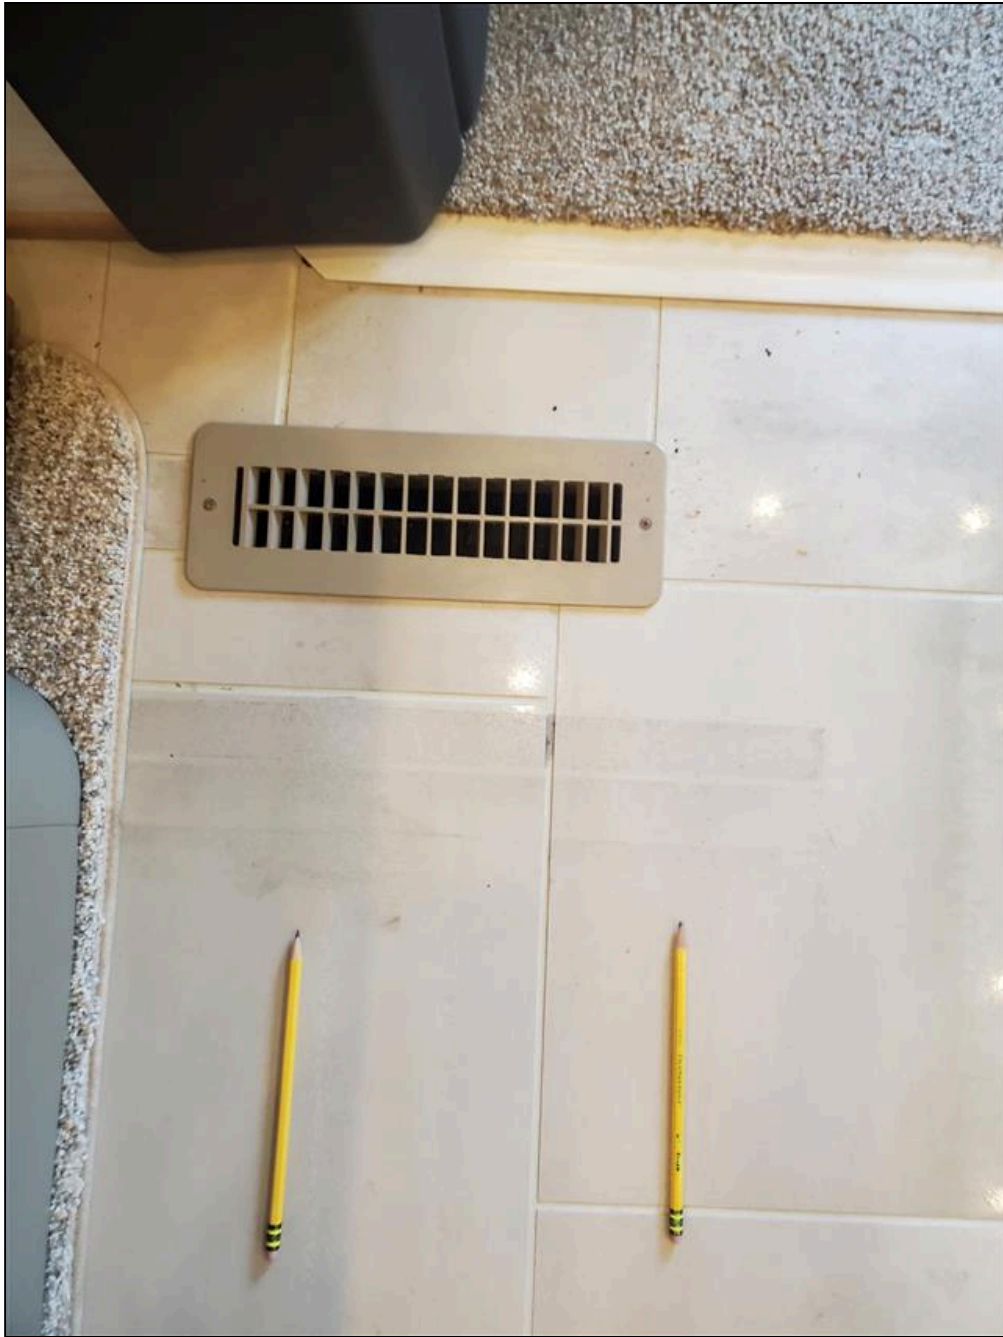
- 🔧 Scuff Marks were Observed on the Floor Material due to the Slideout Rollers

Scuff Marks were Observed on the Floor Material due to the Slideout Rollers
