RV Inspection Report

**Inspection Date / RV Model:
Newmar Superstar 4065 2023**

**Pierre Fortin
5753 Highway 85 N Lot 8511
Crestview, Florida, 32536**

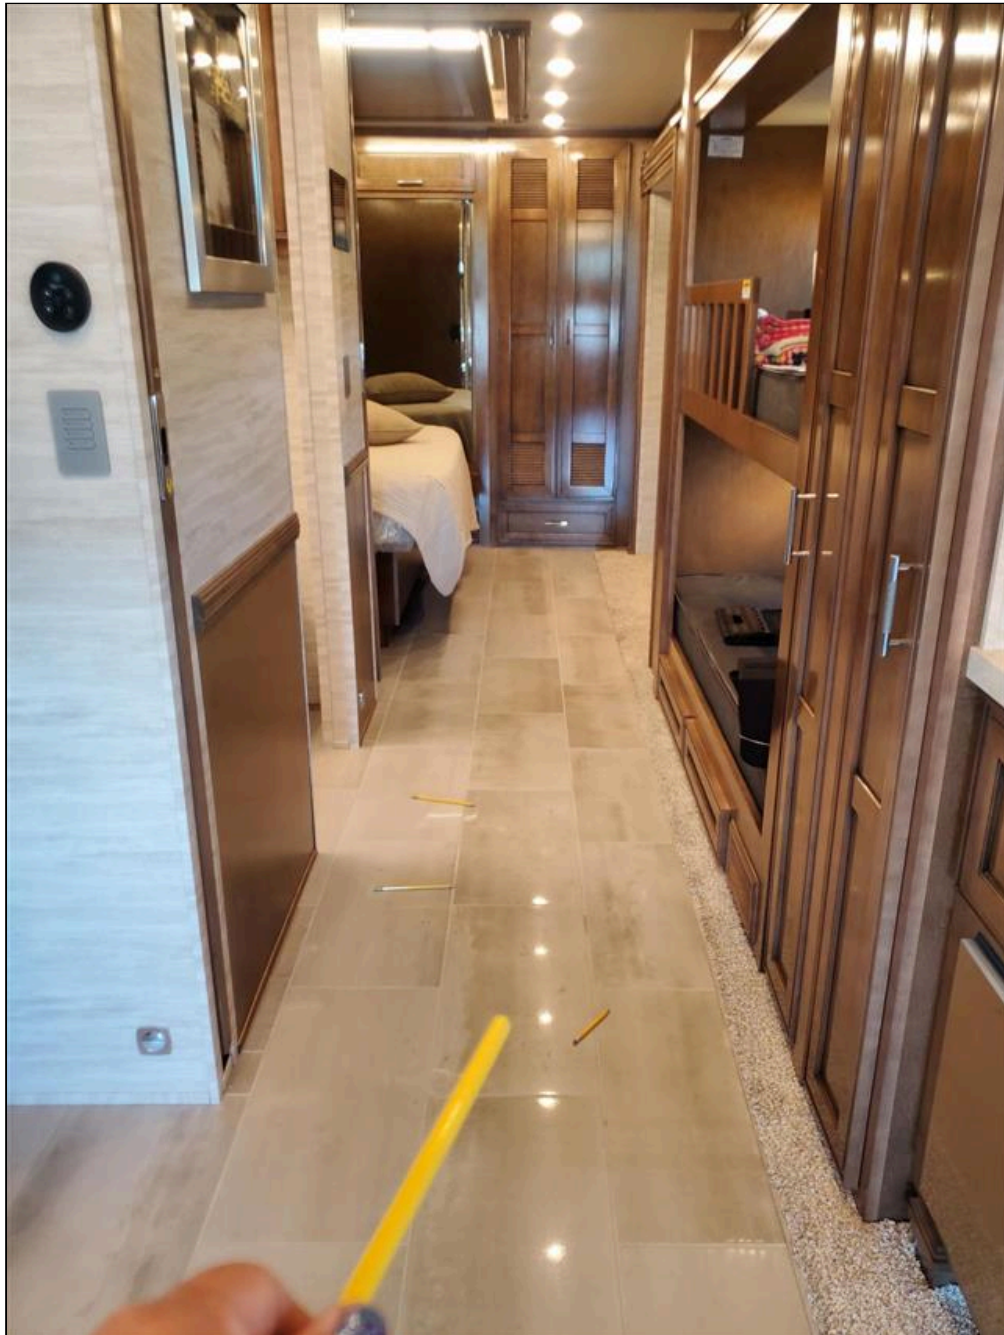
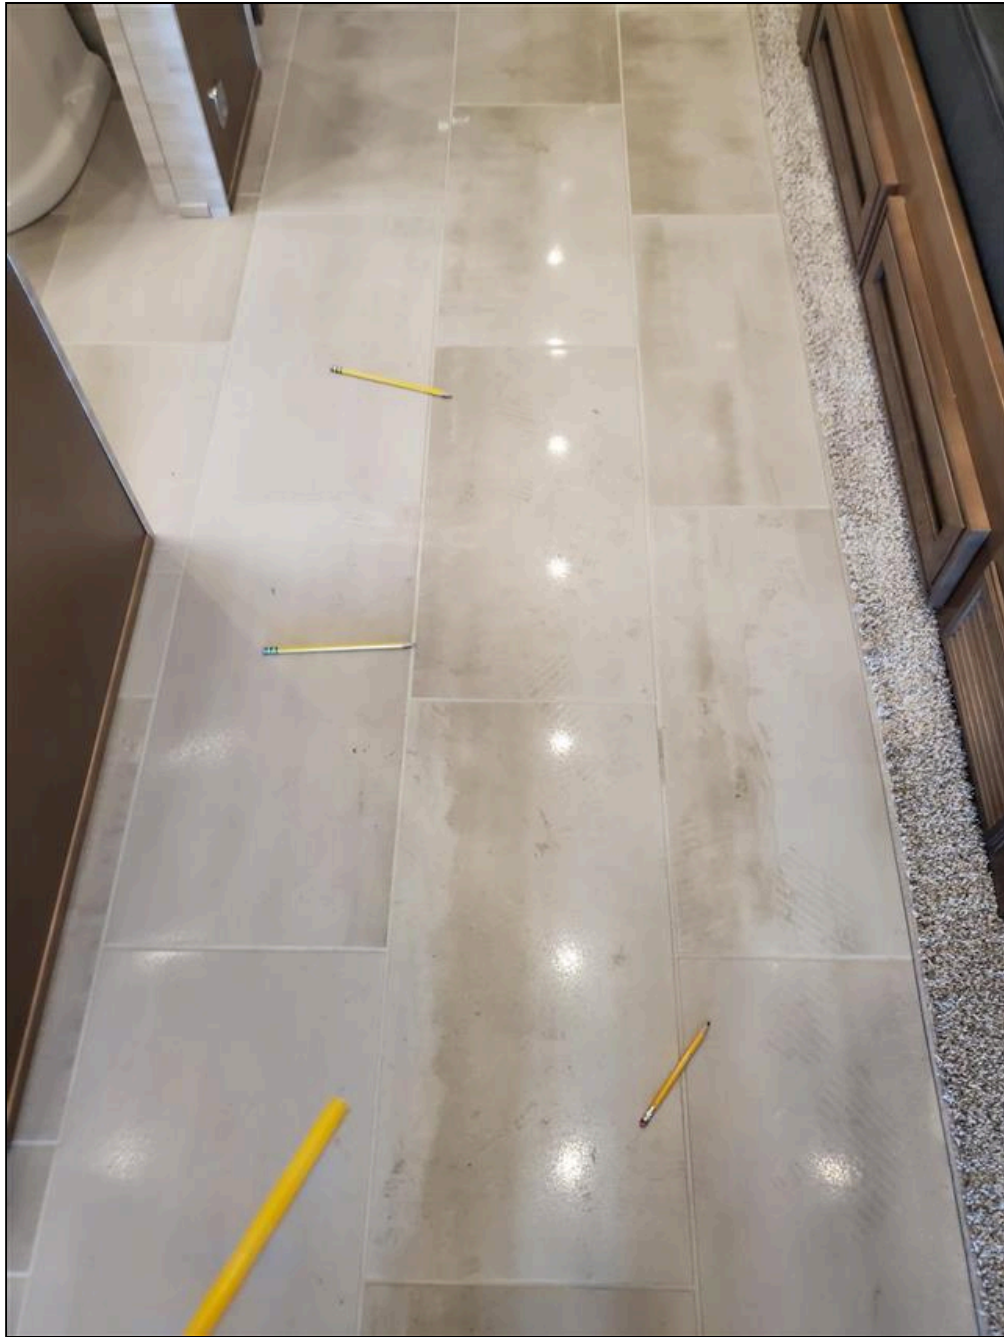
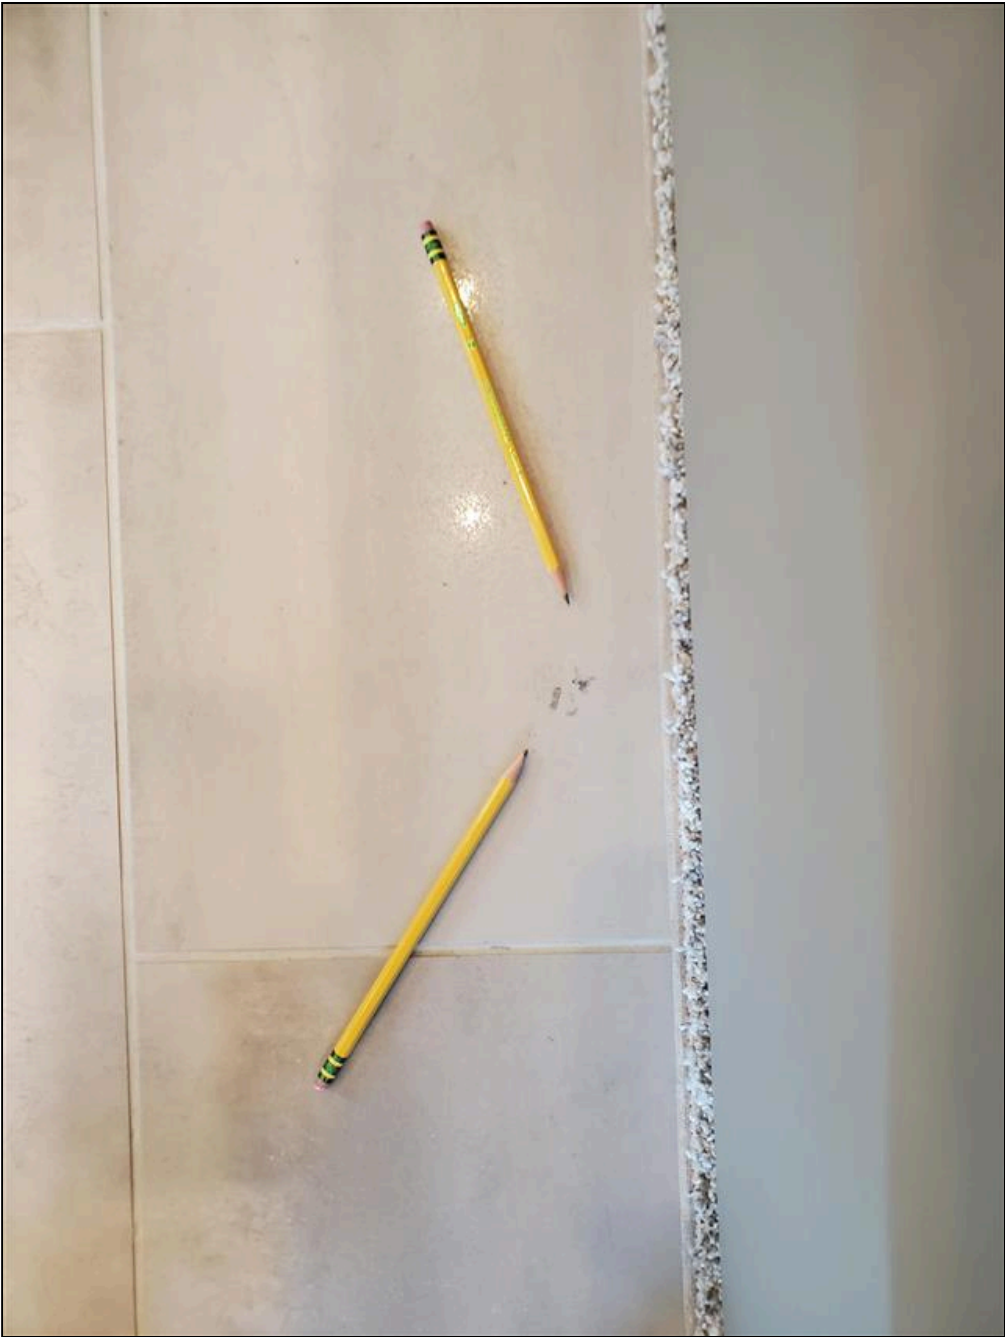
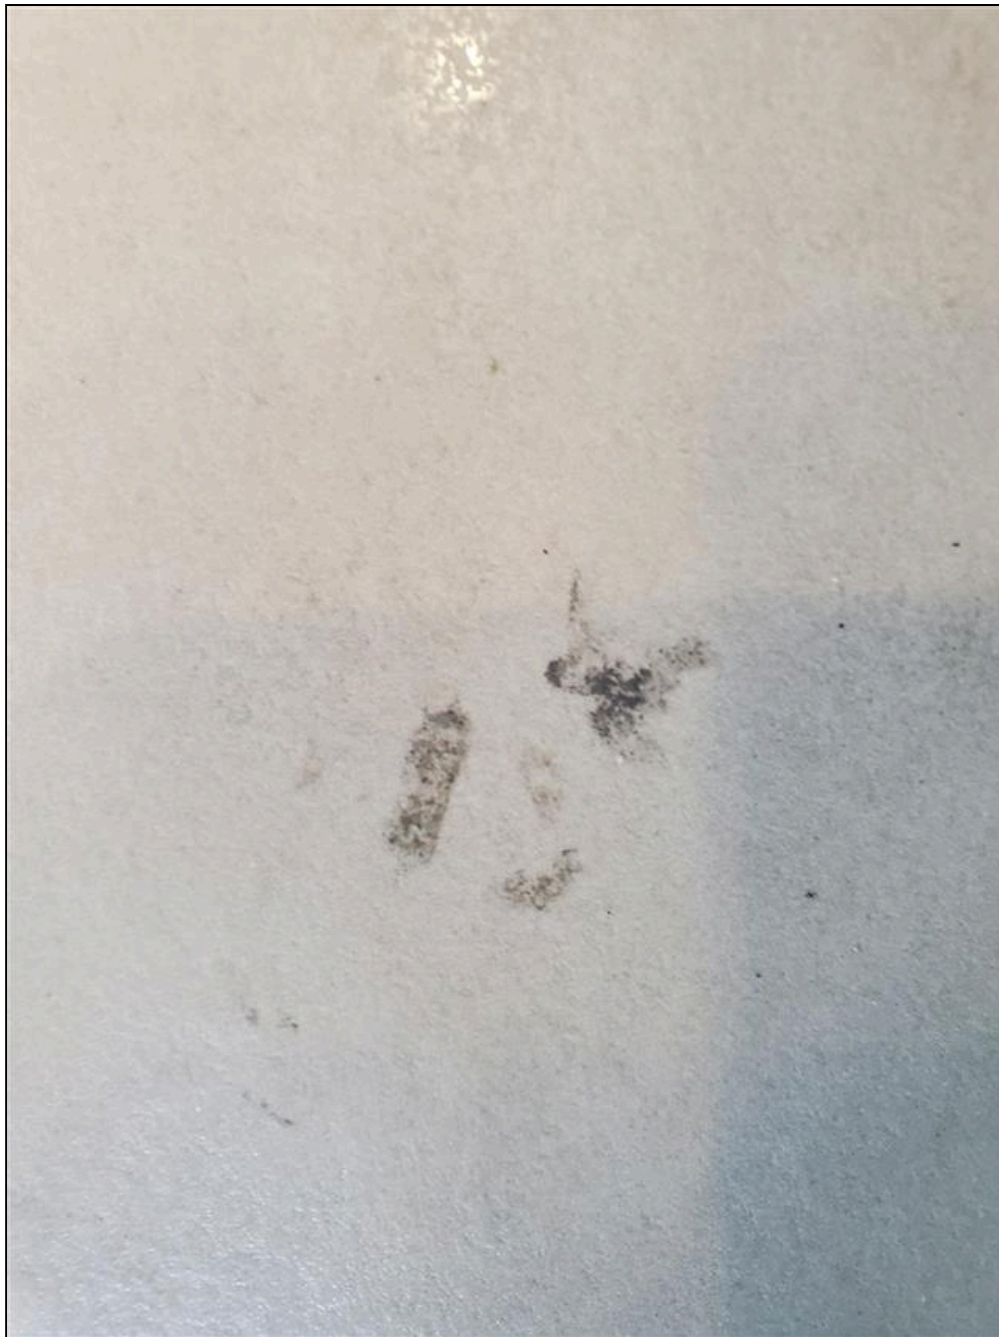
Residues were Observed on the Flooring Material.

We cannot State if it is Stained or Dirt.

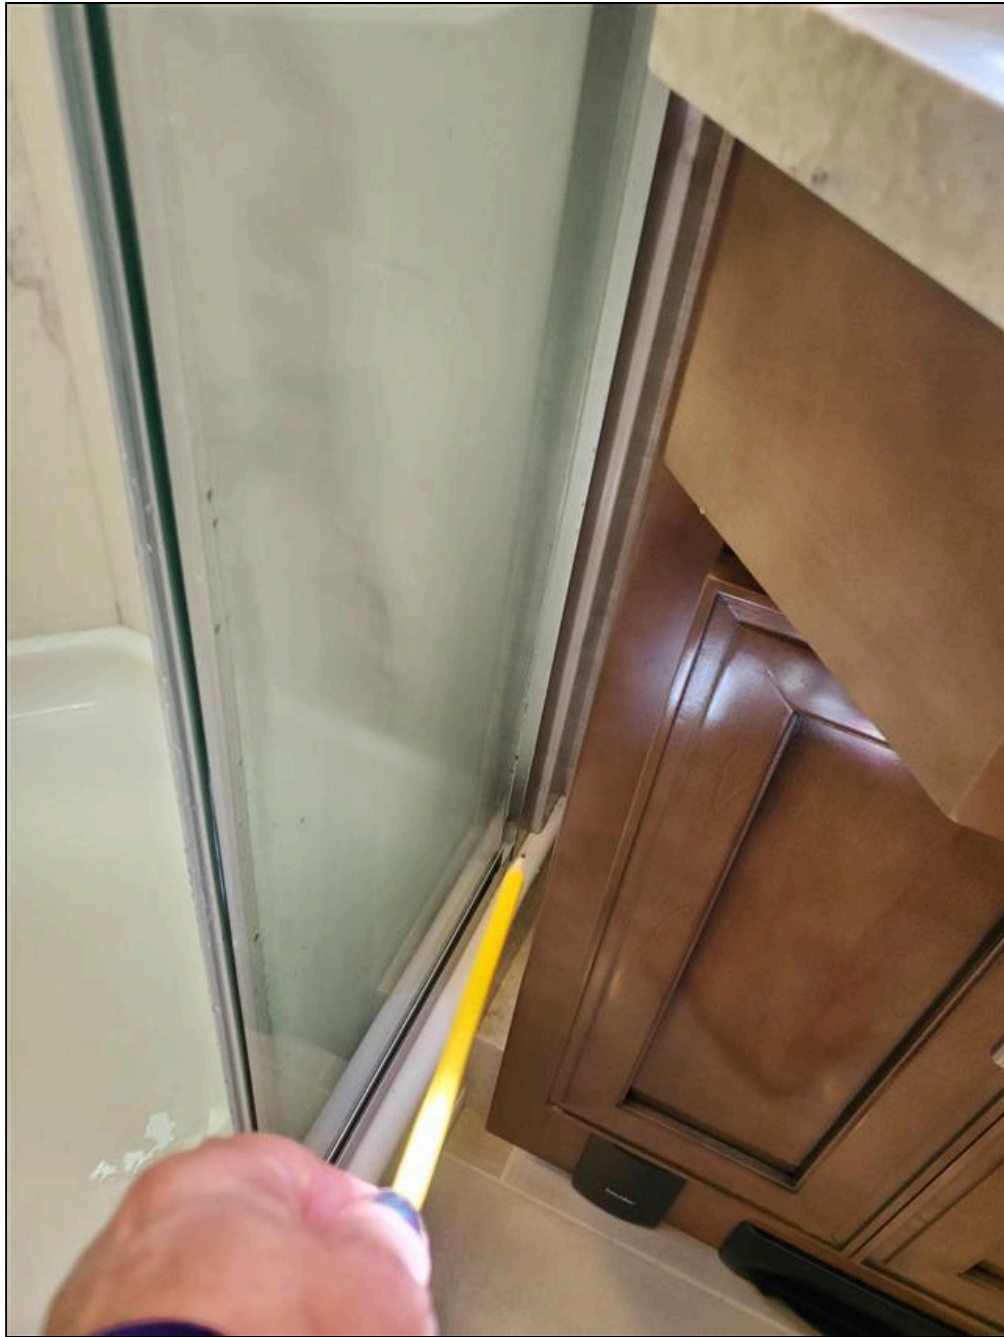
Shower Leaks are Observed at Moment of Inspection. Inspector recommends to have the Issue fixed before water Damages occur

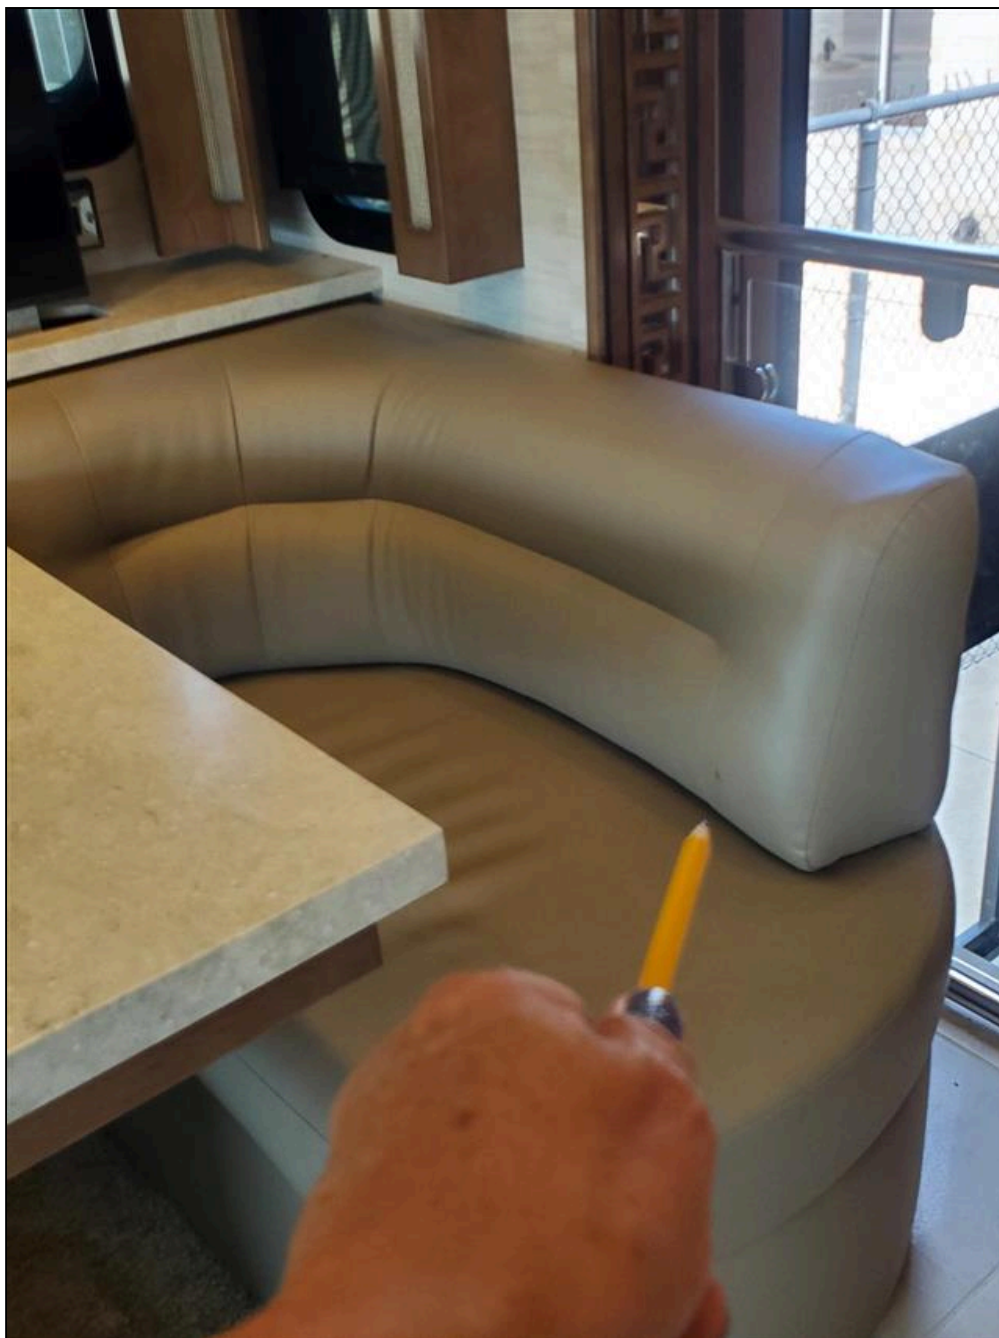
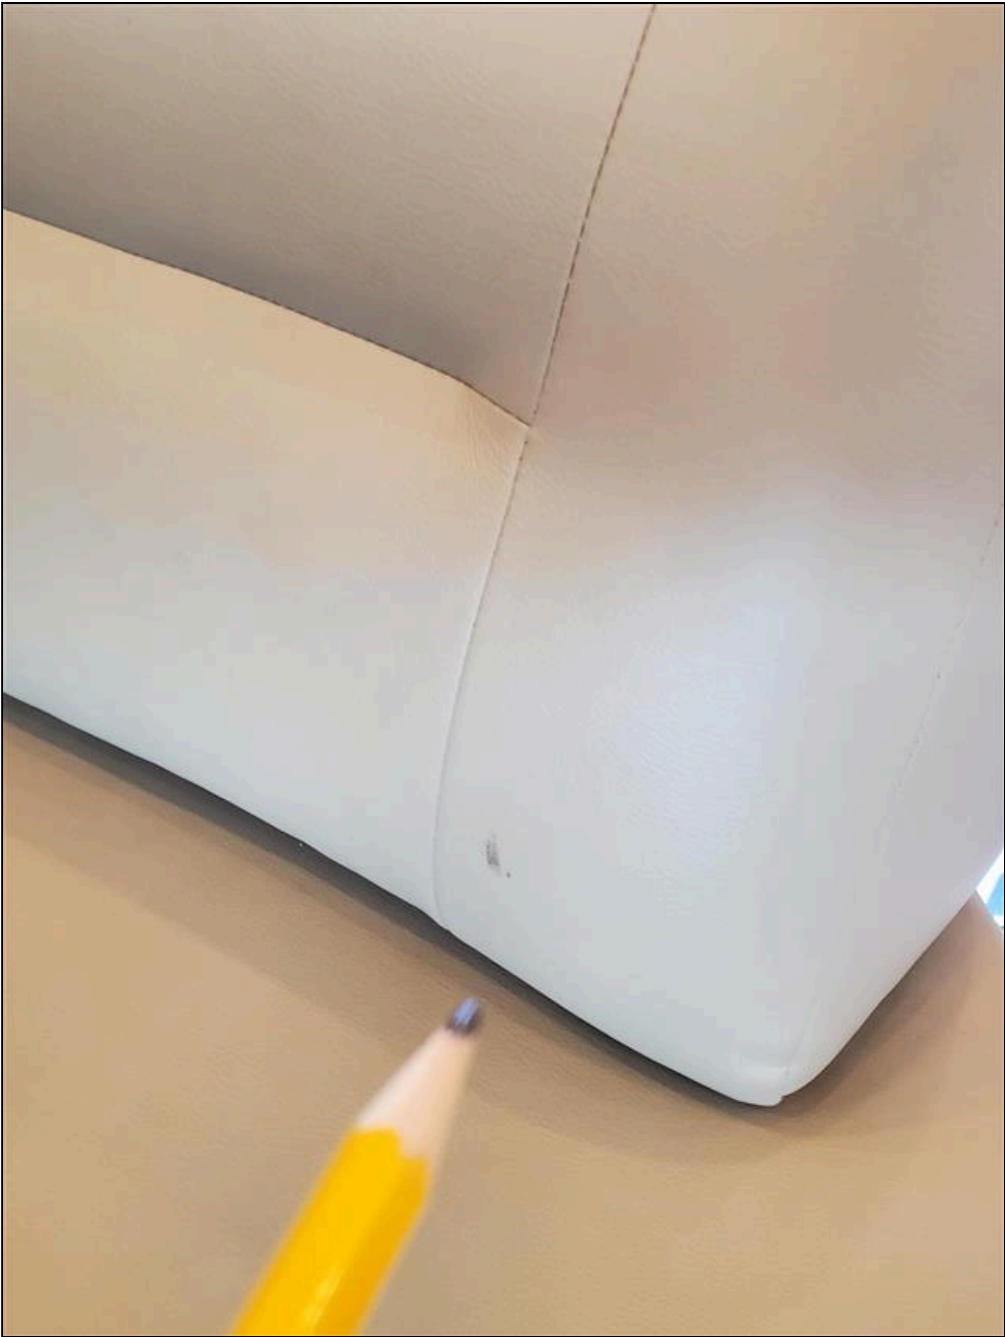
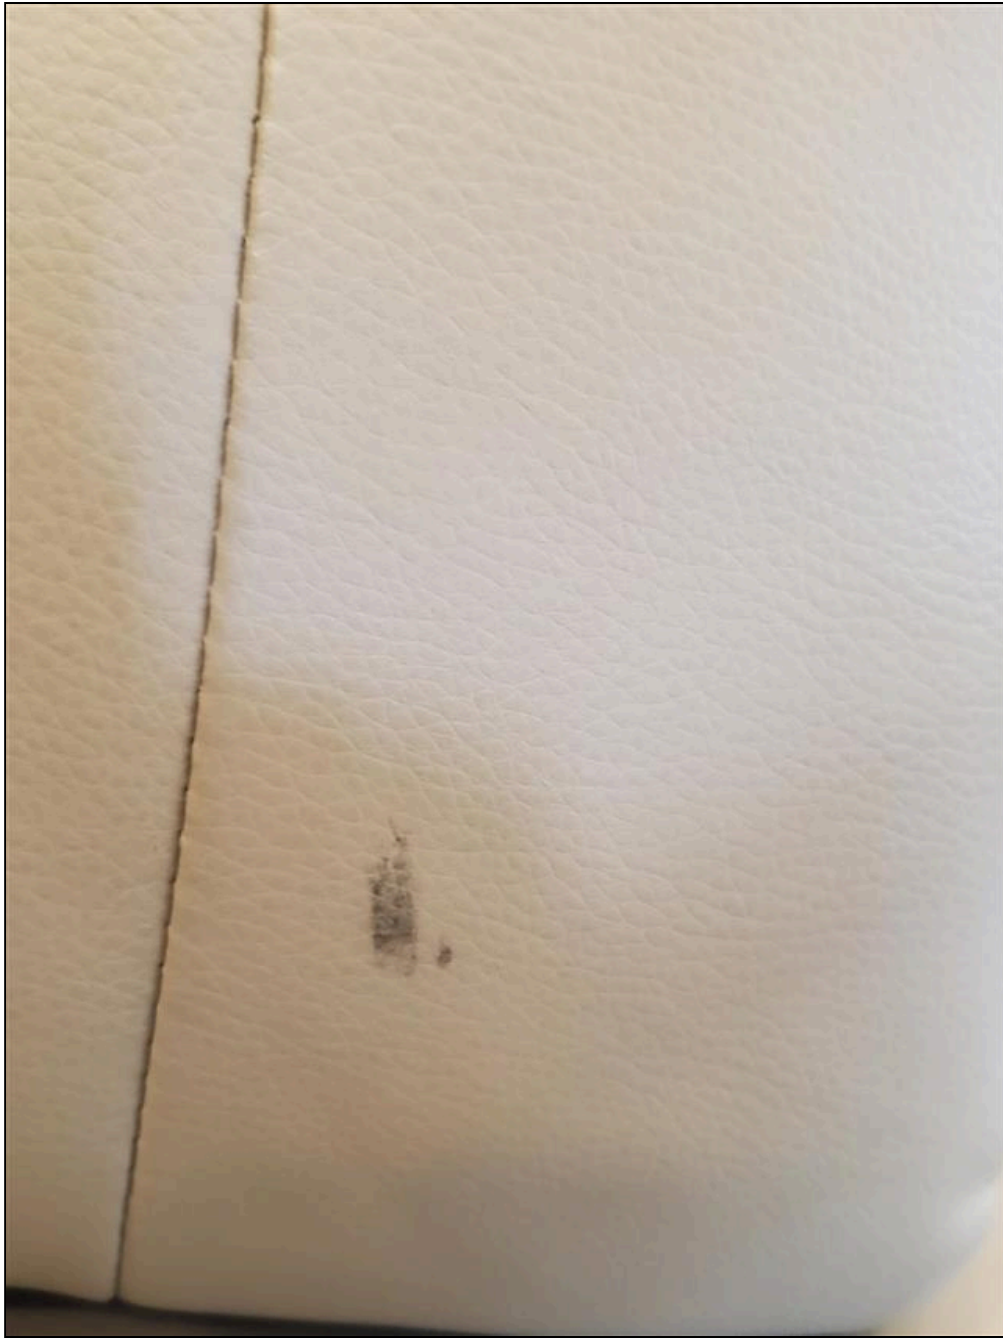
(1) Residues or Stains were Observed on the Material

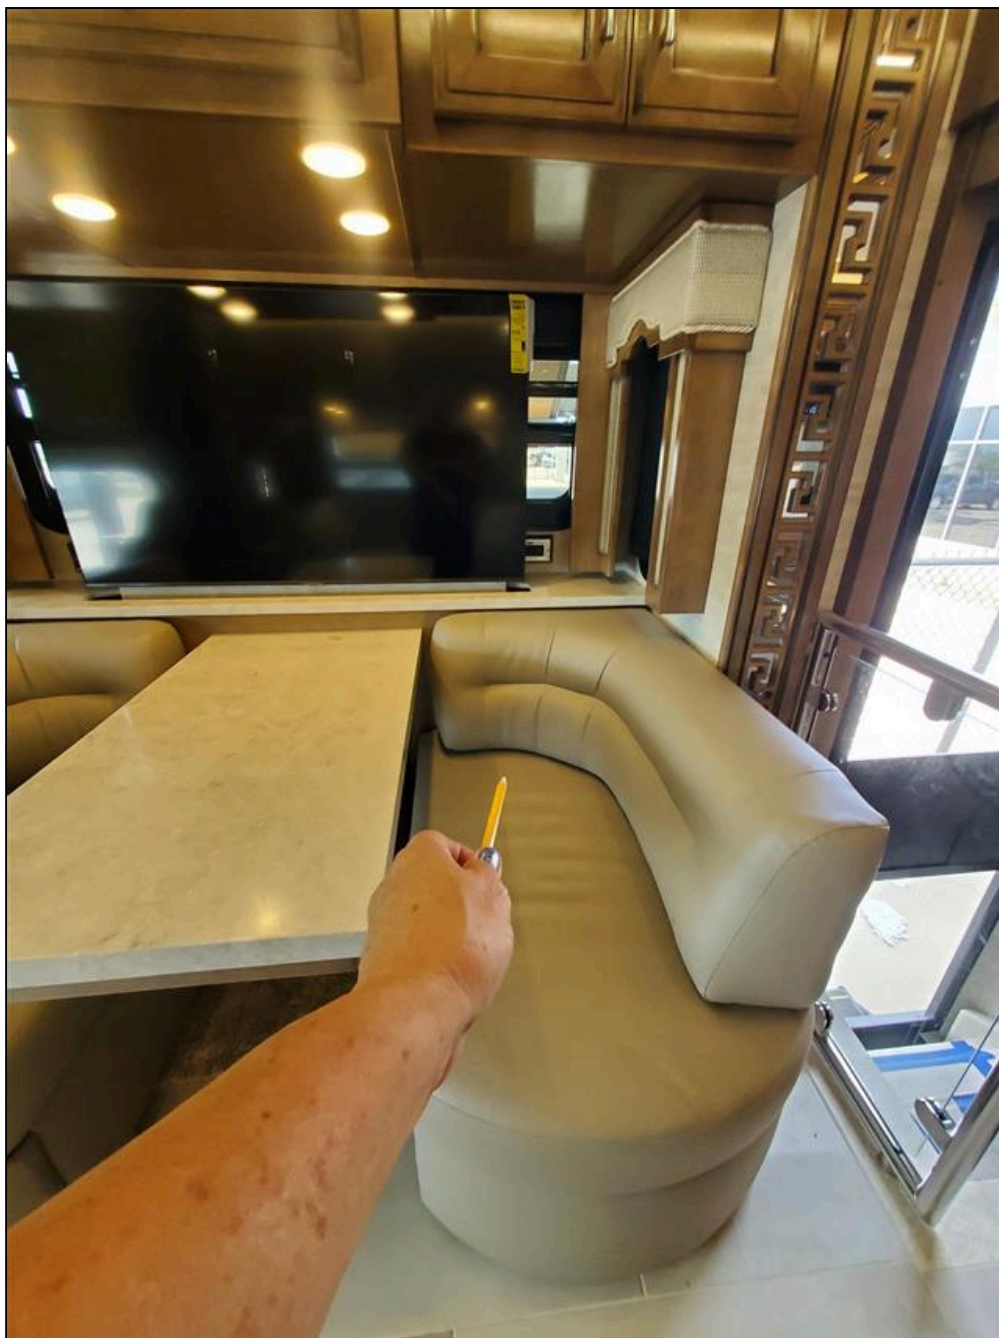
(2) Residues or Stains were Observed on the Material

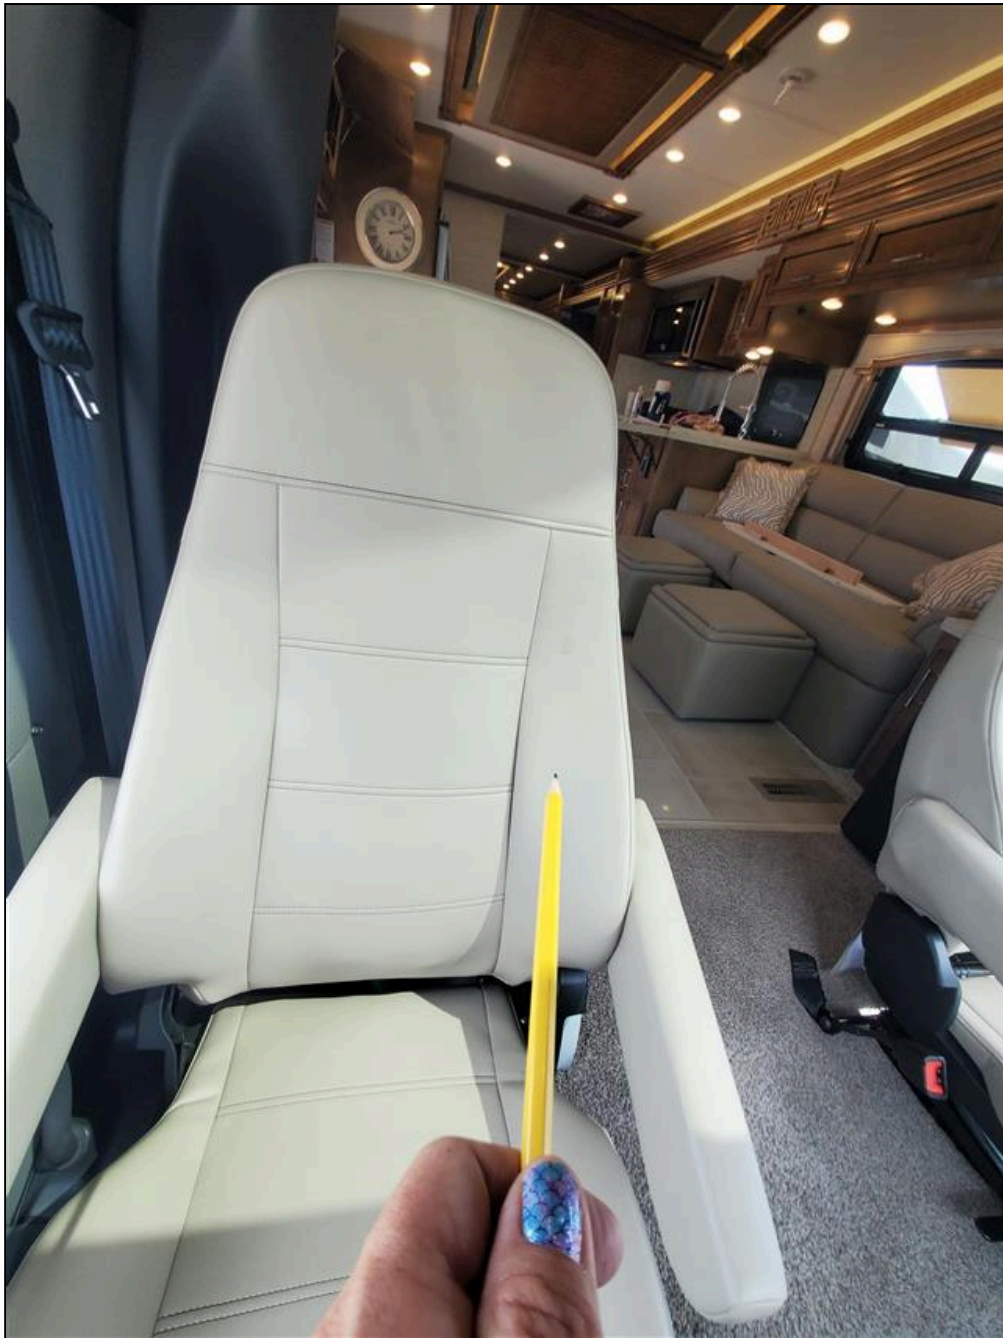
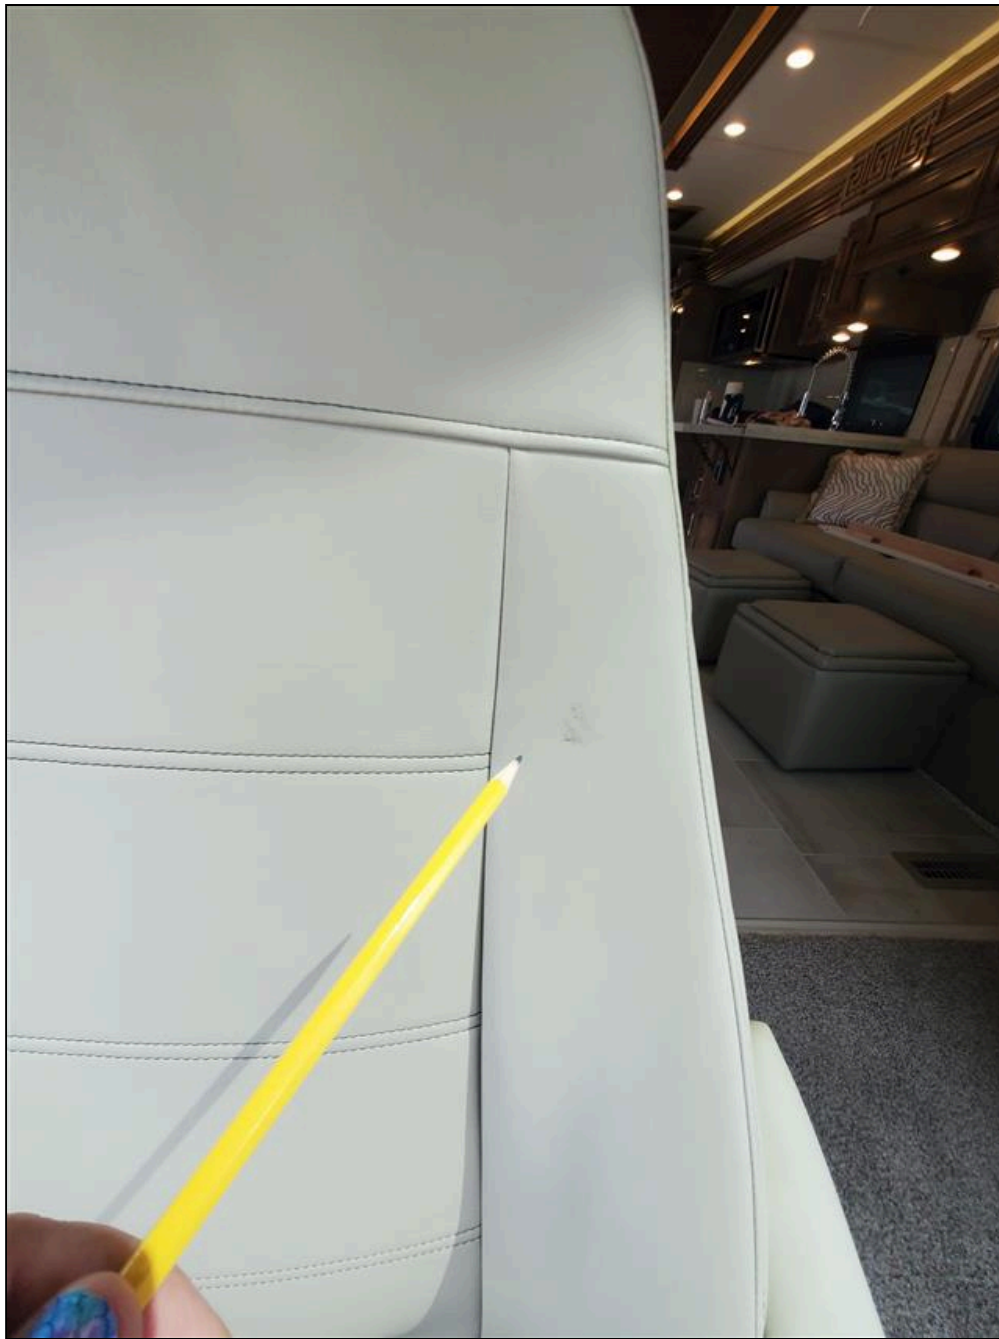
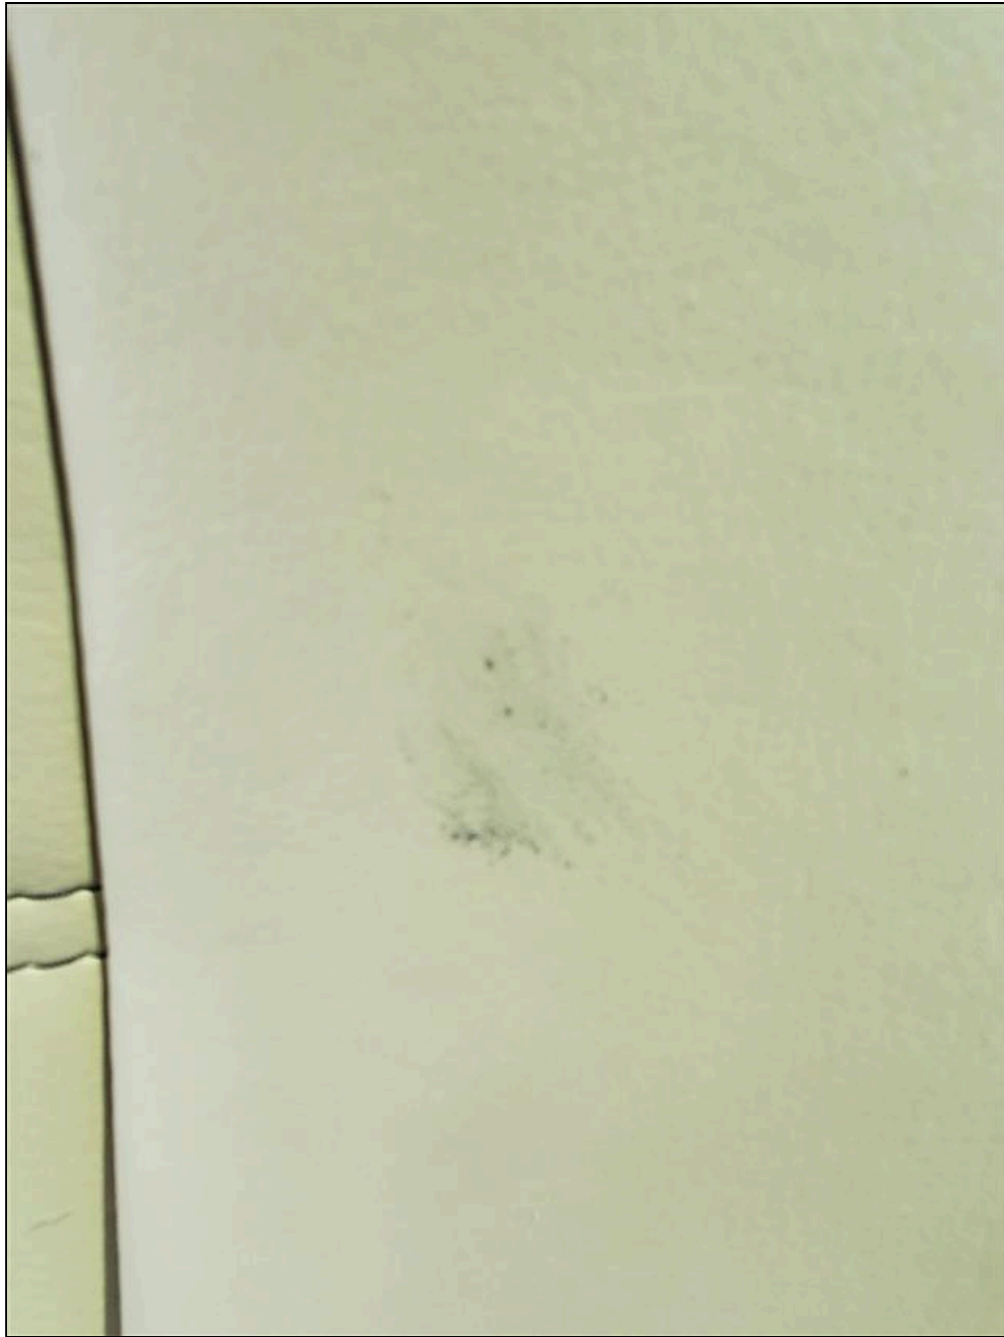
(2) Stain or Residue was Observed
