RV Inspection Report

**Inspection Date / RV Model:
Newmar Superstar 4065 2023**

**Pierre Fortin
5753 Highway 85 N Lot 8511
Crestview, Florida, 32536**

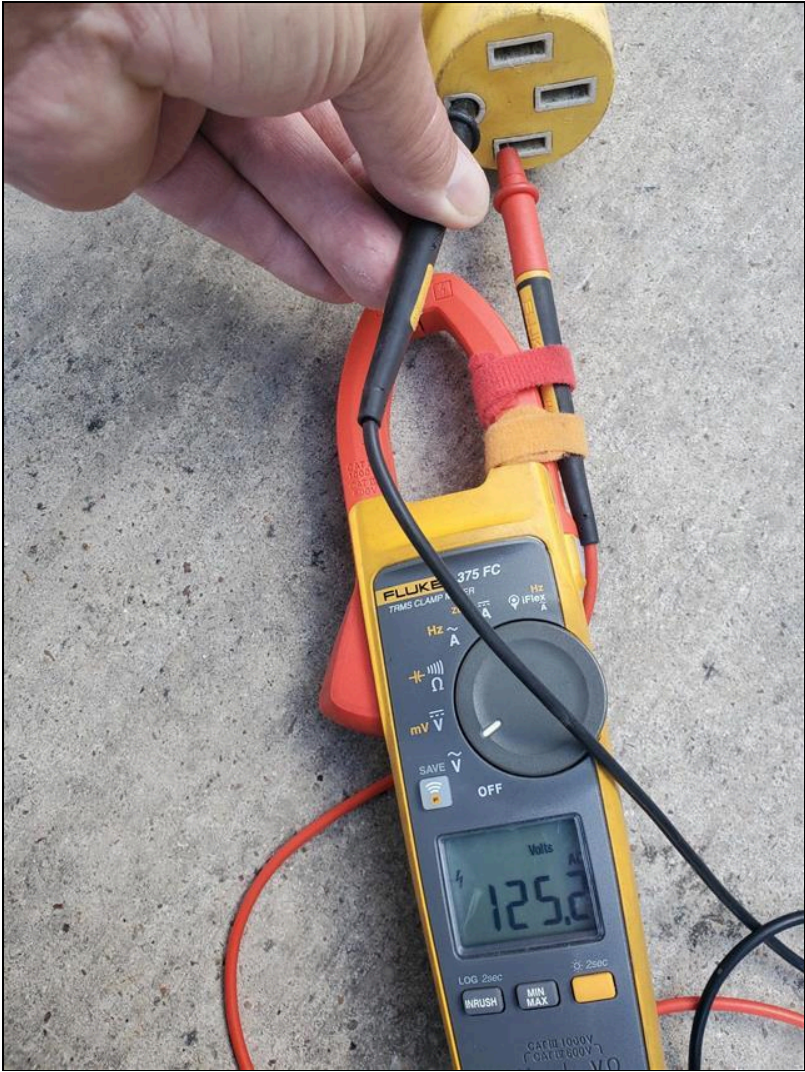
Power at Pedestal Verified Before Testing Unit
