RV Inspection Report

**Inspection Date / RV Model:
Newmar Superstar 4065 2023**

**Pierre Fortin
5753 Highway 85 N Lot 8511
Crestview, Florida, 32536**

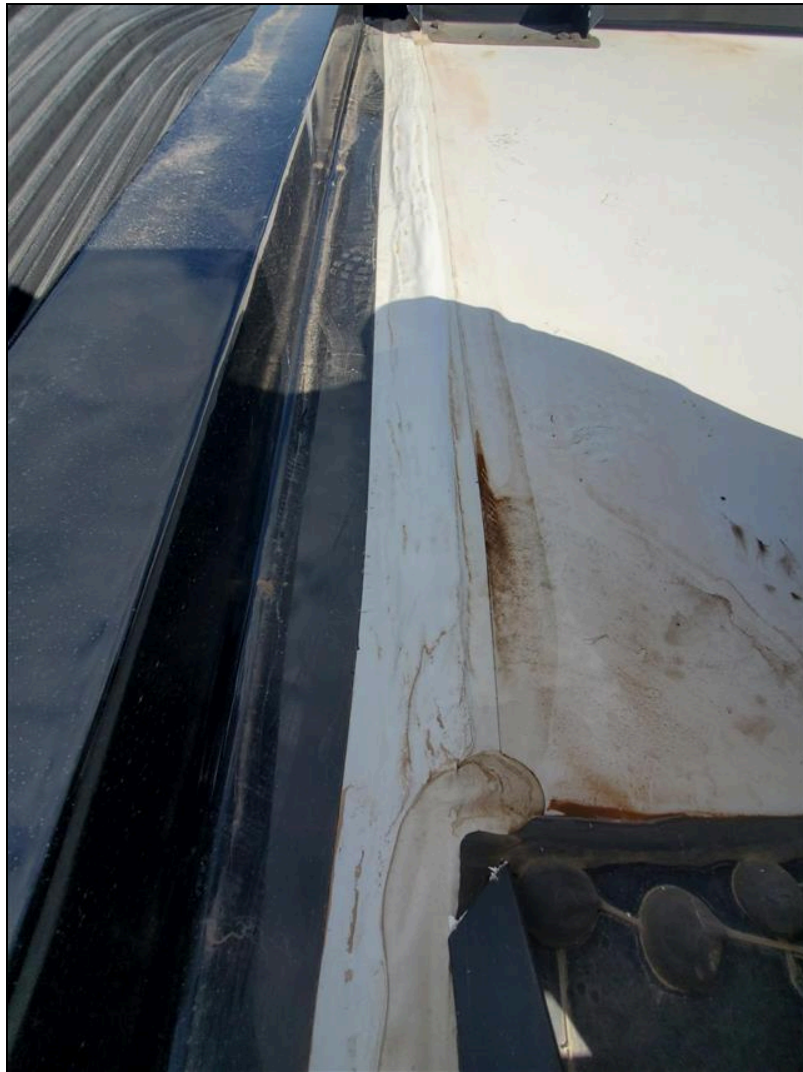
\$ (2) Sealant required to avoid further water intrusion on the top seam of the rubber joint

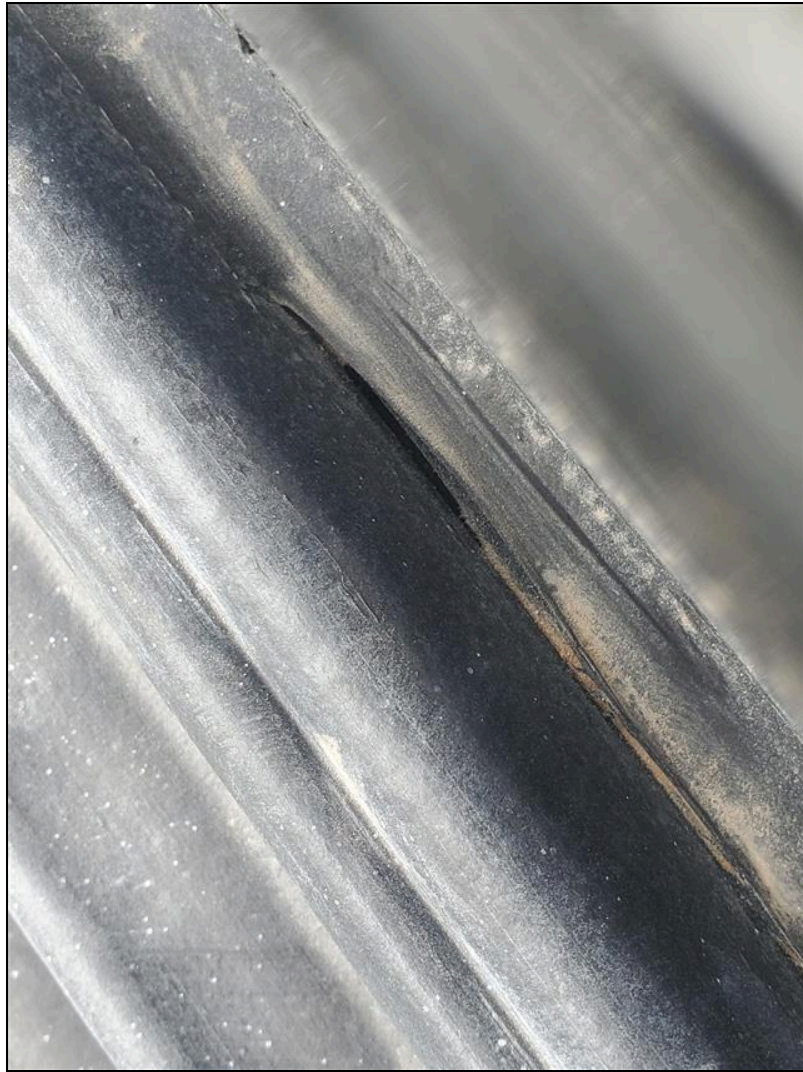
2.2 Trim Rail (Curbside)

Trimrail curbside view from front to rear

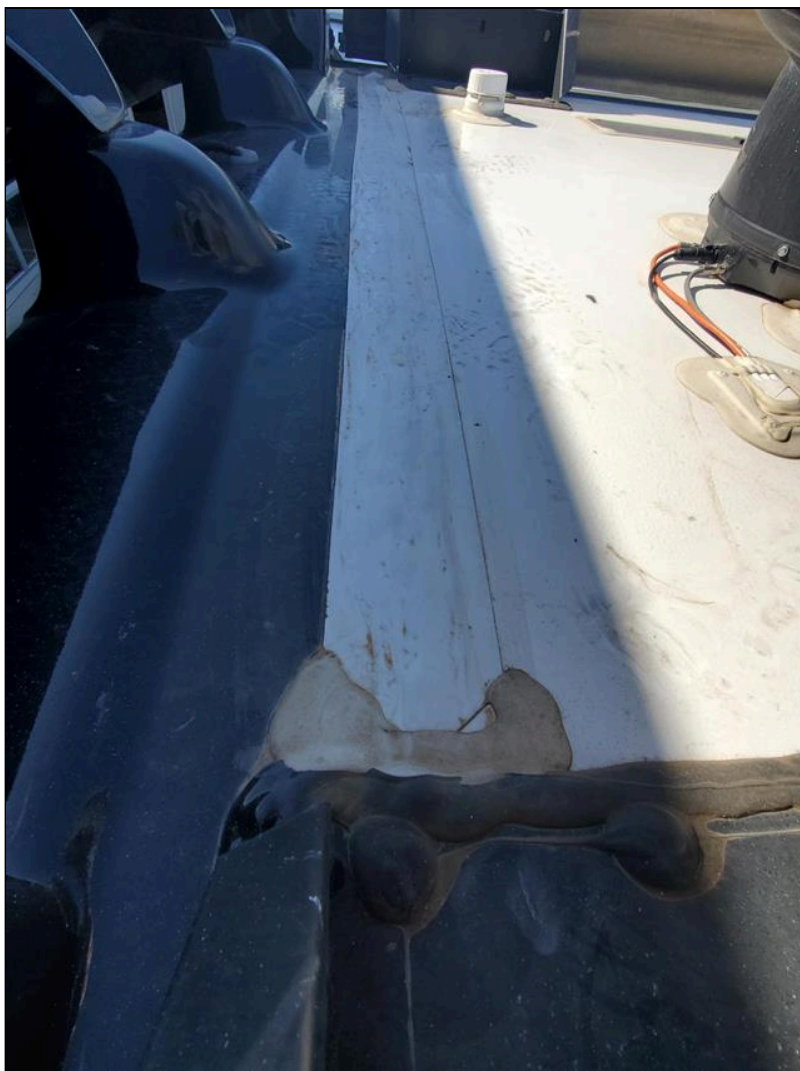
2.4 Trim Rail (Streetside)

Trimrail track rubber material, protecting the screws from the element, is not inserted as intended and requires to be addressed to avoid water intrusion

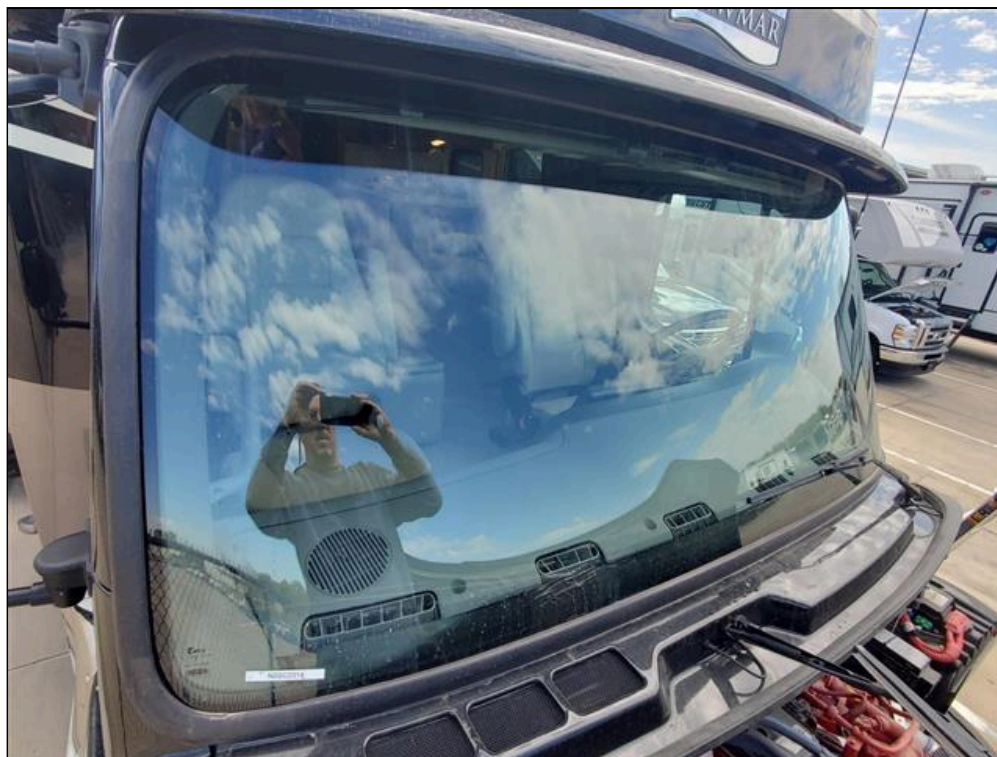
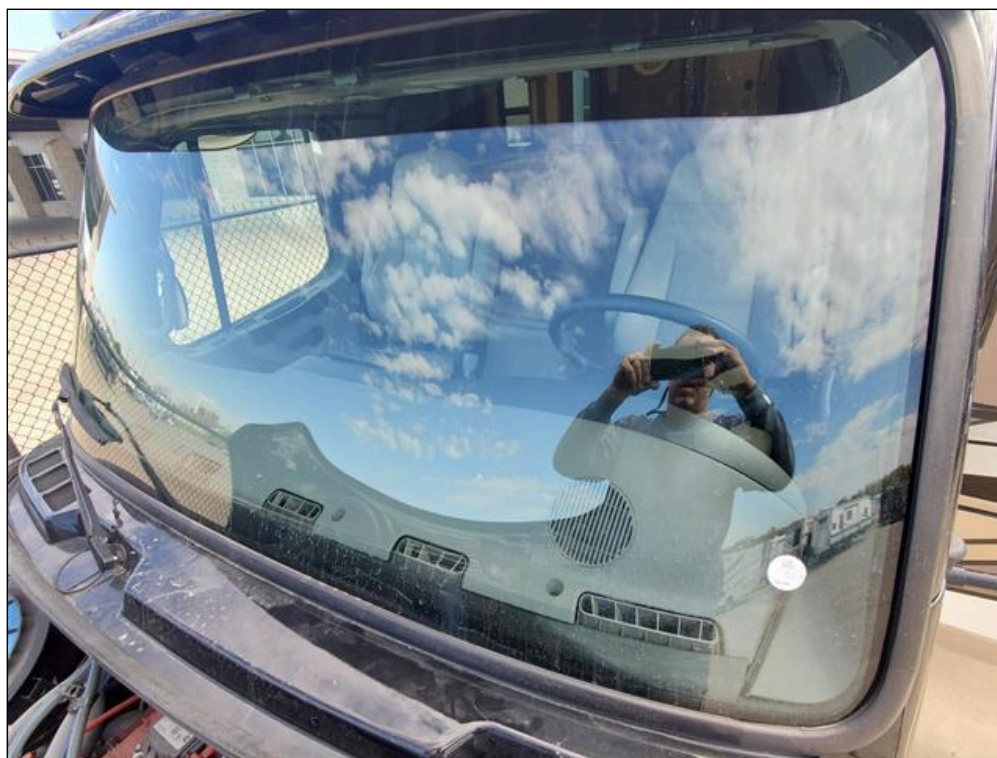
Windshield has no chips or cracks at moment of inspection

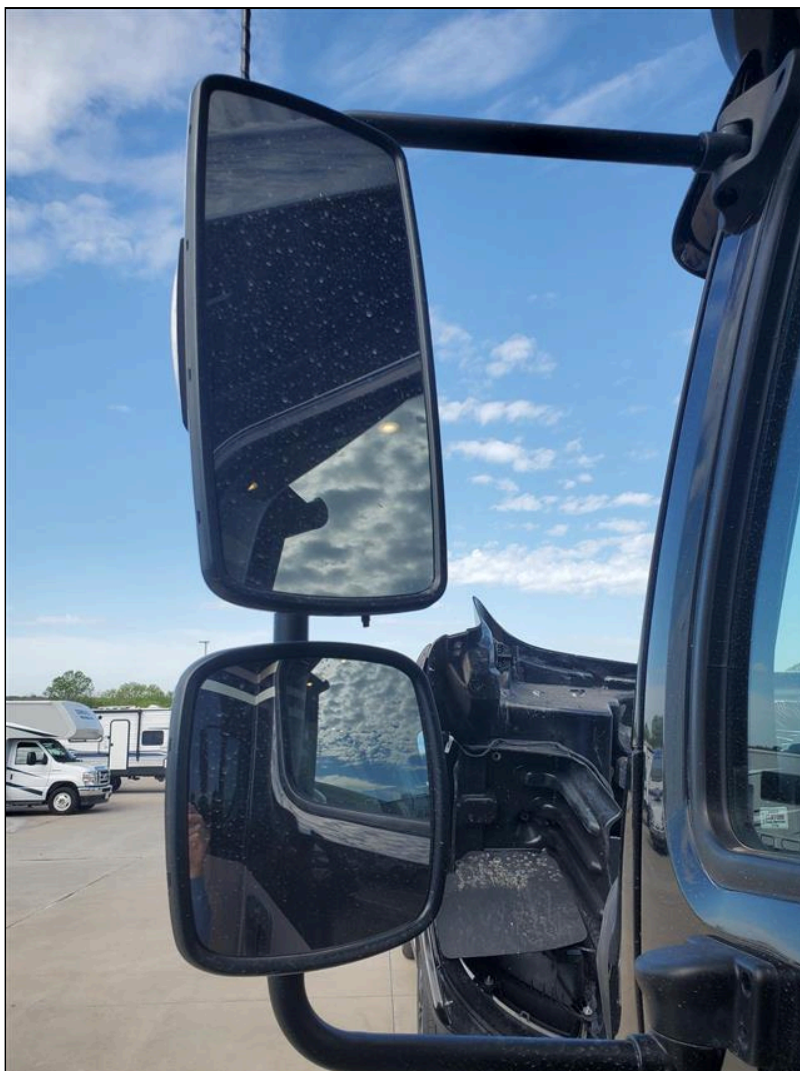
Every Functions operated as Intended at Moment of Inspection

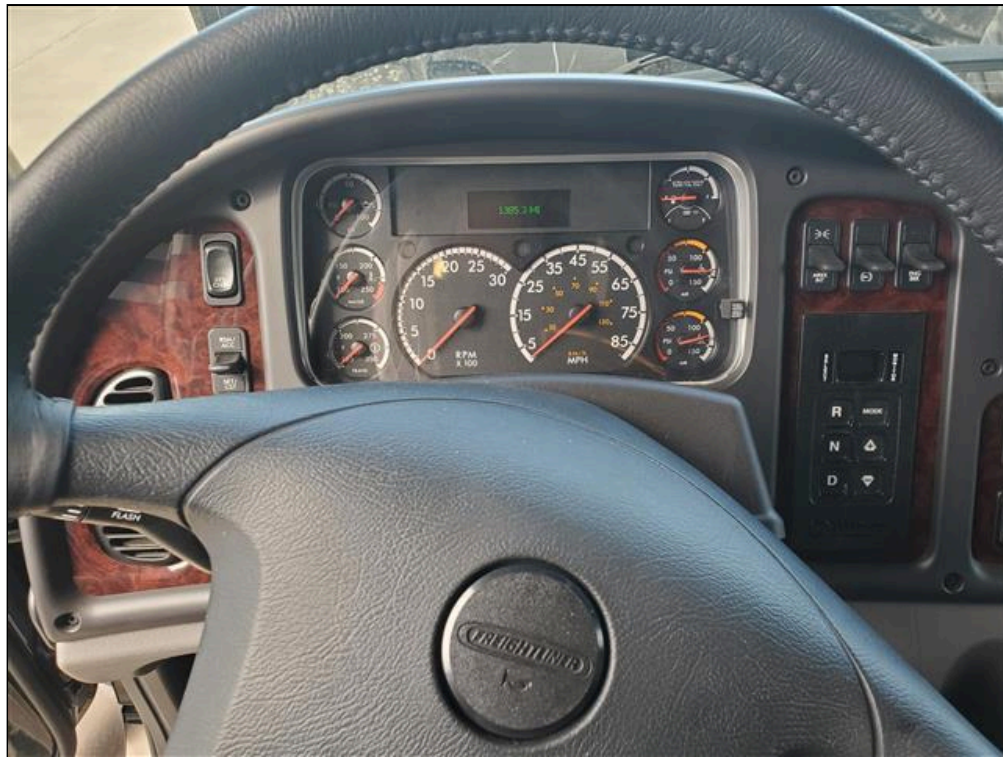
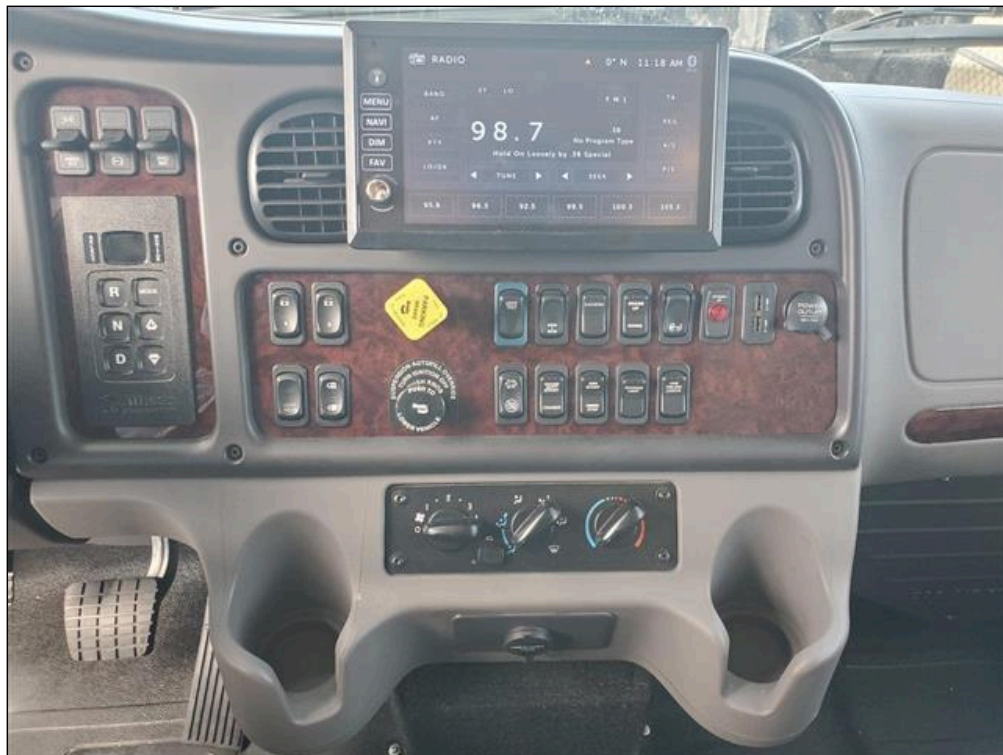
3.7 Dashboard - General Condition

Dashboard Looks in Good Condition

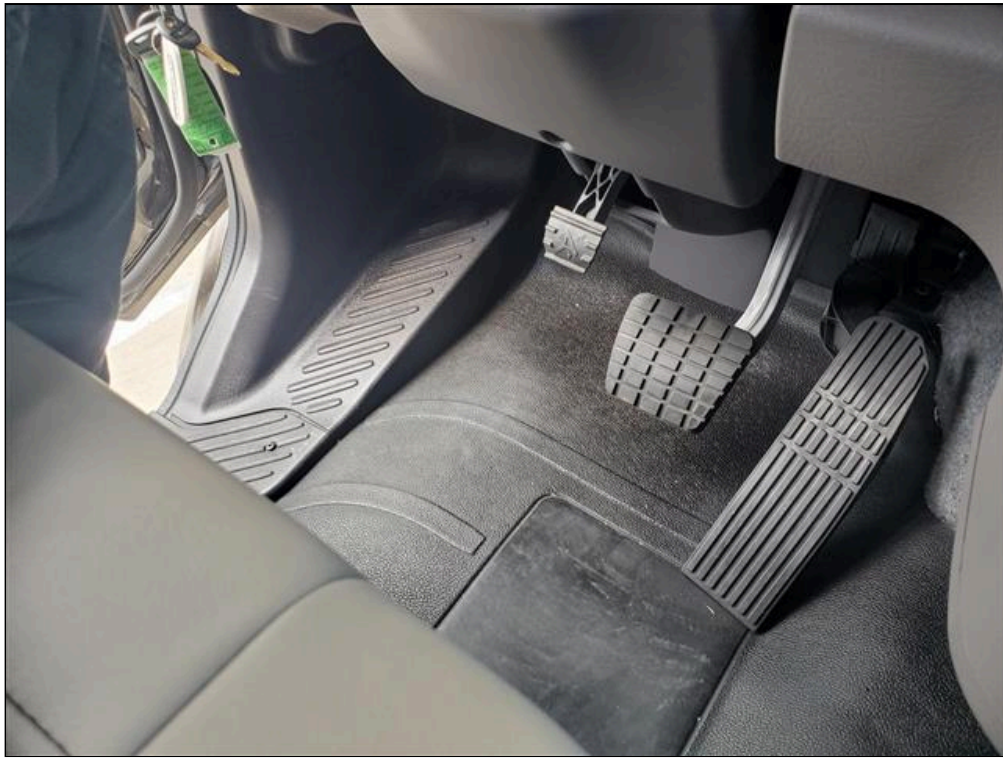
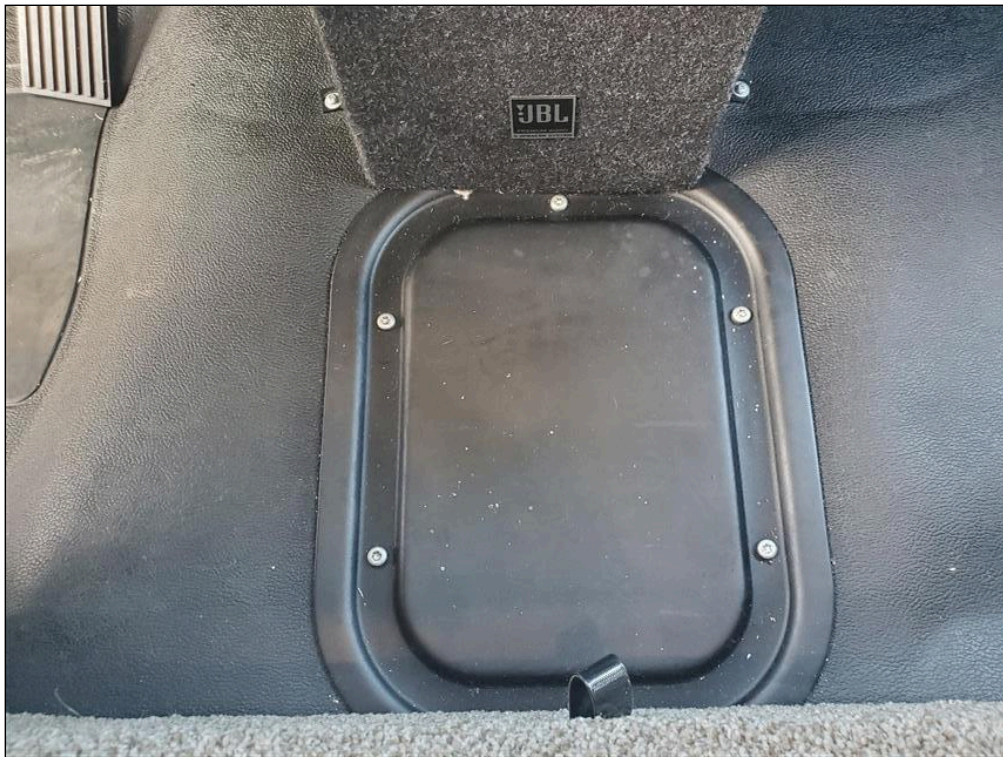
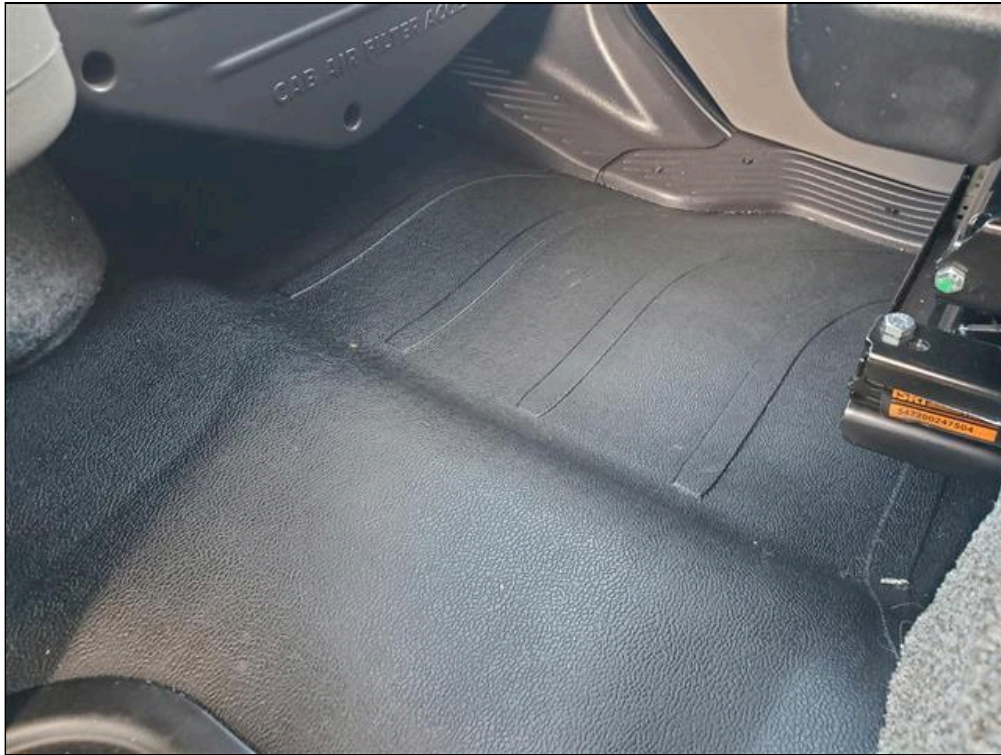
3.8 Driving Area - General Condition

Cab Area in Good Condition

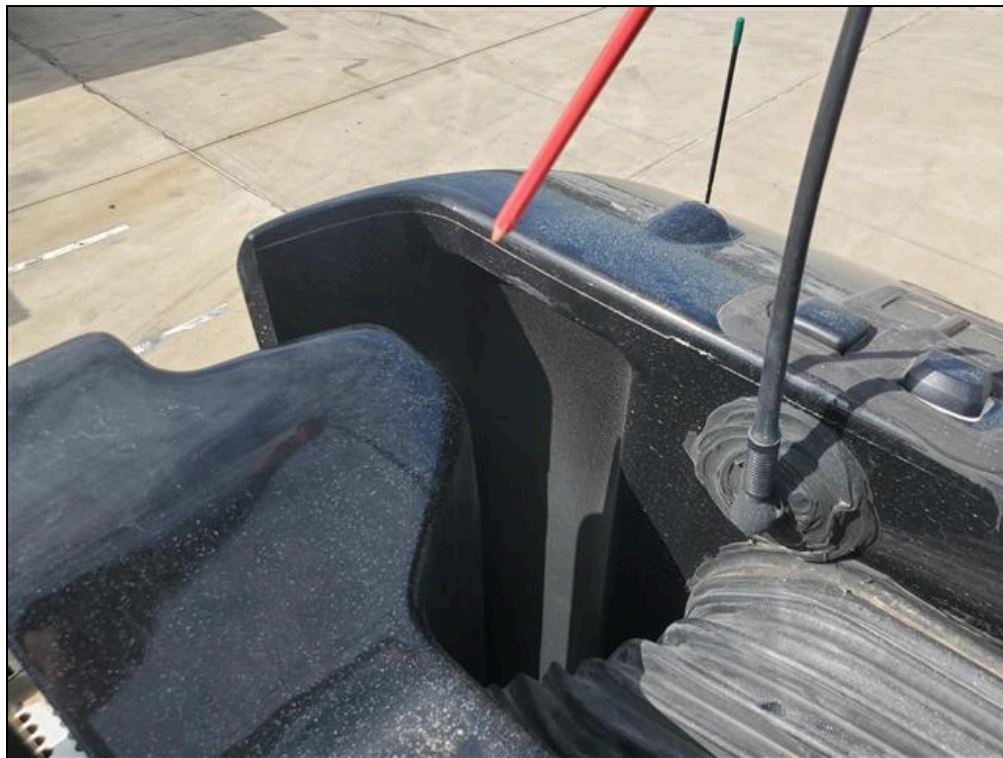
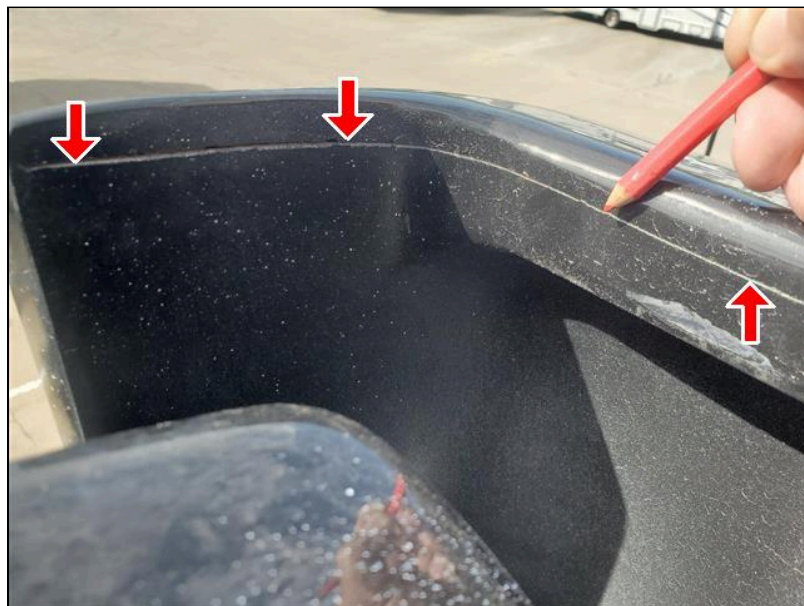
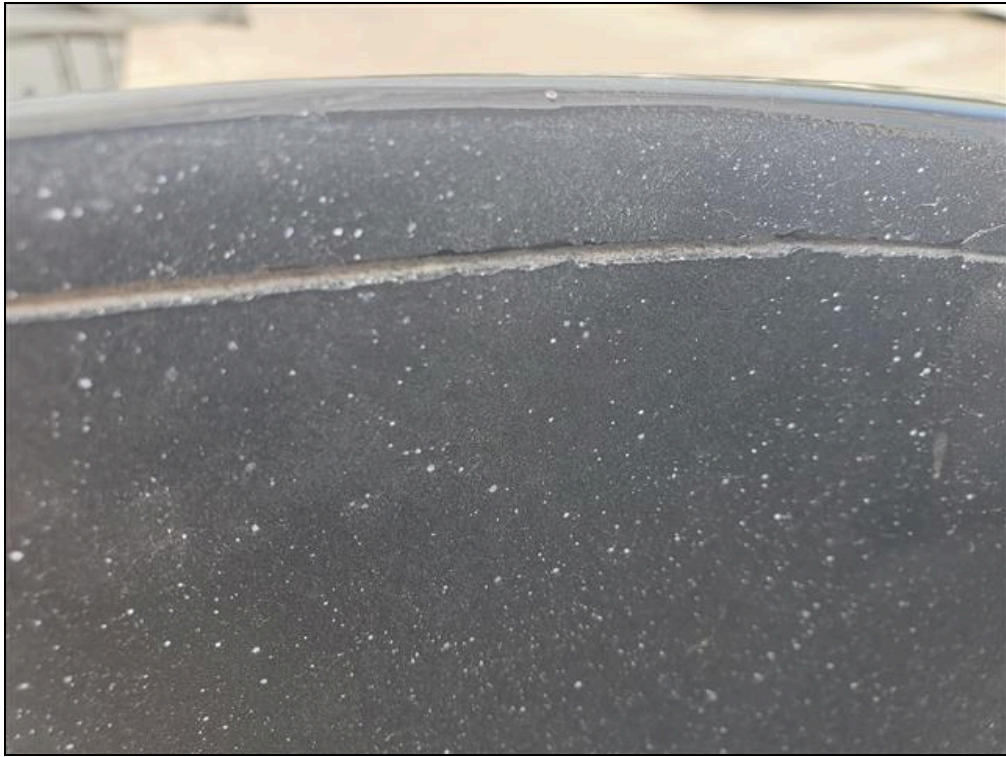
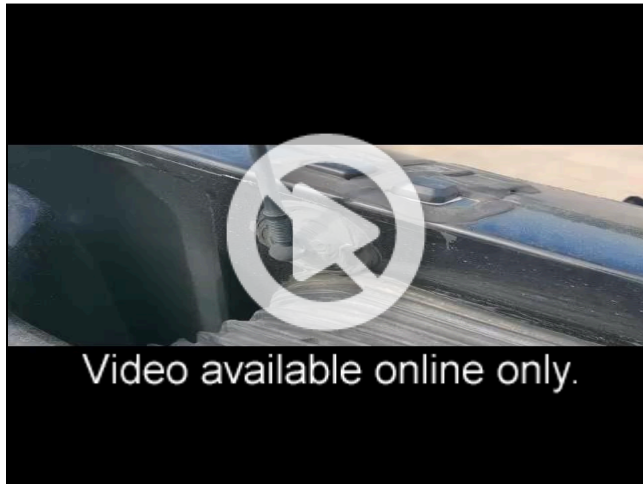
4.0.A Sidewall Condition

(1) Inside corner of front cap is showing signs of separation

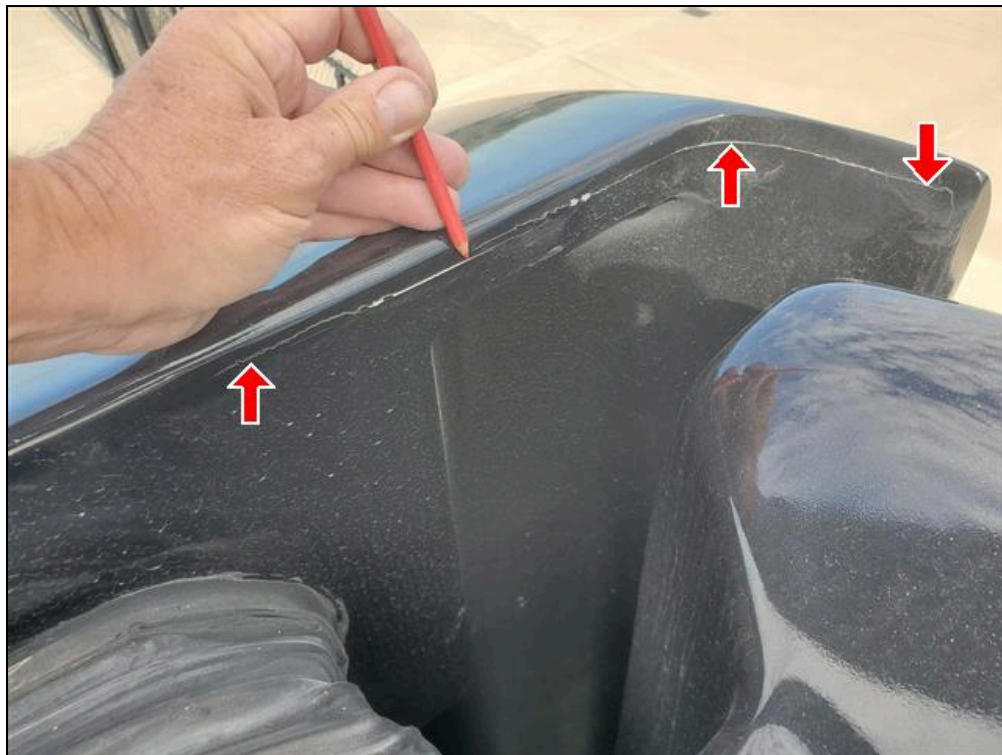
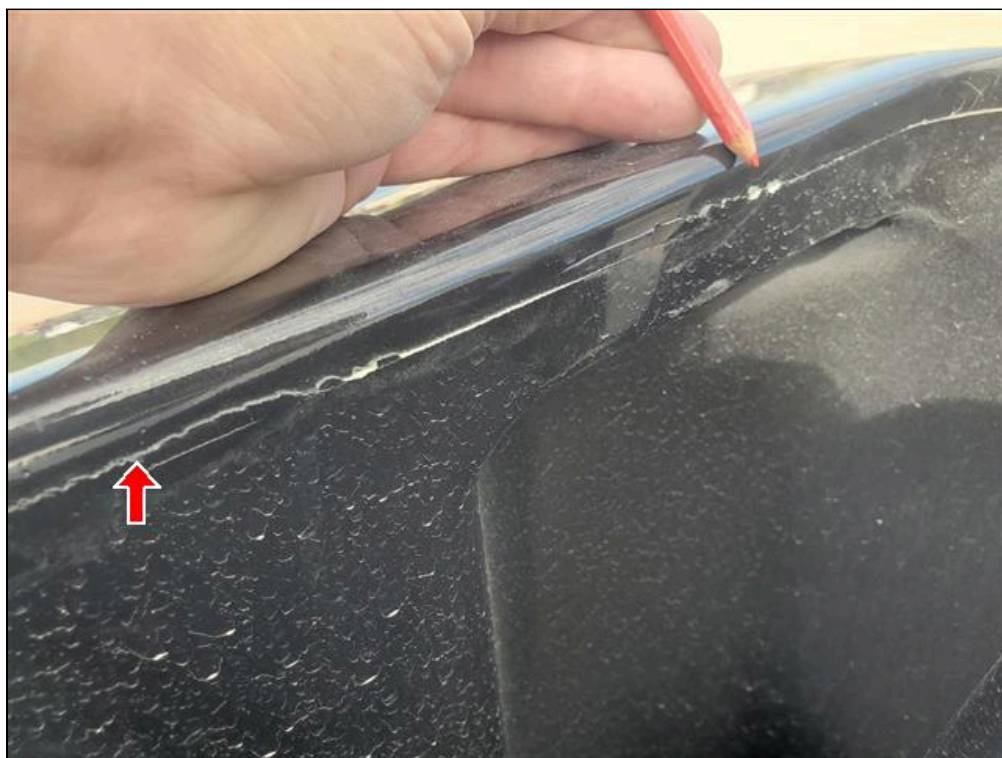
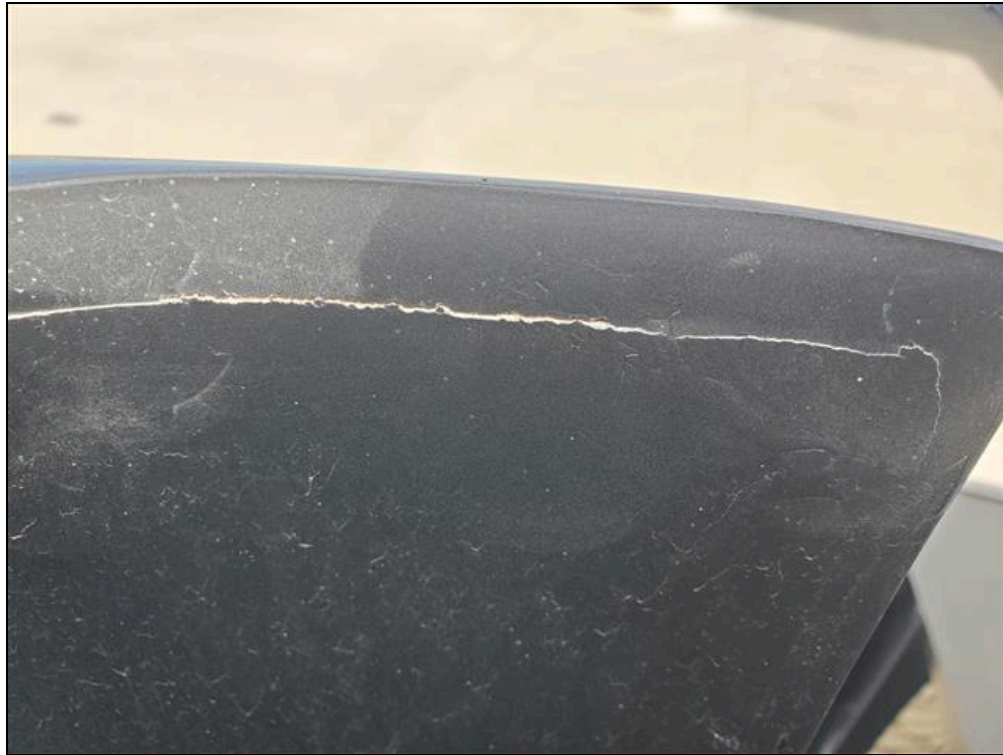
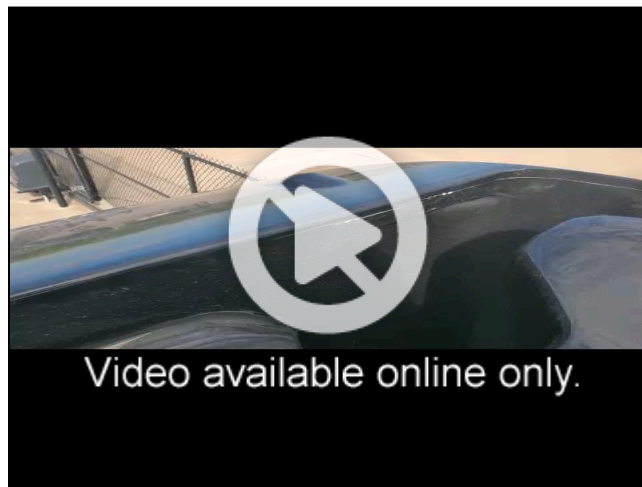
\$ (2) Inside upper corner of the cap shows signs of separation on both corners

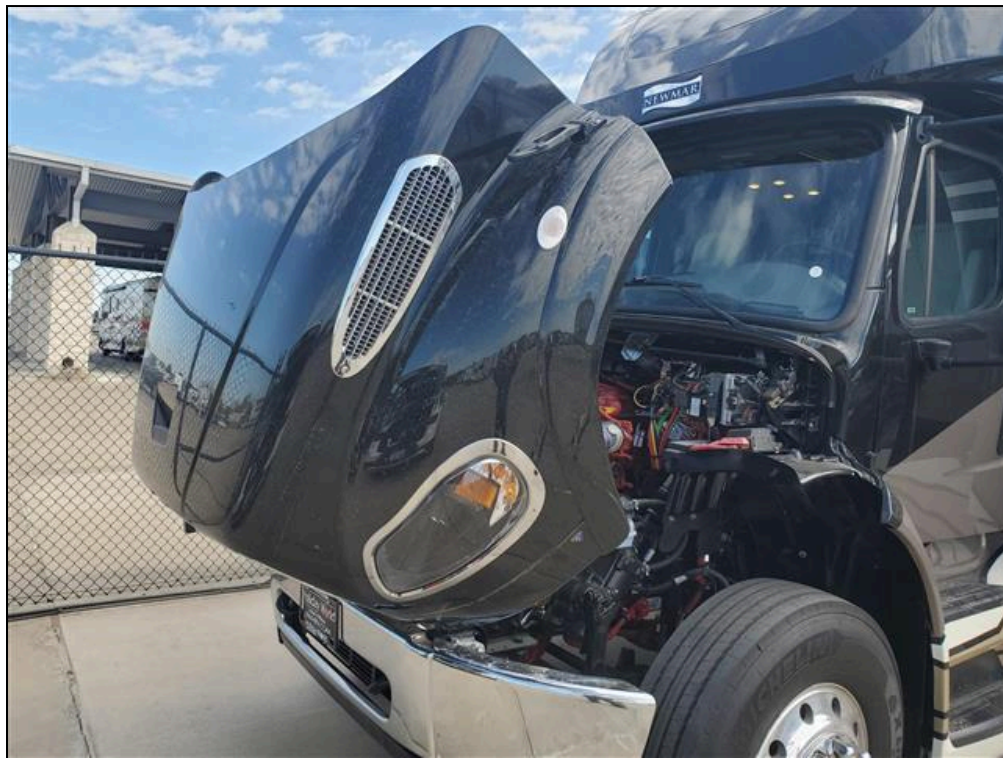
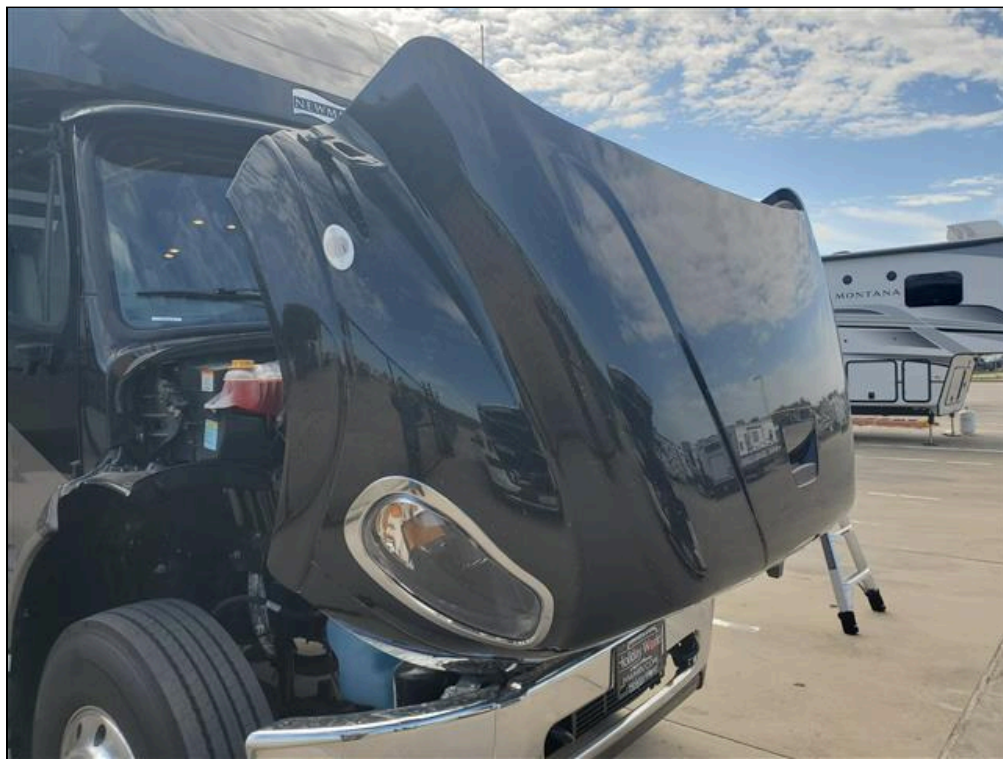
Hood Giving Access to Engine

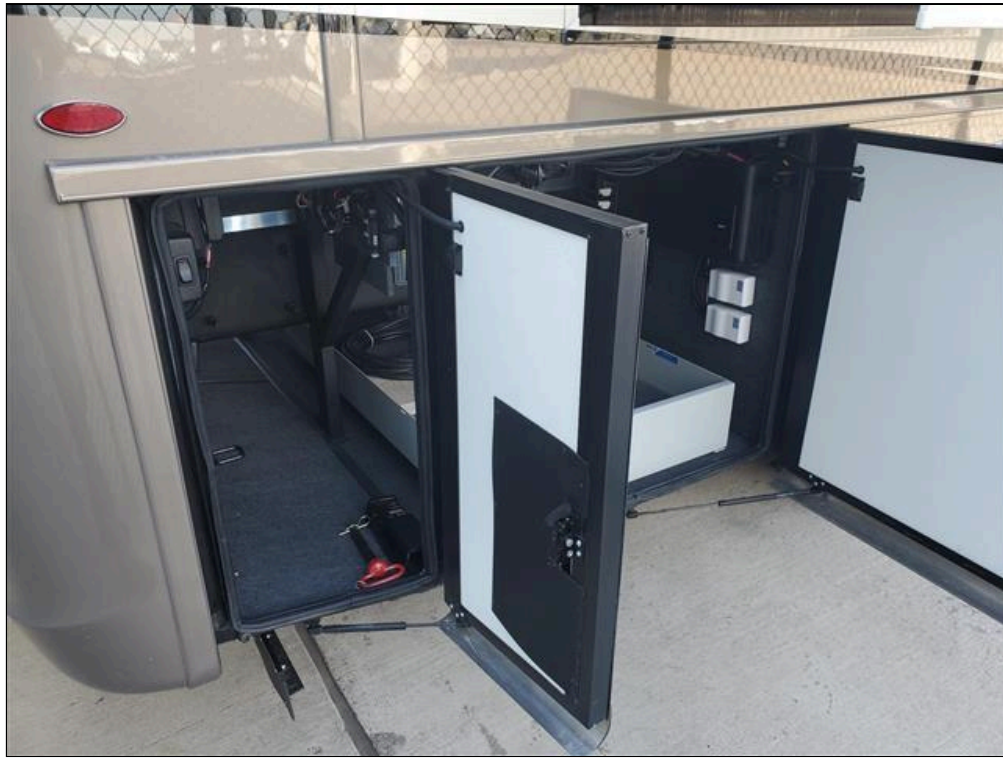
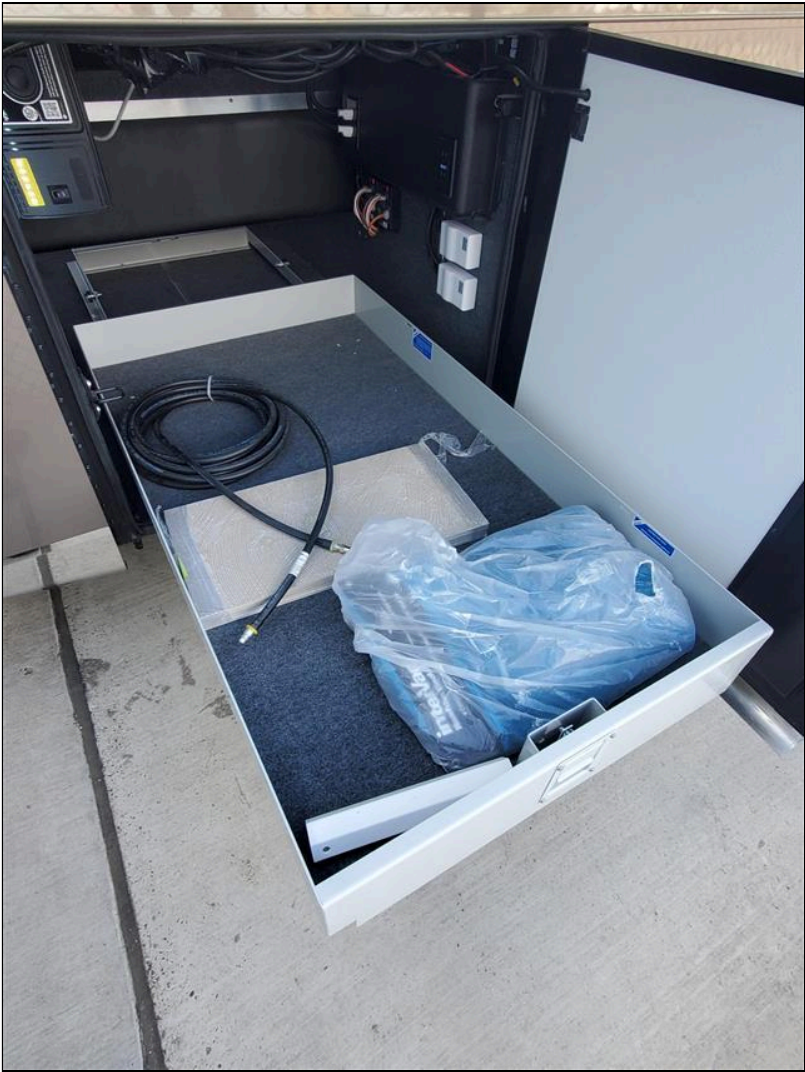
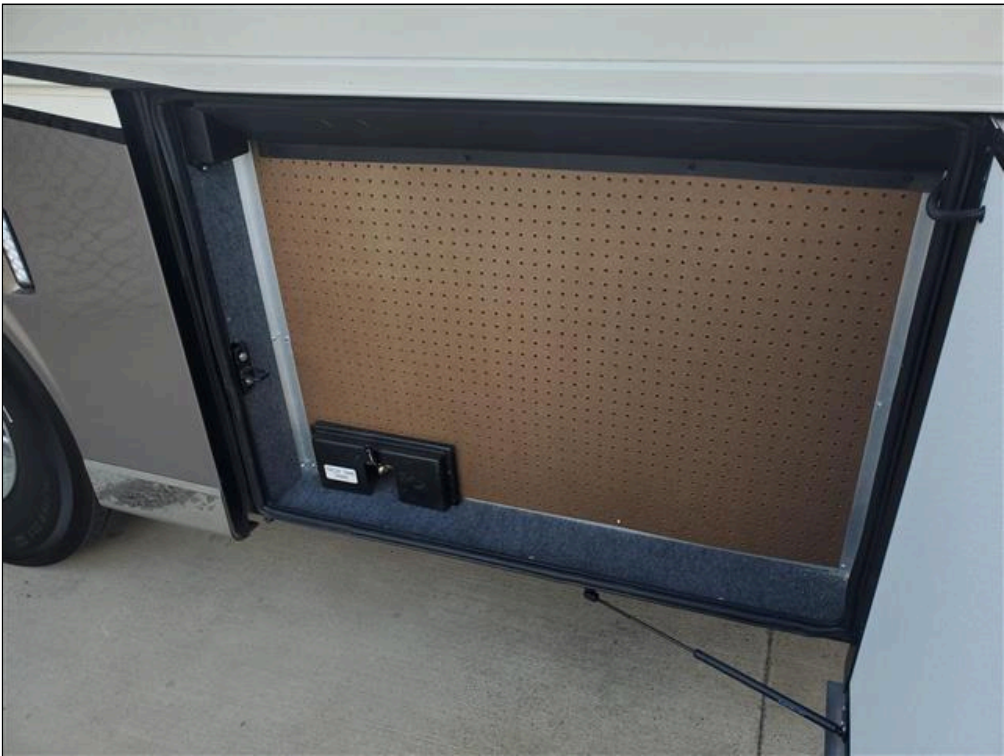
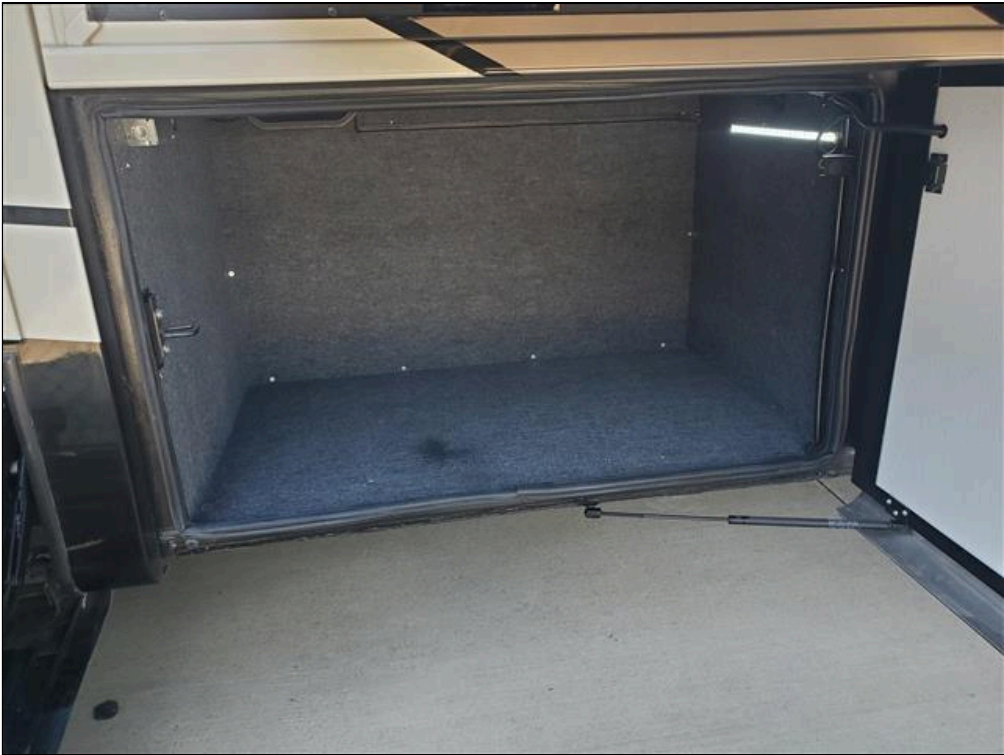
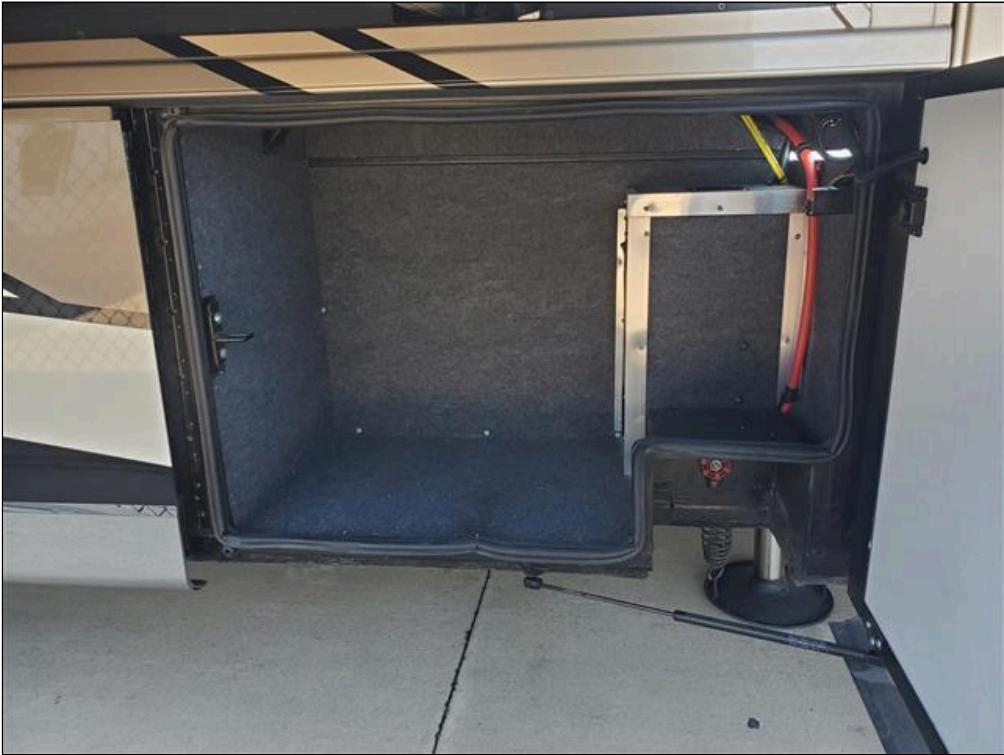
Cargo Doors Worked as Intended at Moment of Inspection

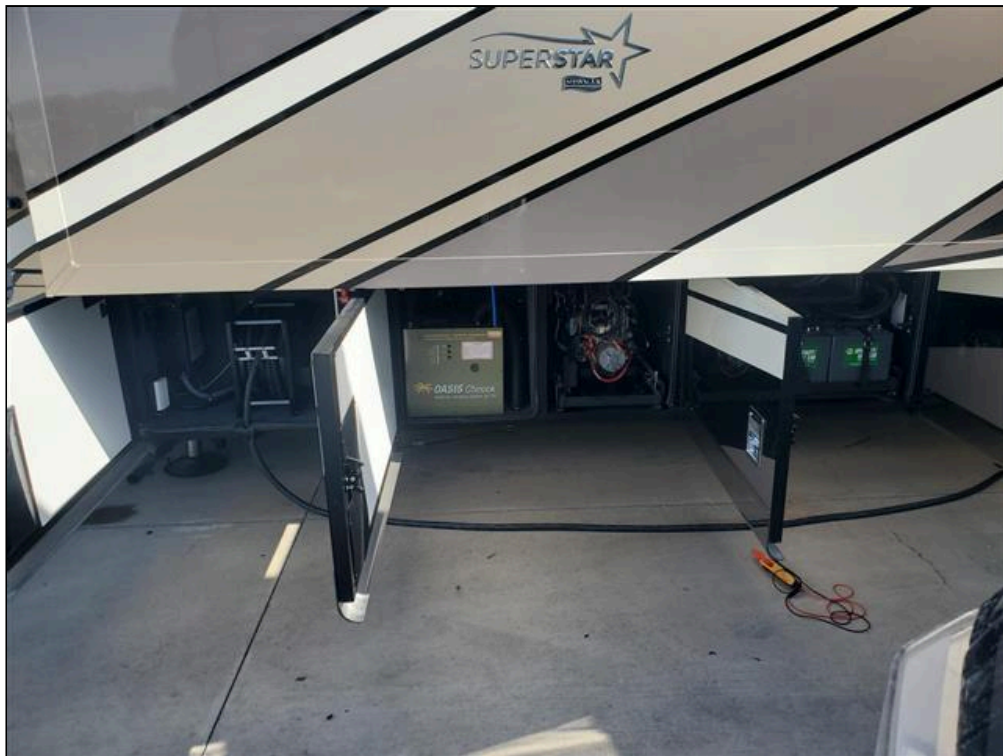
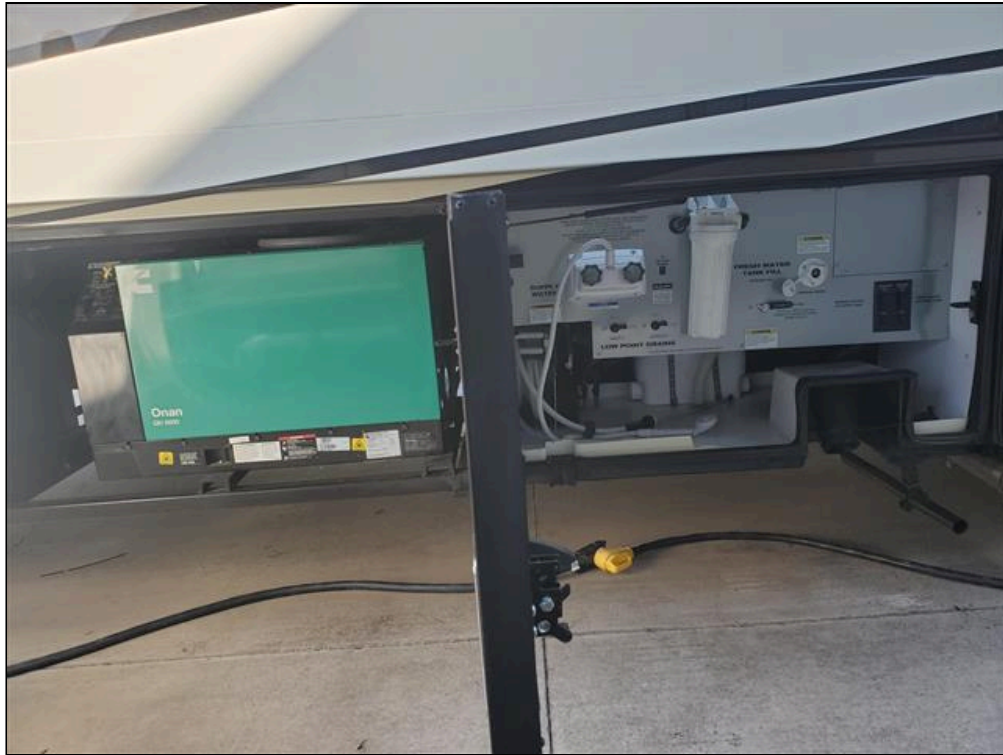
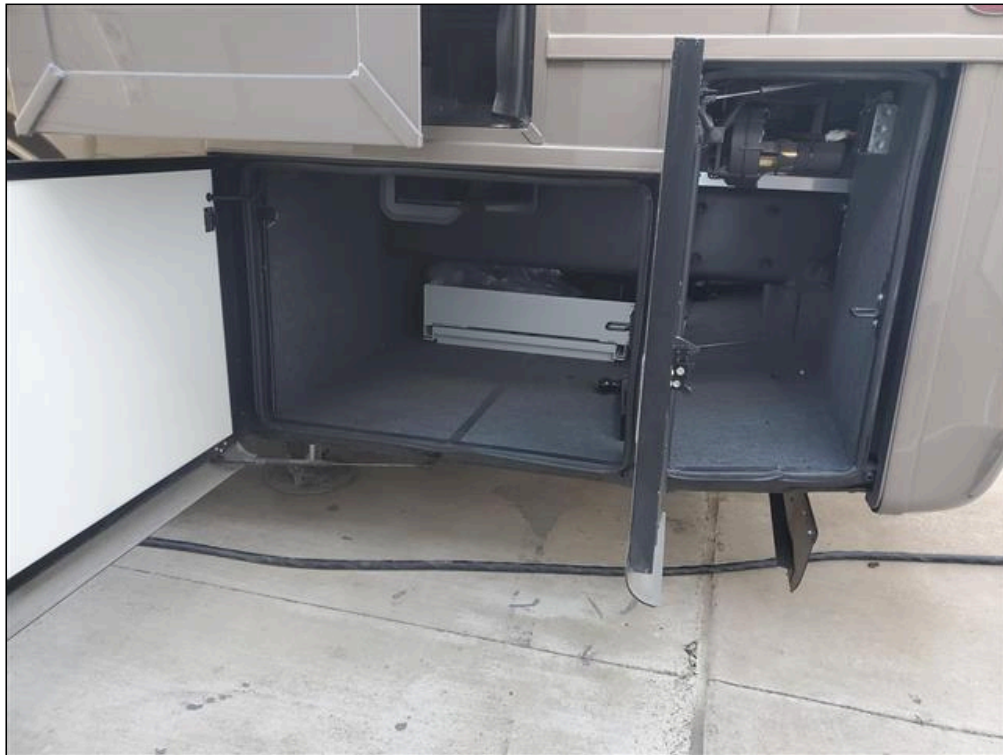
4.3.C Cargo/Access Doors or Hood

Cargo Doors Worked as Intended at Moment of Inspection

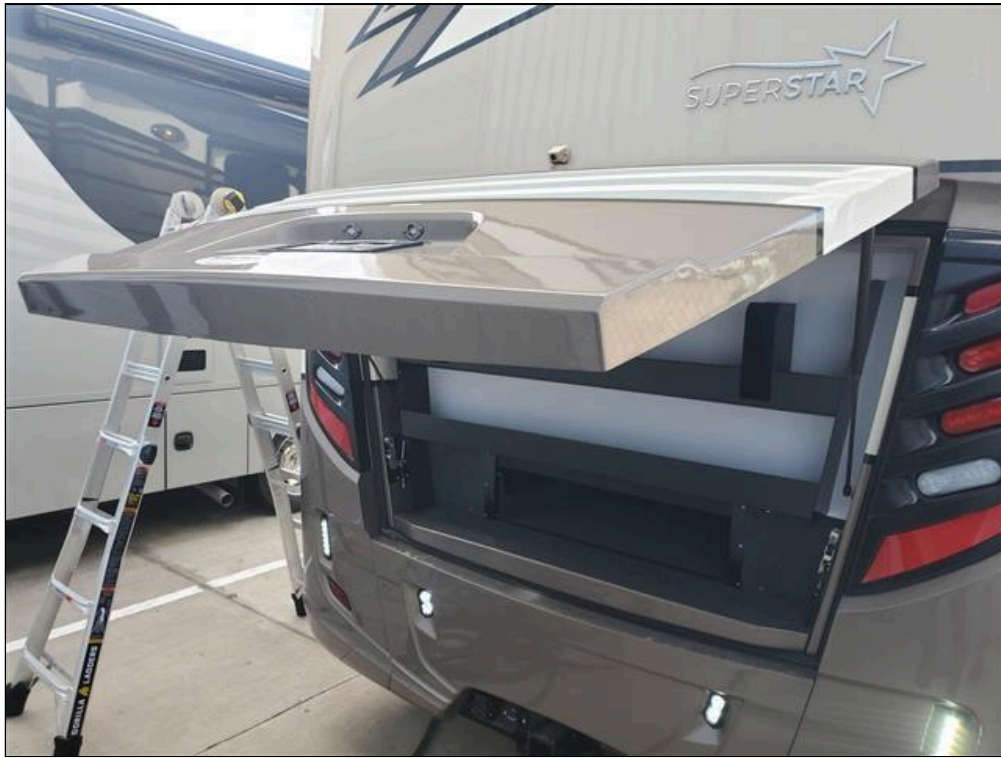
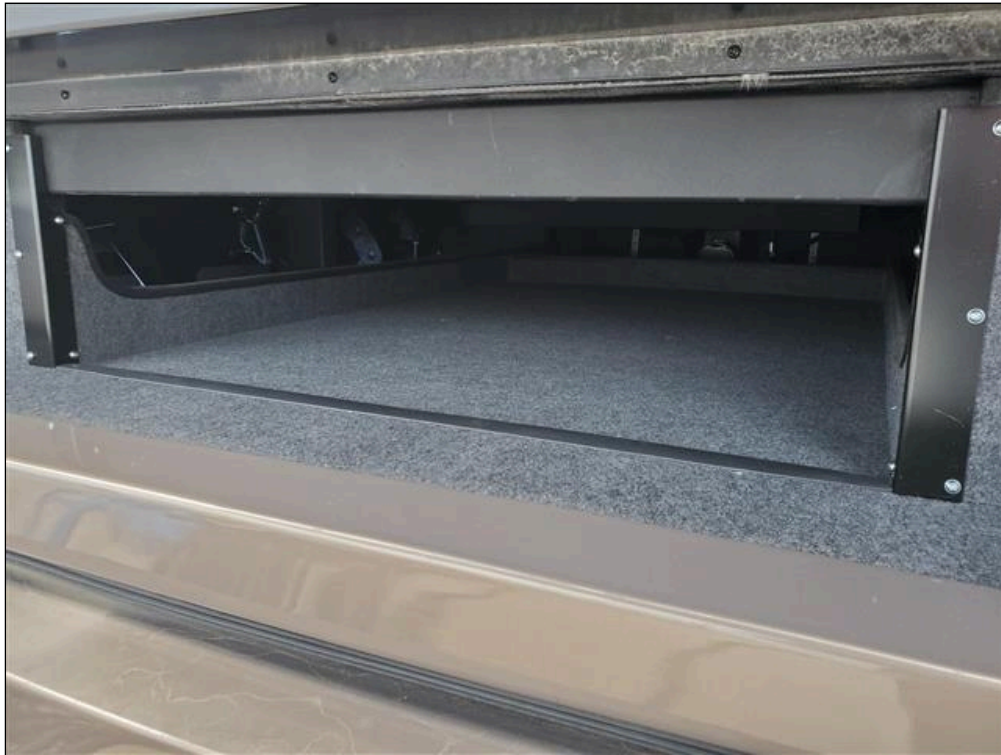
Trays and compartment worked as Intended
