RV Inspection Report

**Inspection Date / RV Model:
Newmar Superstar 4065 2023**

**Pierre Fortin
5753 Highway 85 N Lot 8511
Crestview, Florida, 32536**

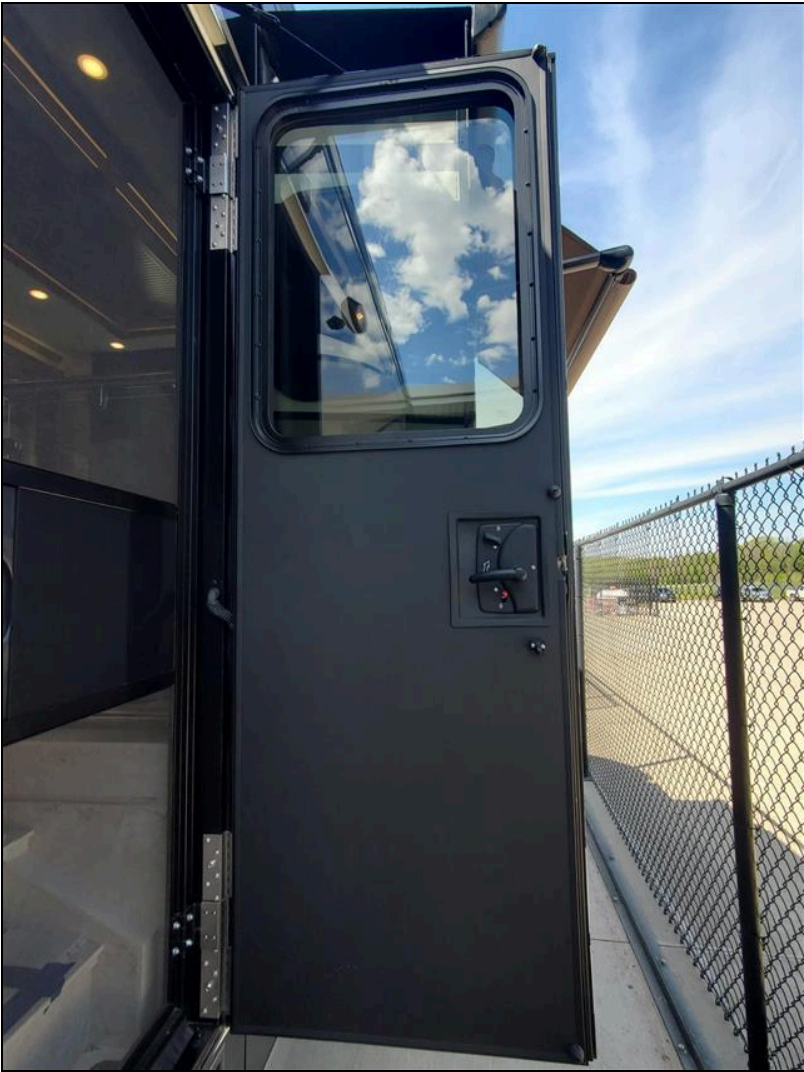
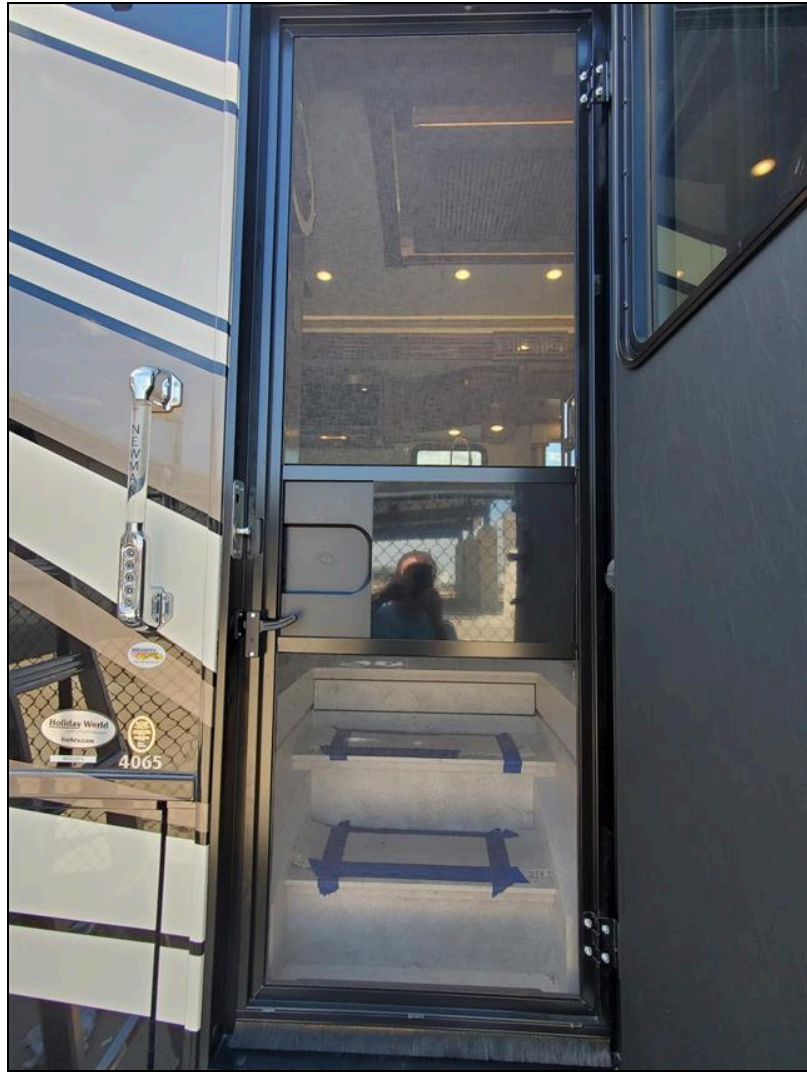
(1) Entrance Door:

Poor

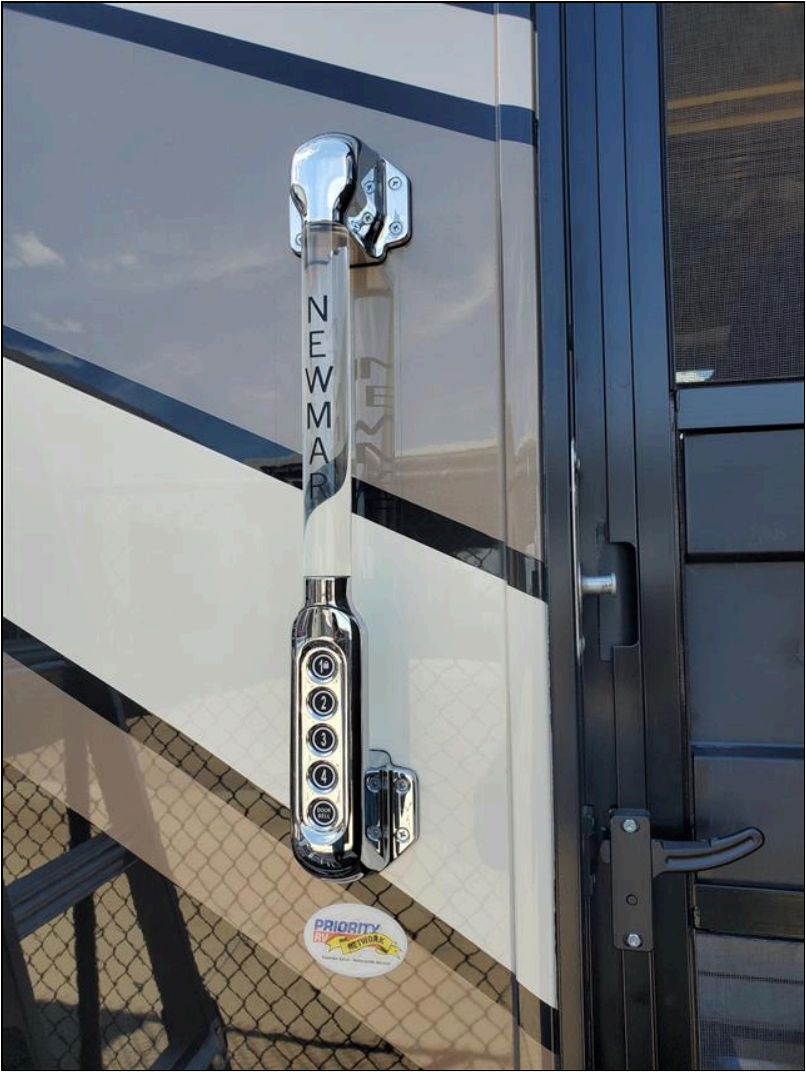
(2) Grab Handle w/ entry code

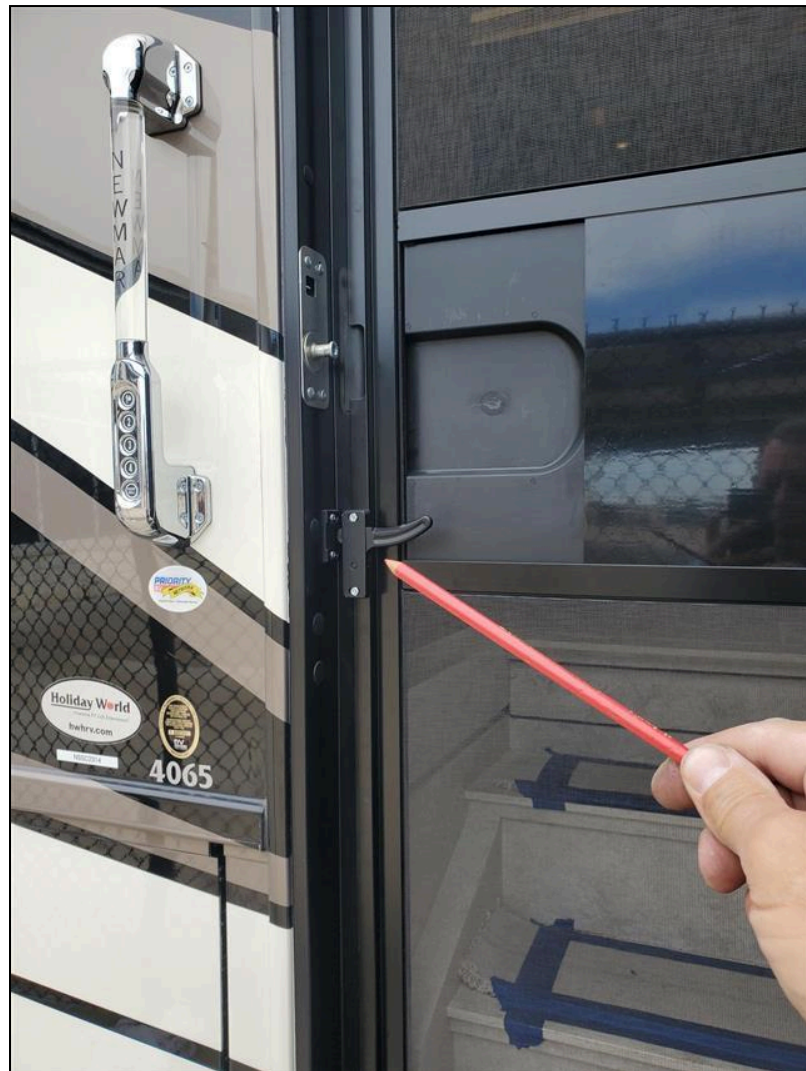
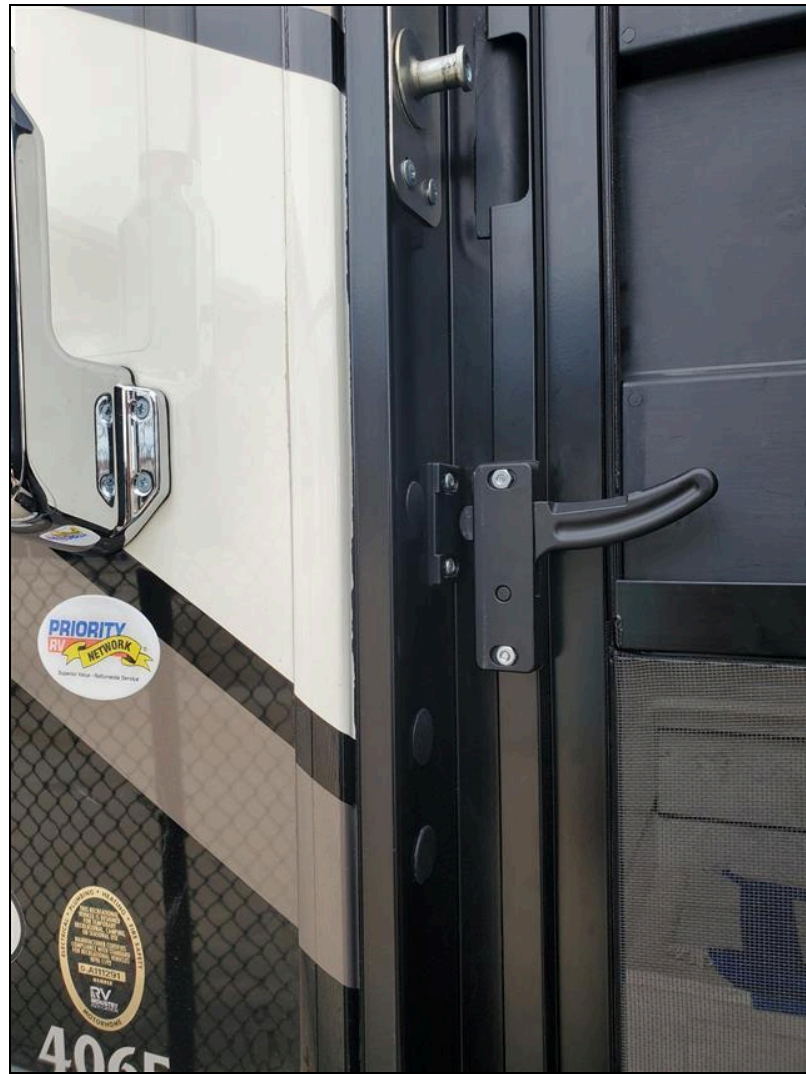
5.0.A Door Condition

(3) Screen door latch requires adjustment to operate as intended

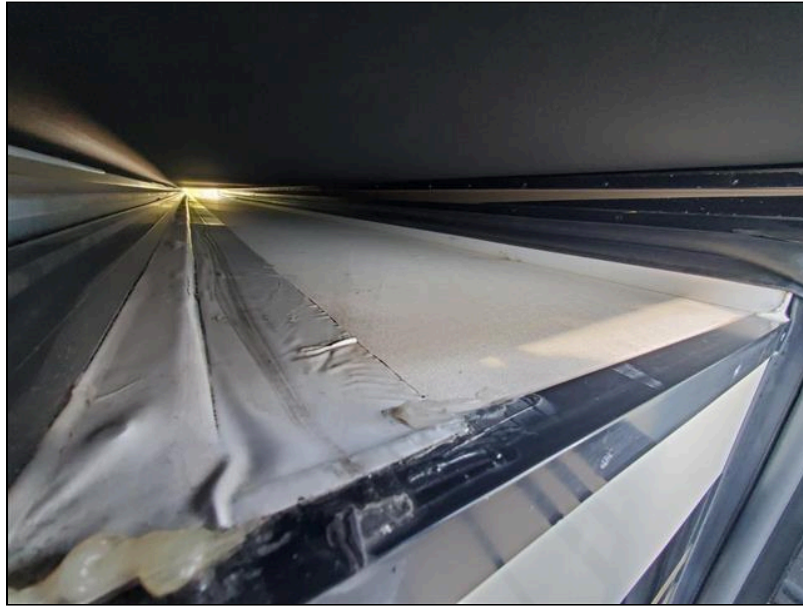
Slideout Roof in Good Condition

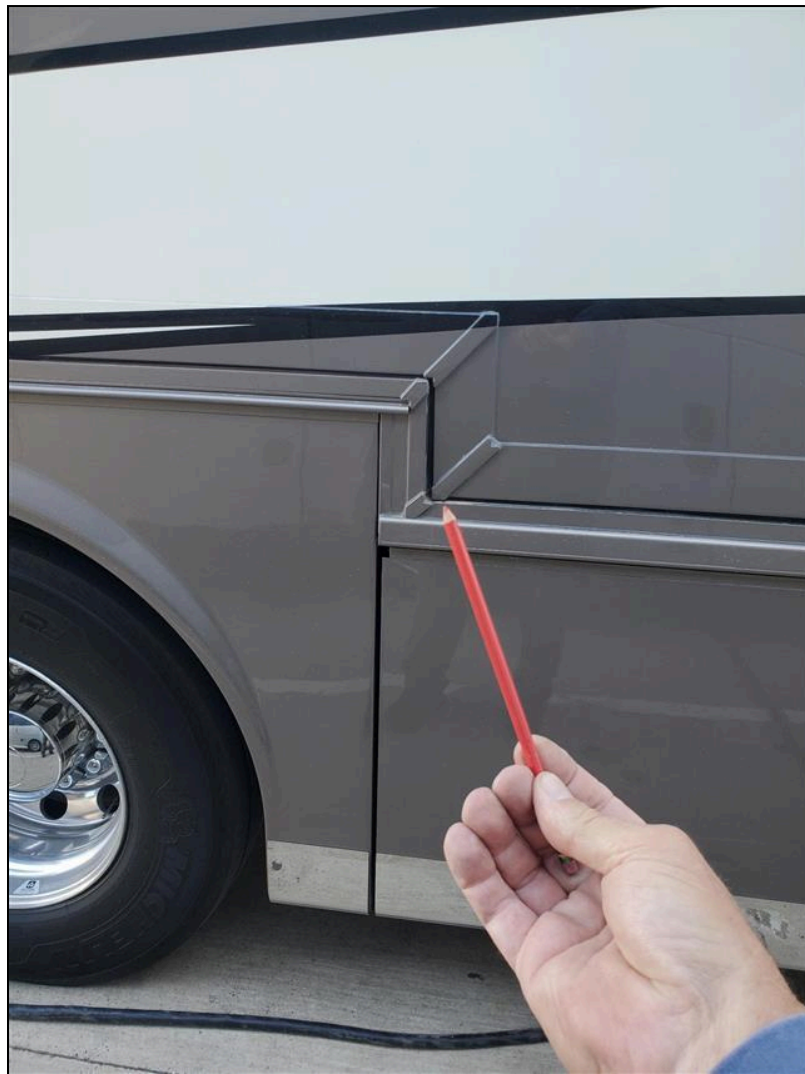
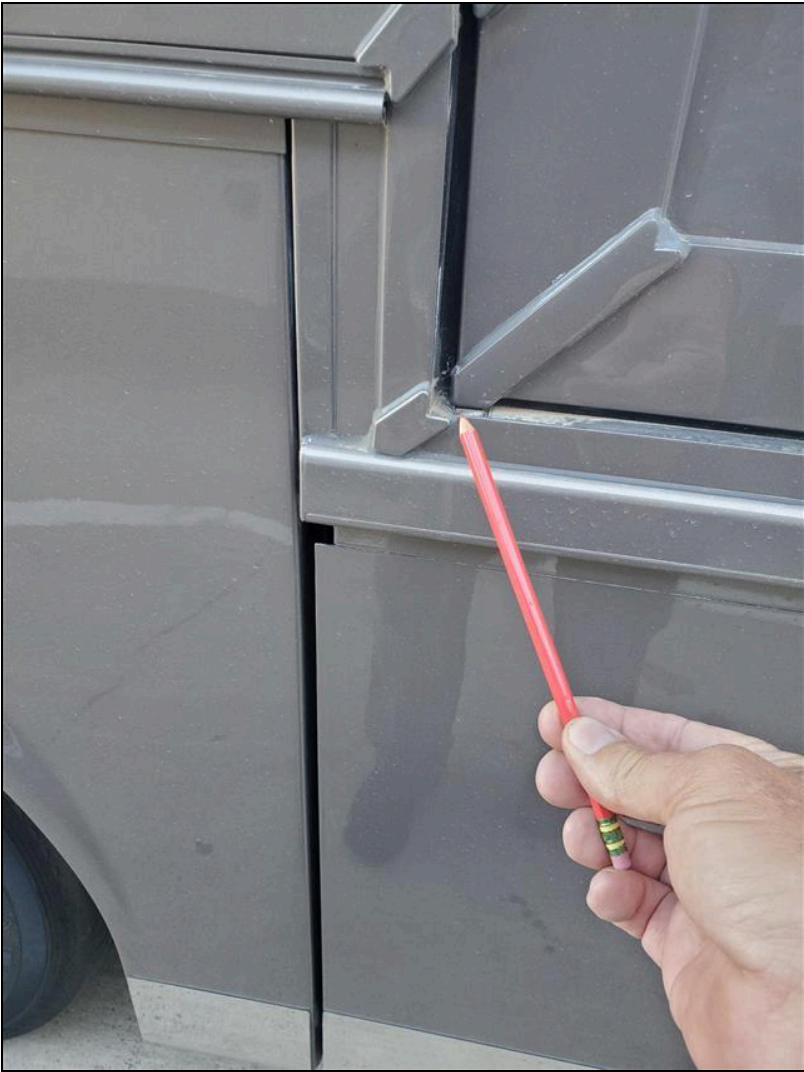
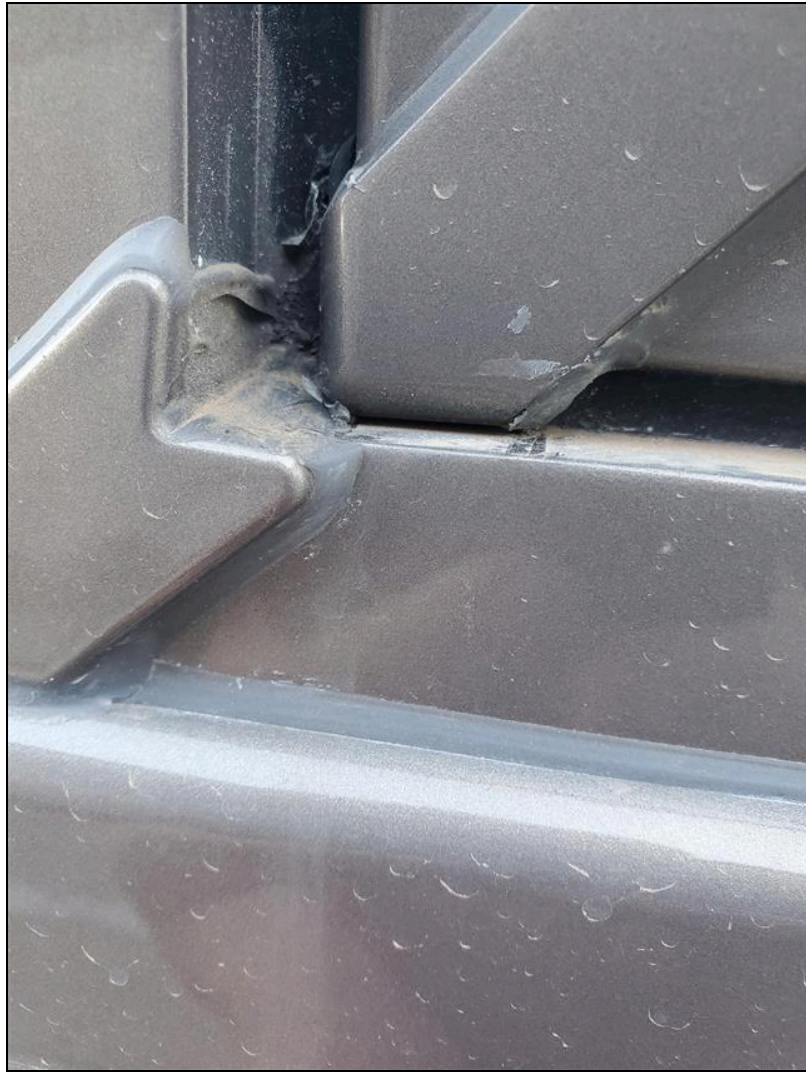
(1) Corner trim is rubbing on the frame

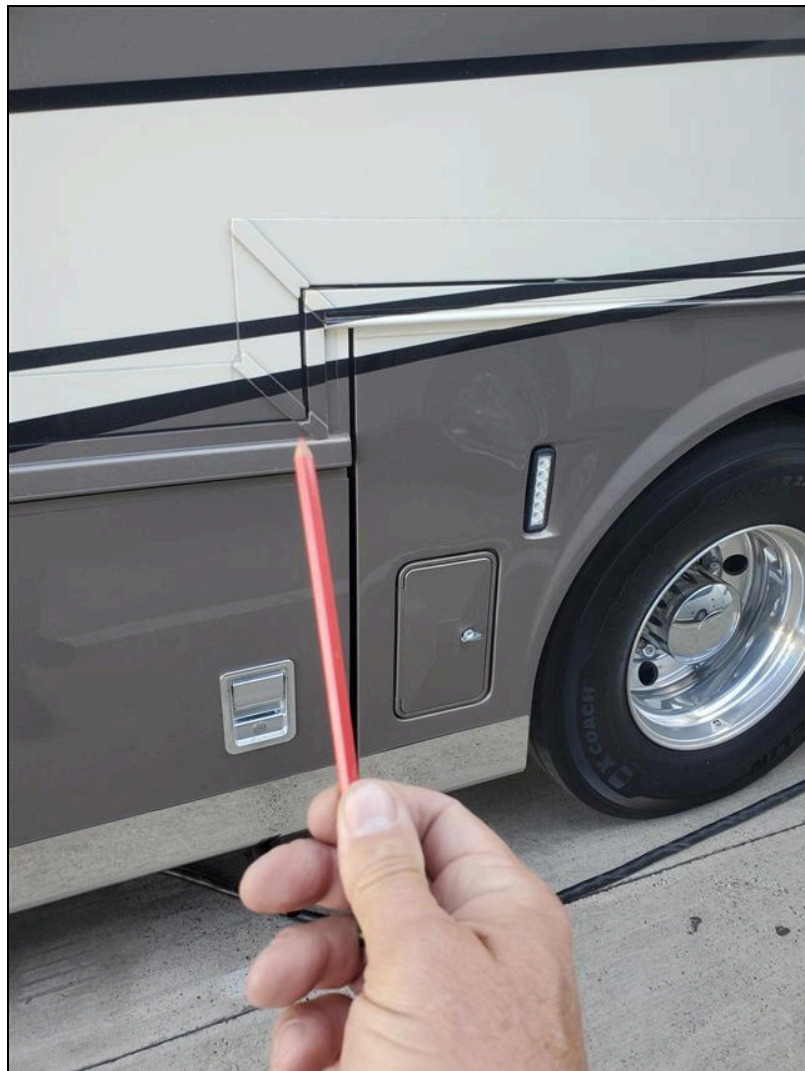
(2) Same with front of trim rubbing on the frame

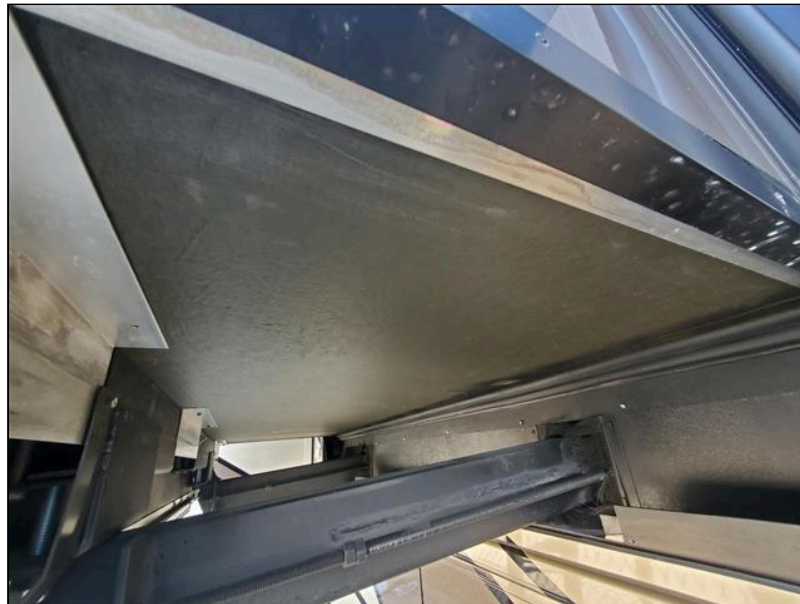
7.14.B Slideout Floor Exterior Condition

Floor looked solid at moment of inspection.

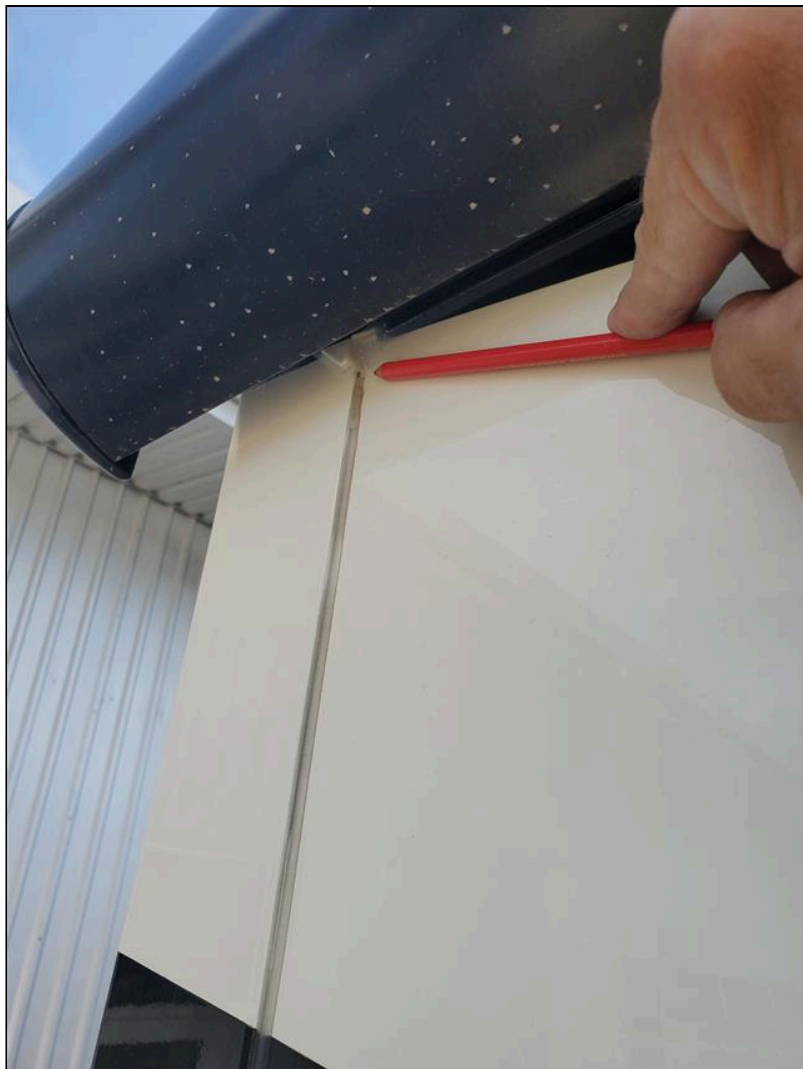
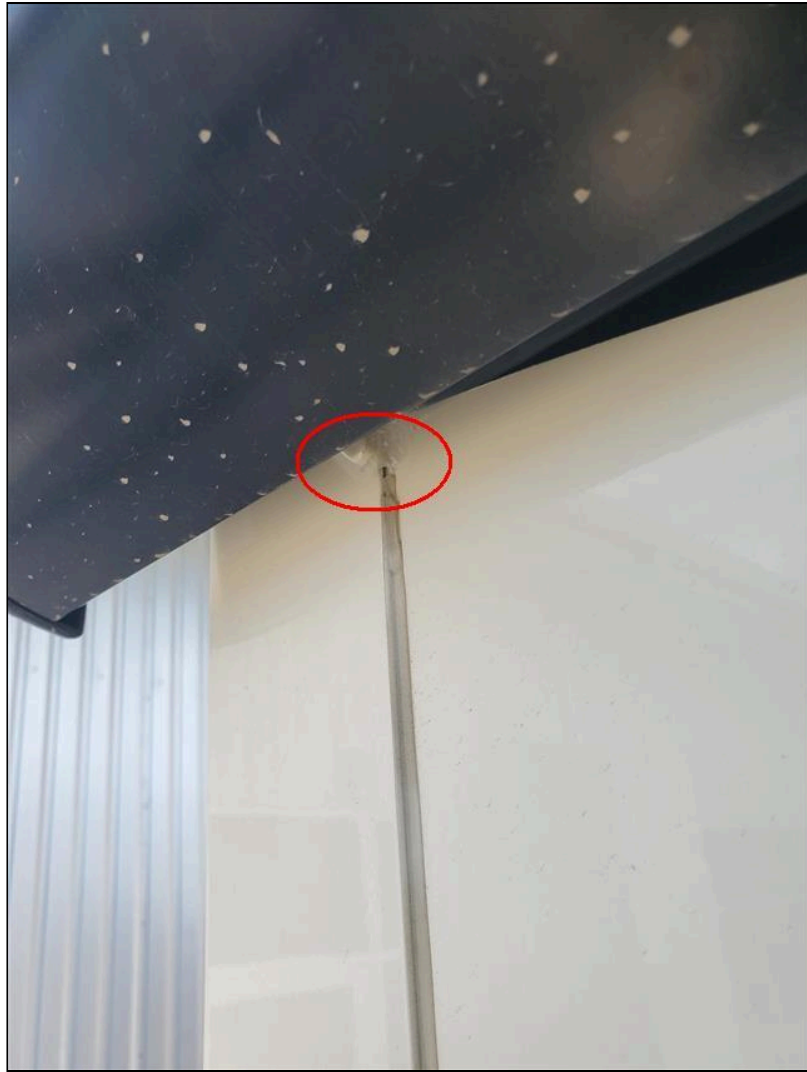
7.1.C Slideout T-Molding Trim

Poor

Upper rear corner requires sealant to avoid further water intrusion

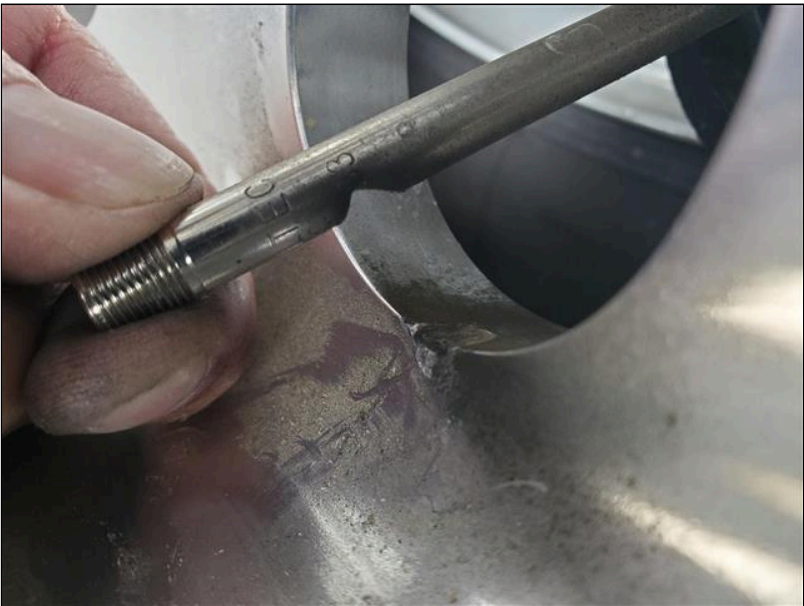
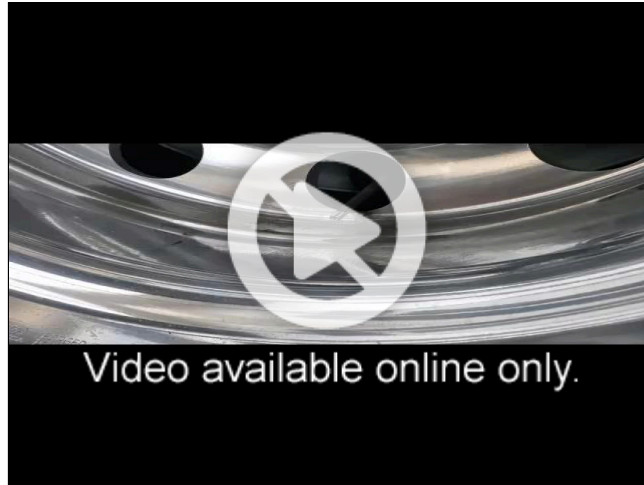
8.0.B Tire Condition

Valve stem extension is worn out and started to scuff the wheel as well

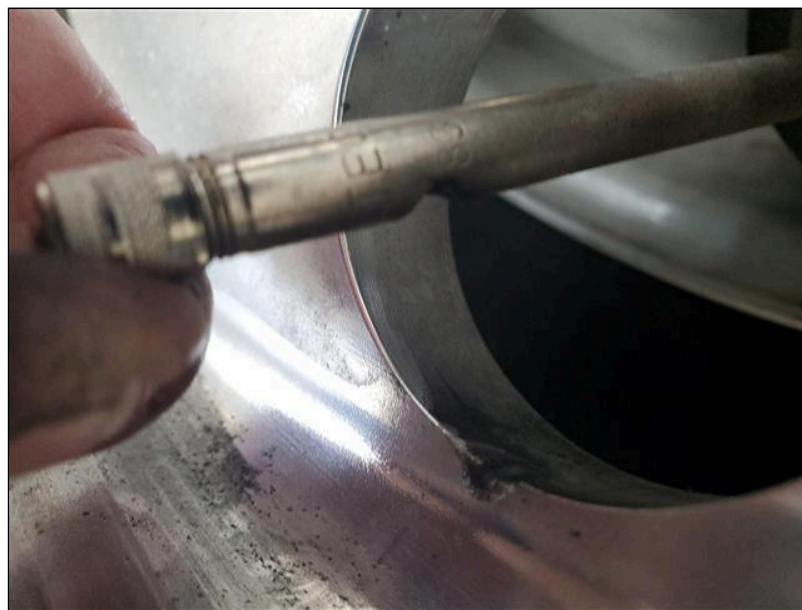
8.0.E Tire Condition
Poor

+ Valve stem extension is worn out to the point of having scuffed the wheel itself

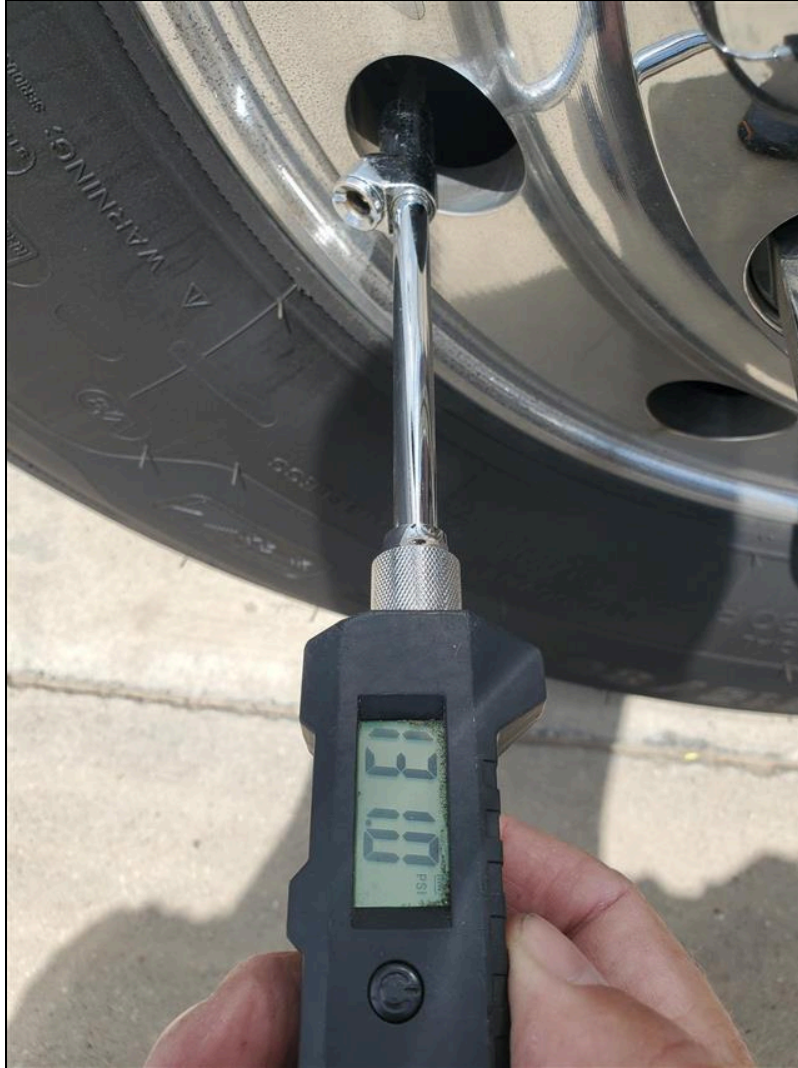
8(F) . Front Wheel Assembly - Streetside

PSI of 131

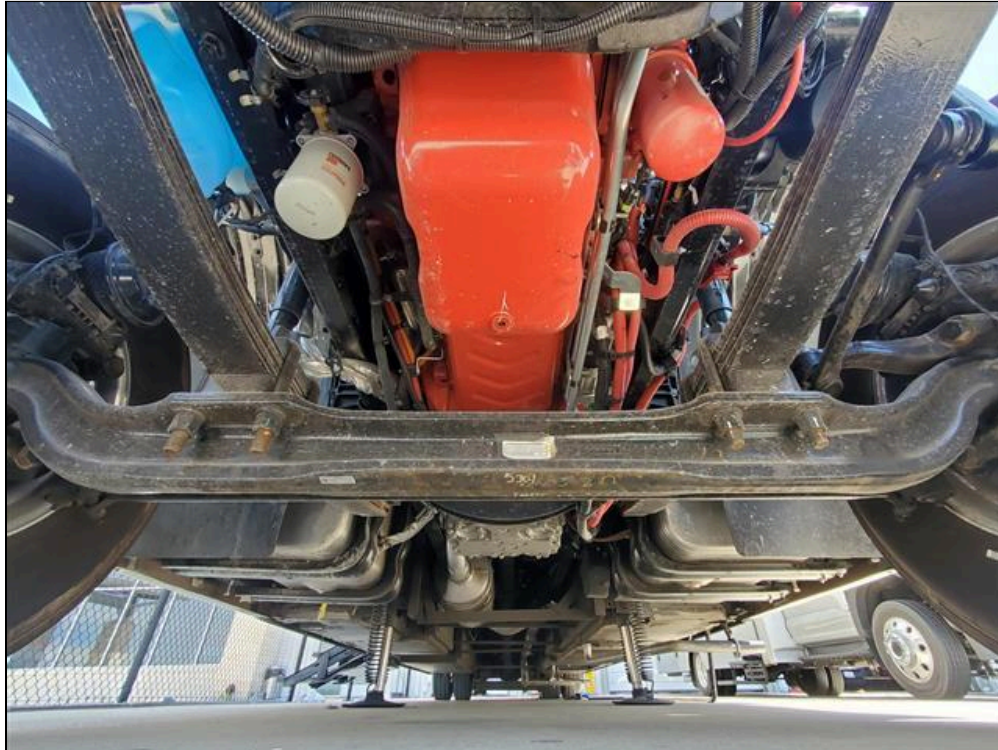
Undercarriage view from Front to rear

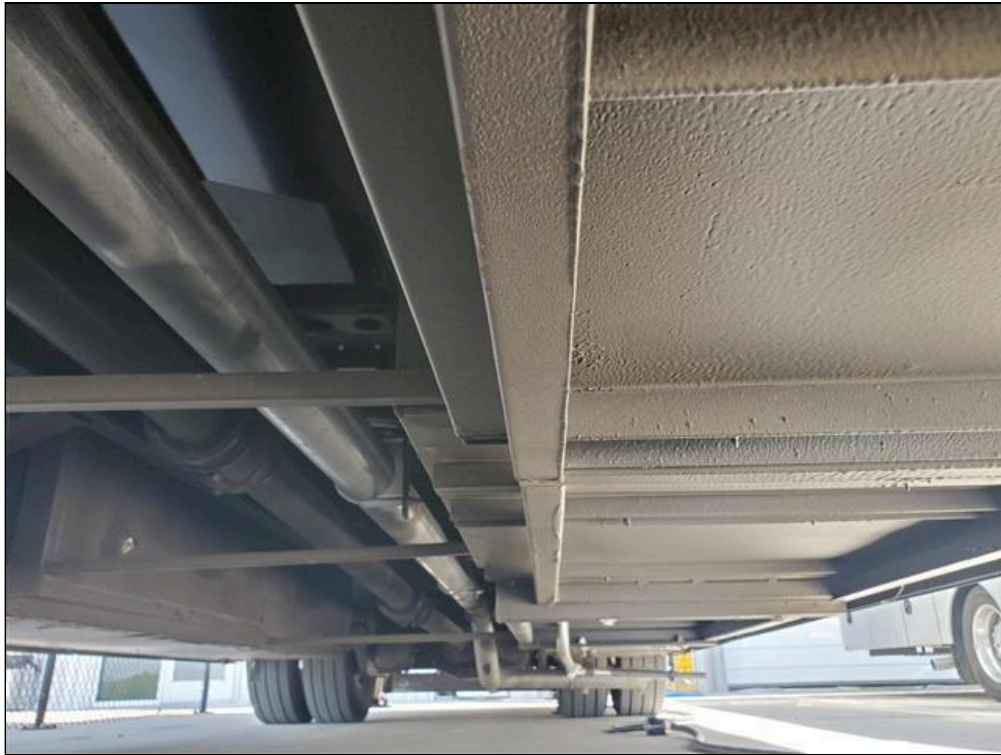
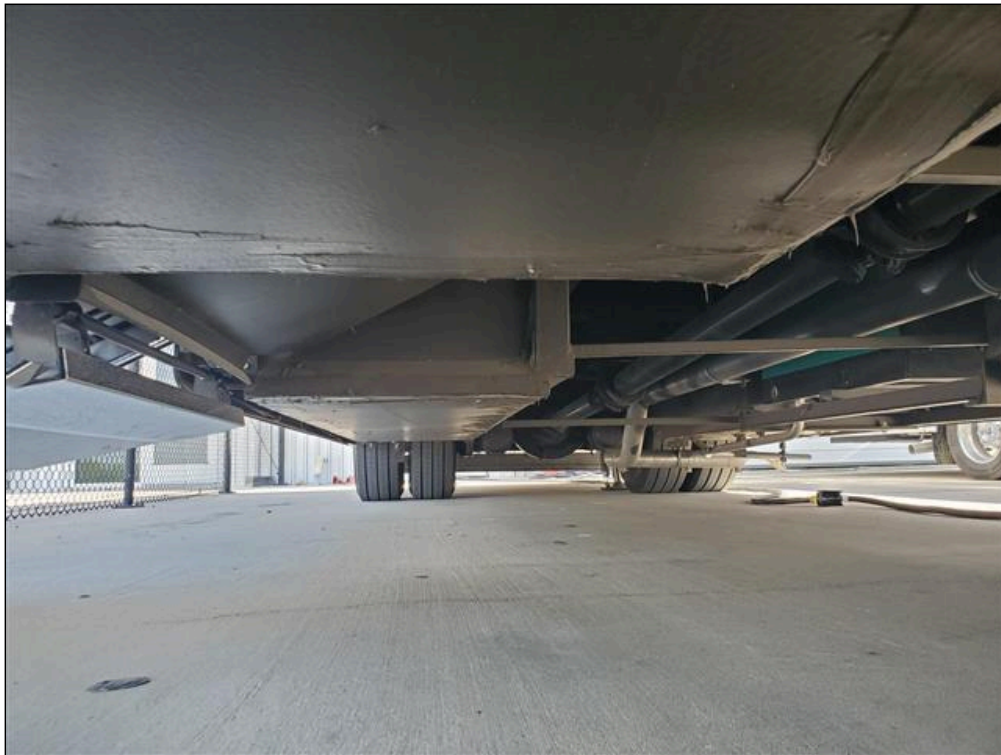
9.0 Chassis and Frame Condition

Frame doesn't show signs of damage or scuff marks at moment of Inspection

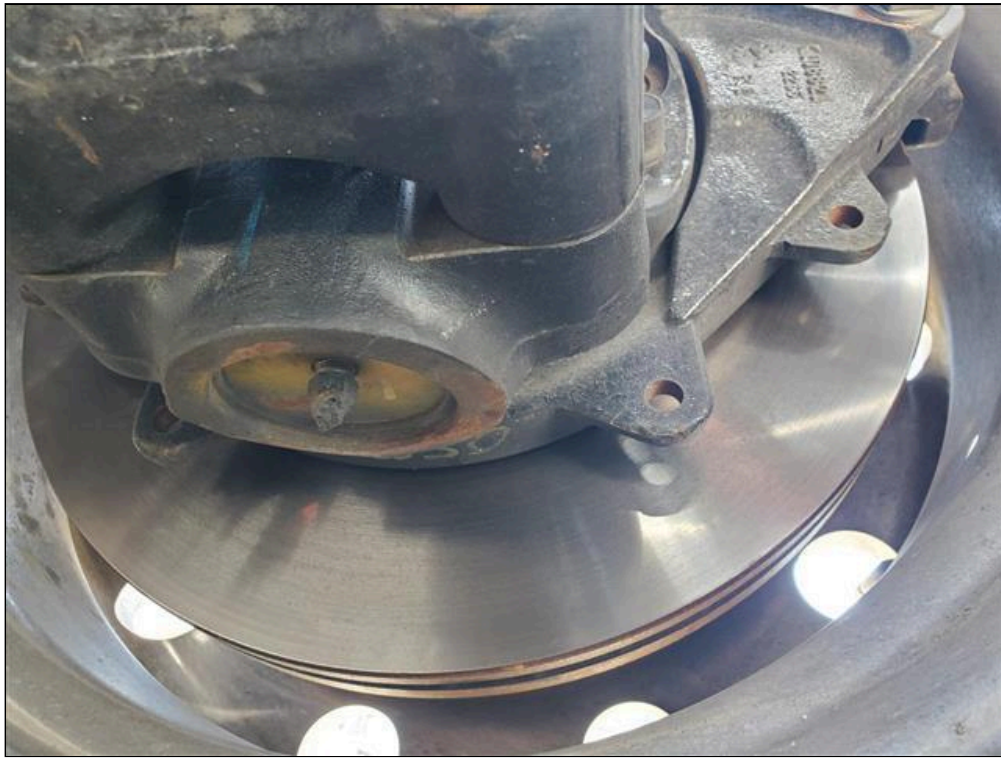
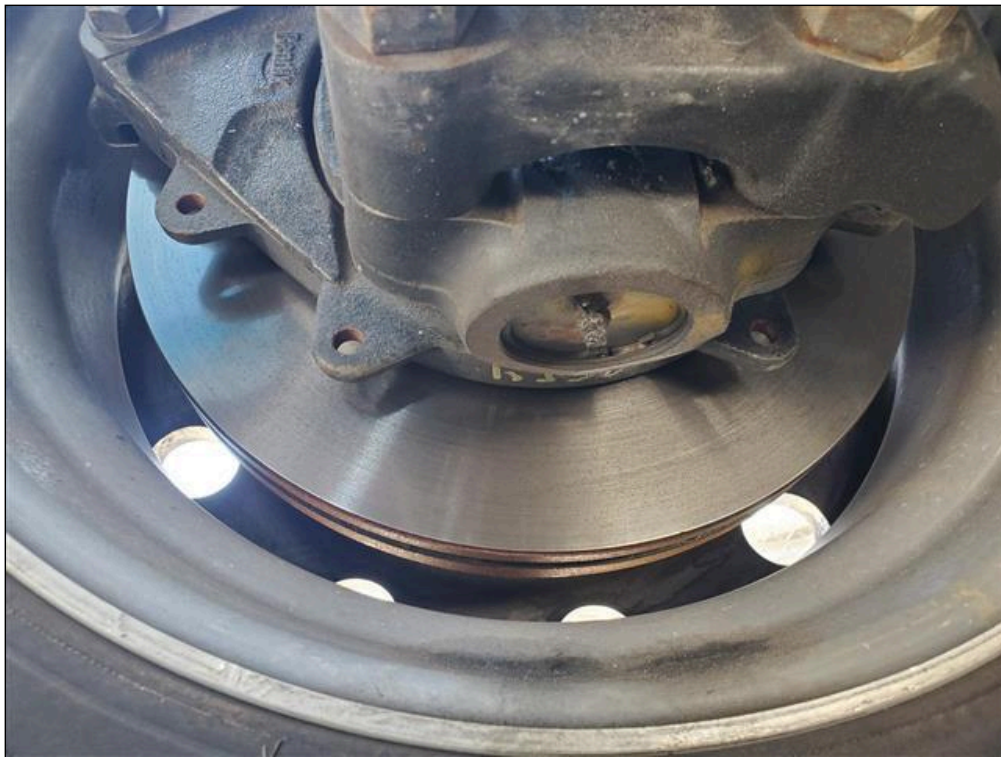
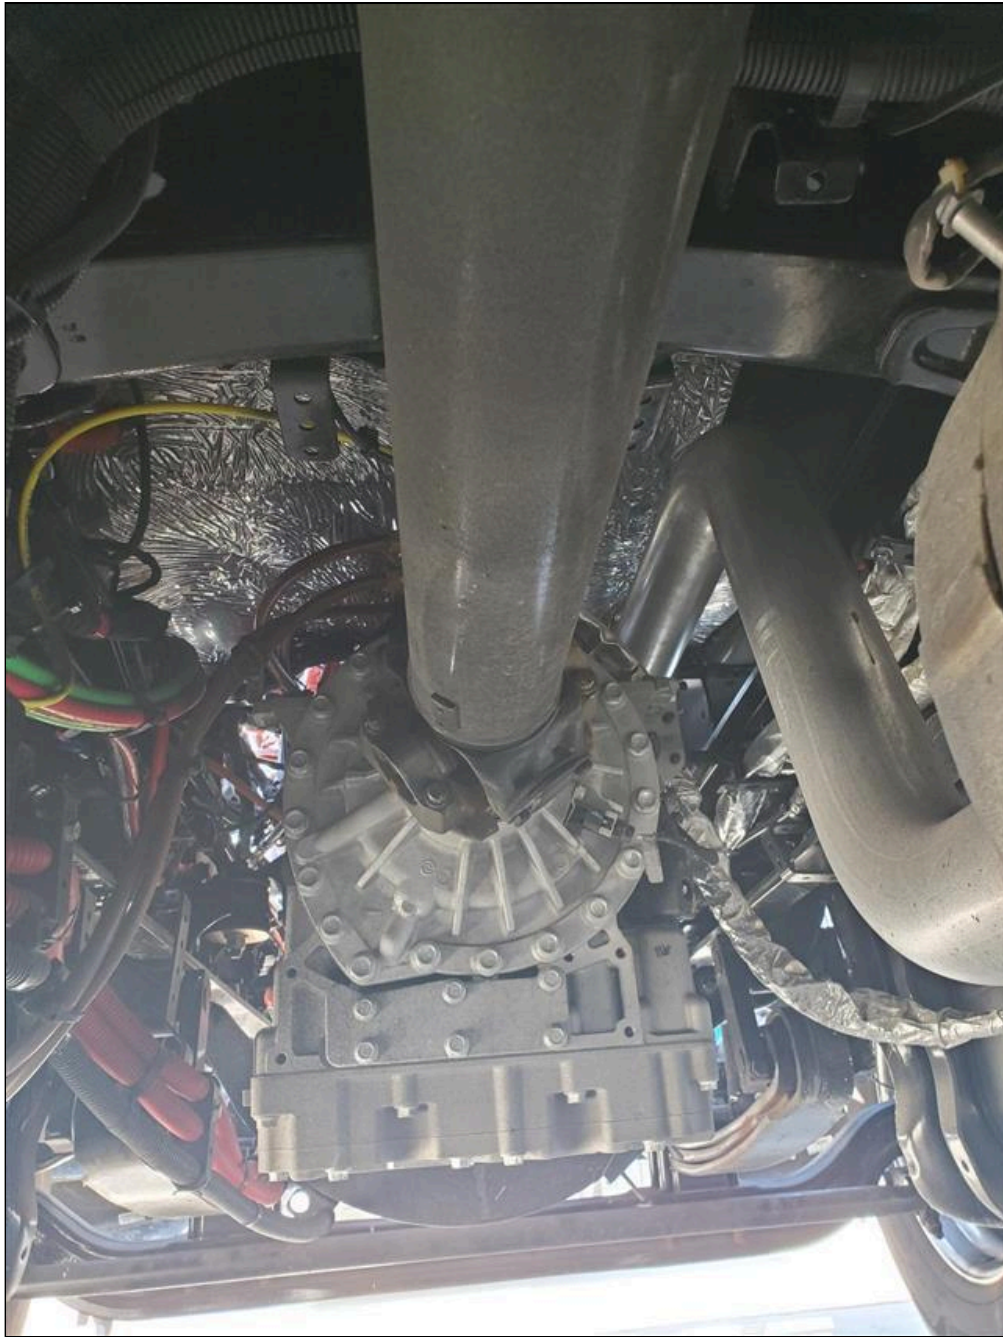
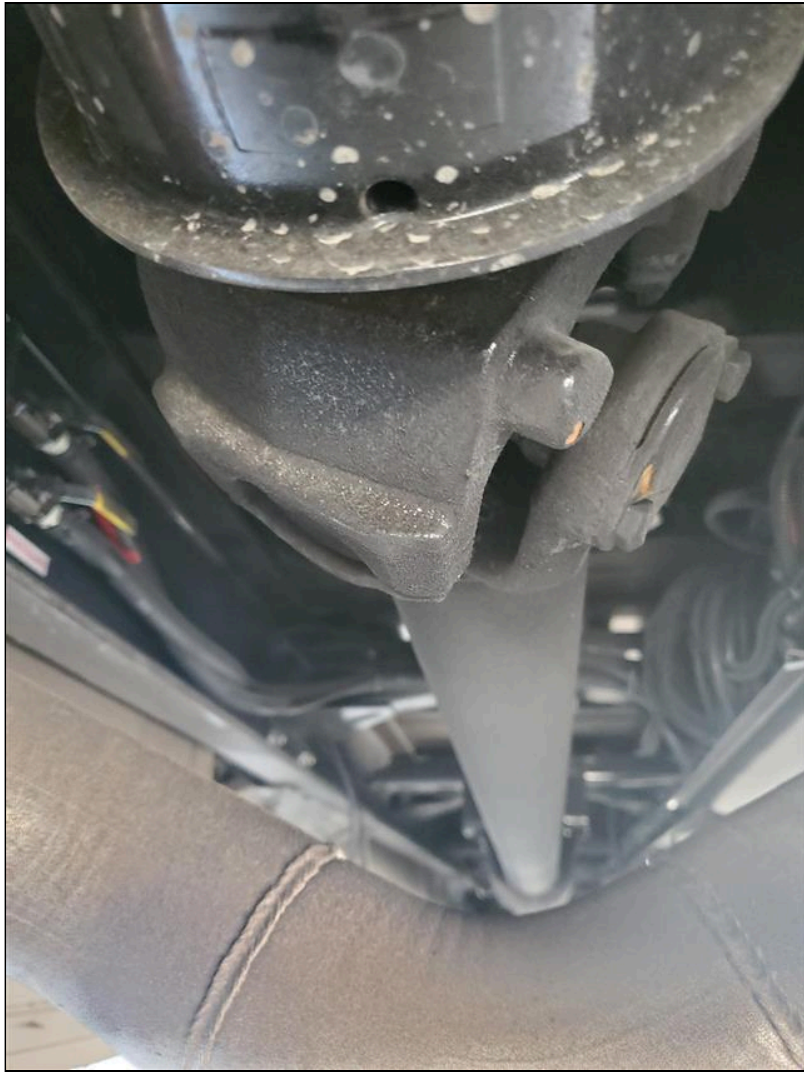
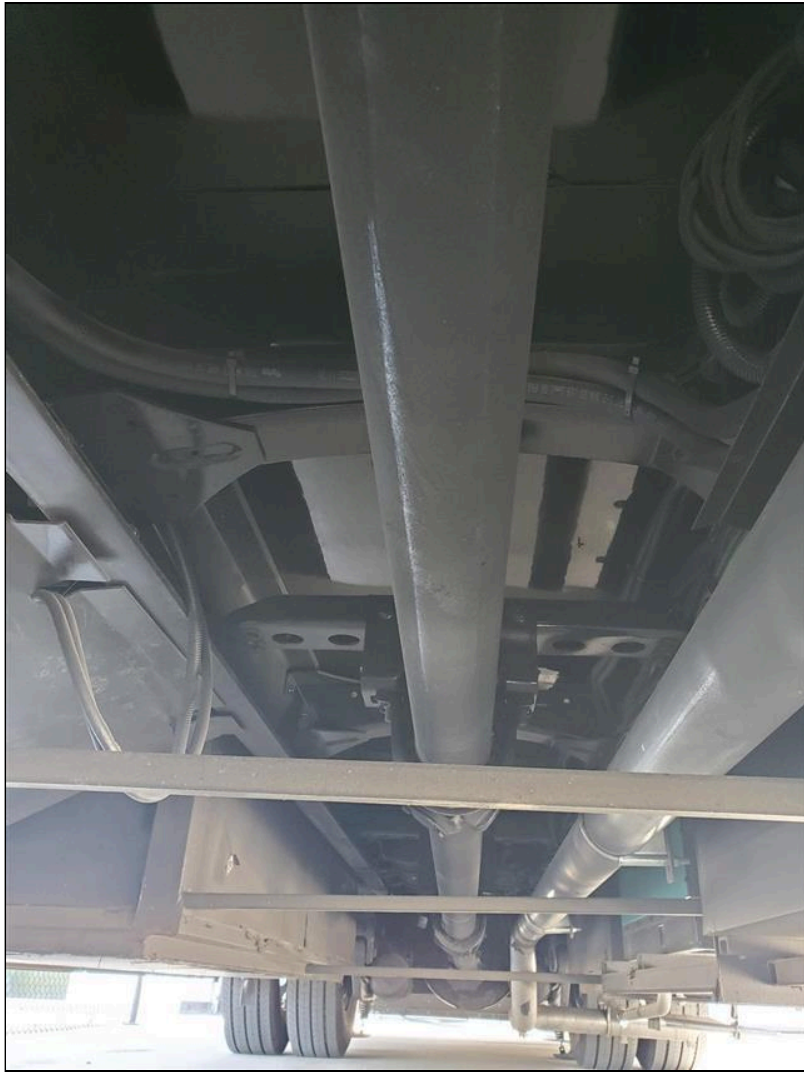
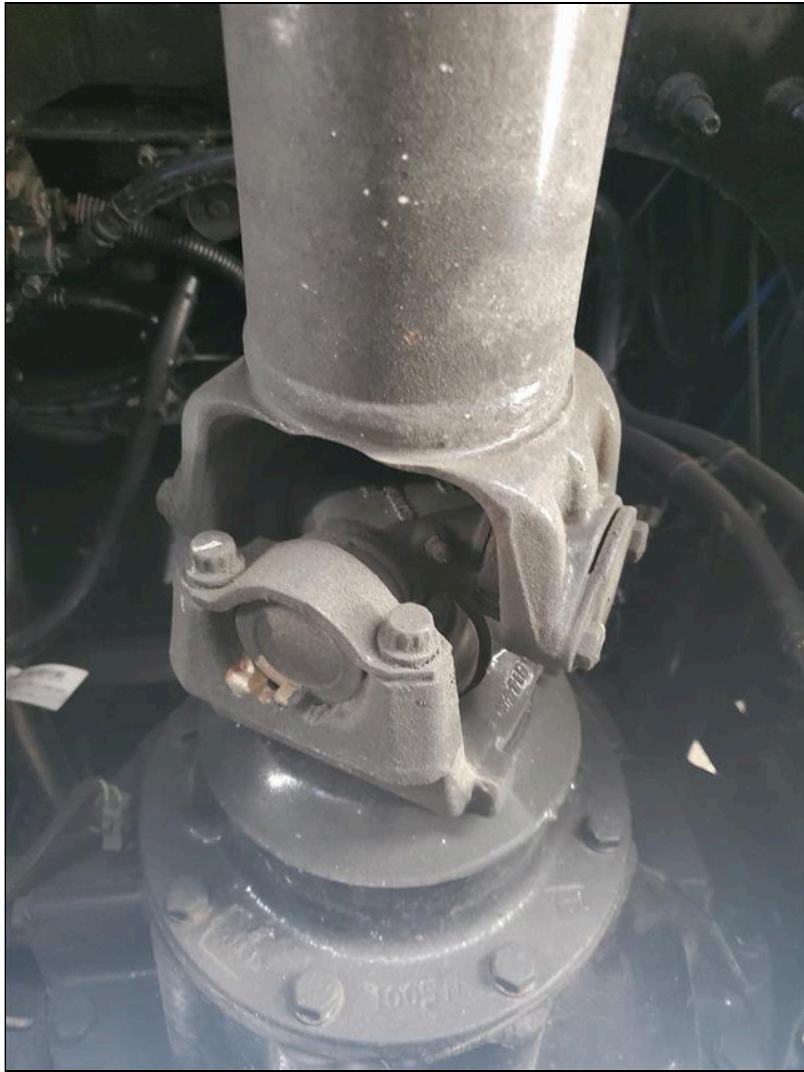
9.2 Running Gear (Axles, Springs, Rims, other Components)

Inspector didn't Observe any Components being Compromised or Physically damaged upon Visual Inspection

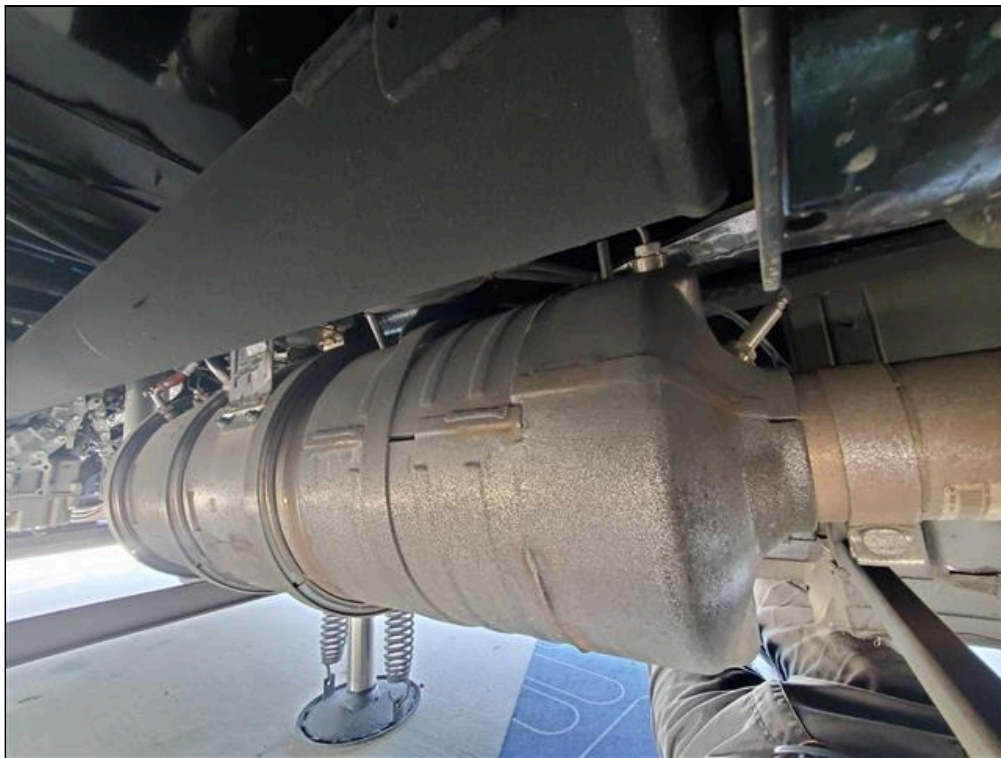
9.3 DEF Exhaust Converter Condition

DEF Exhaust Converter Looked in Good Condition
