RV Inspection Report

**Inspection Date / RV Model:
Newmar Superstar 4065 2023**

**Pierre Fortin
5753 Highway 85 N Lot 8511
Crestview, Florida, 32536**

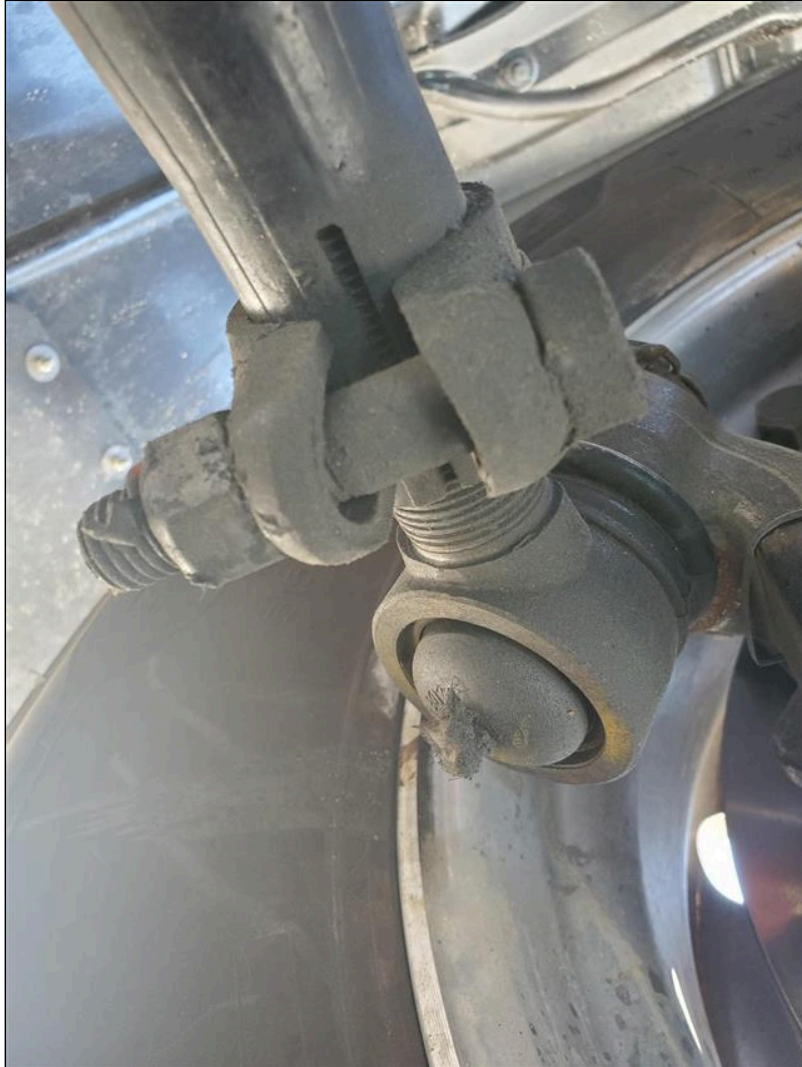
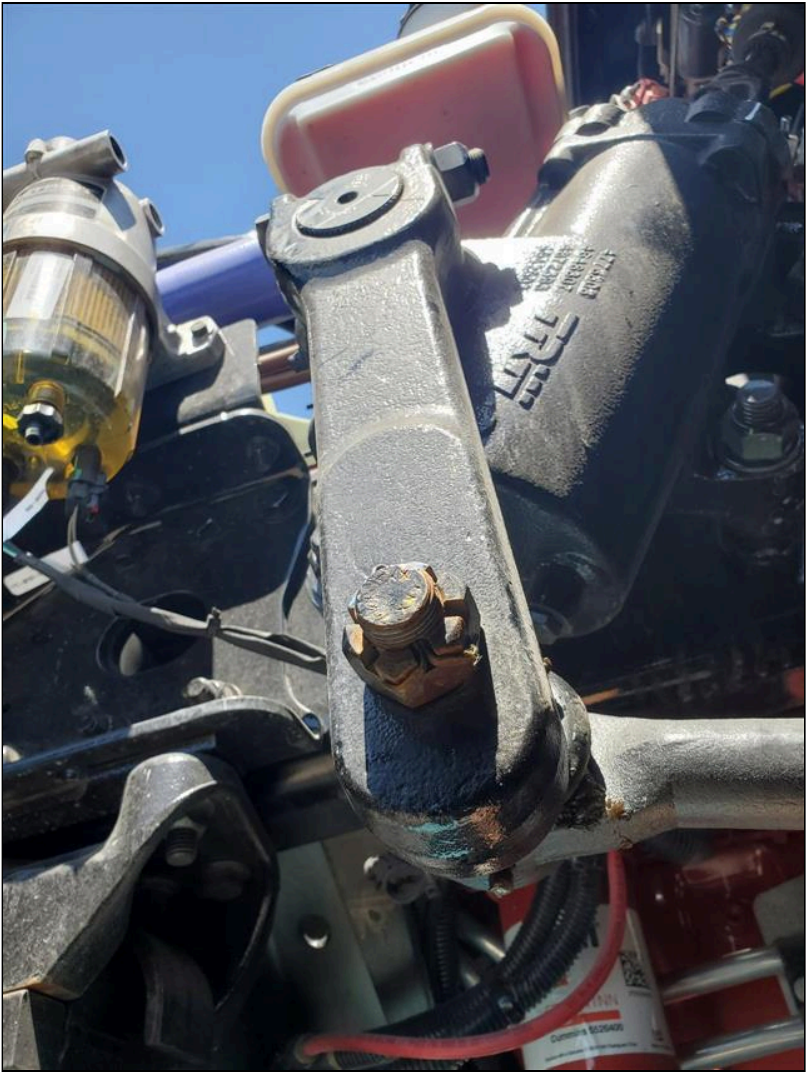
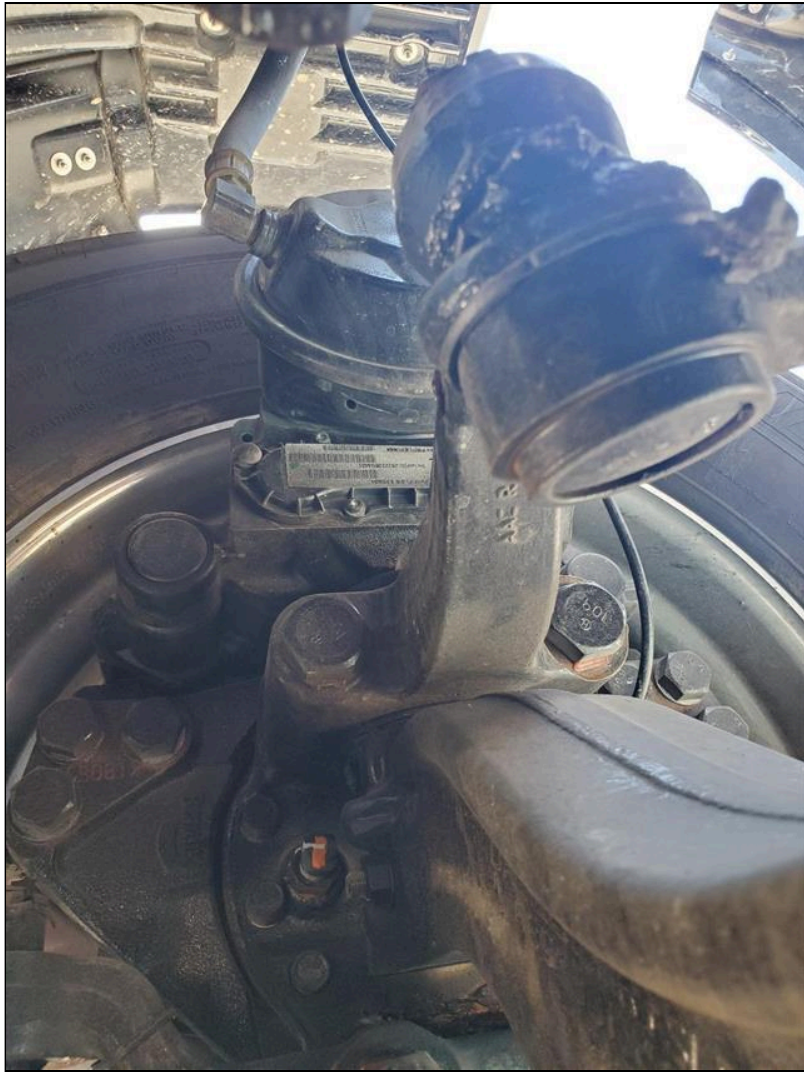
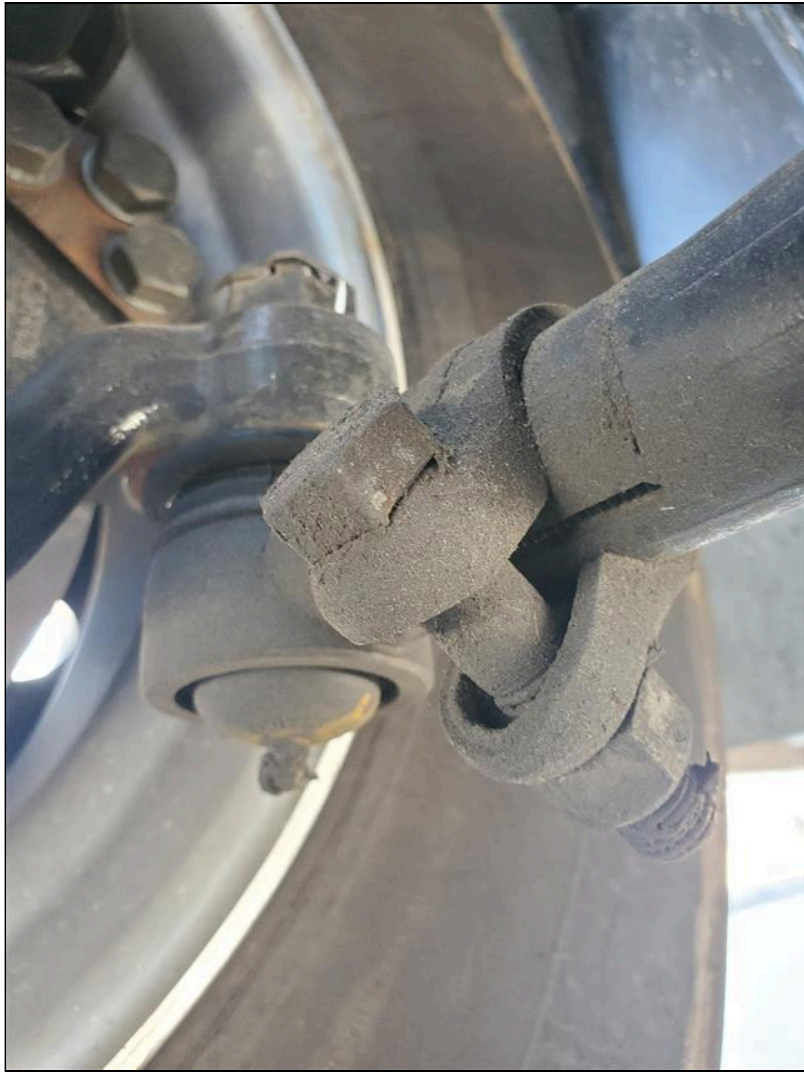
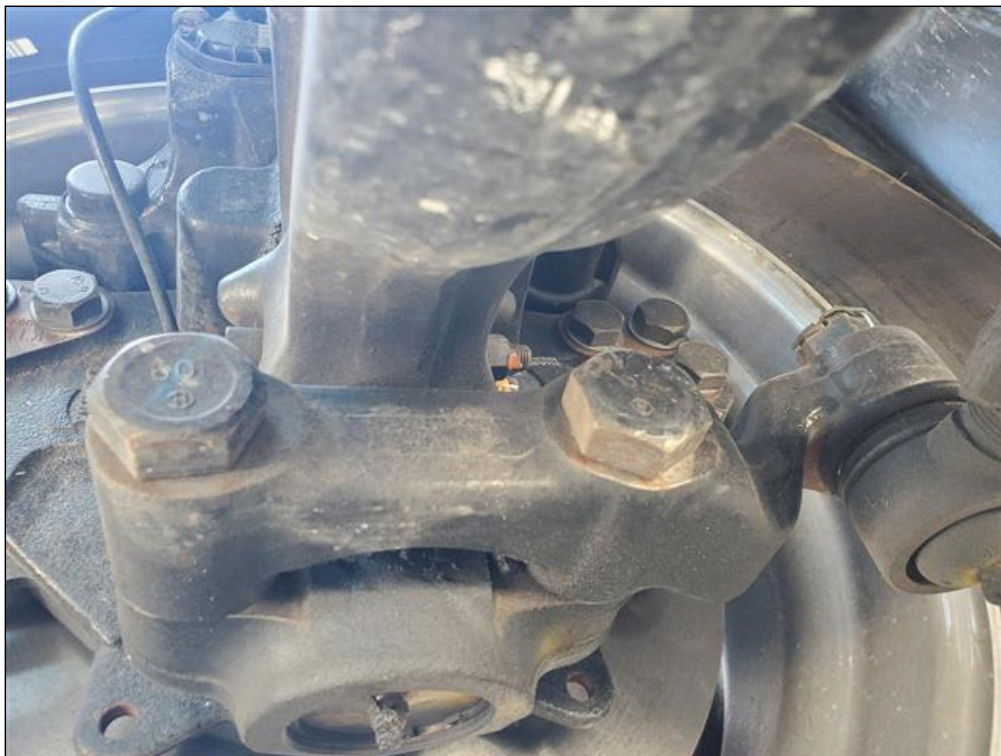
9.4 Steering Components

Inspector didn't observe any visually critical components failure regarding the Steering Components that would led to believe of any imminent safety issues at moment of inspection.

A certified mechanic inspection would be recommended to confirm any present mechanical problems.

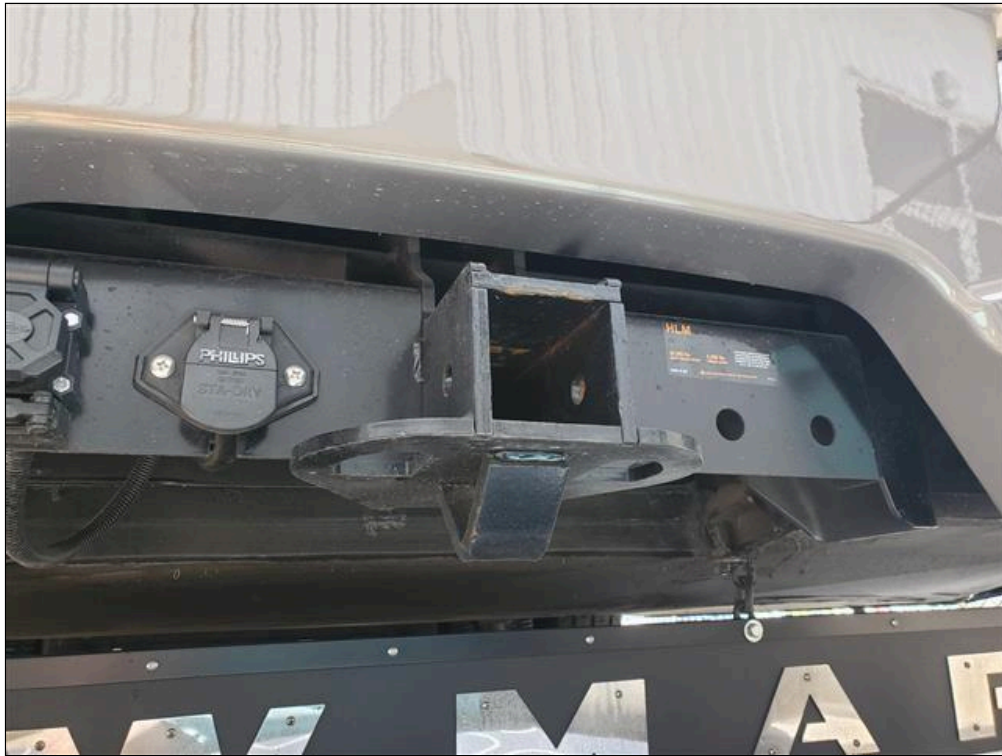
10.0 Hitch Receiver Condition

Acceptable

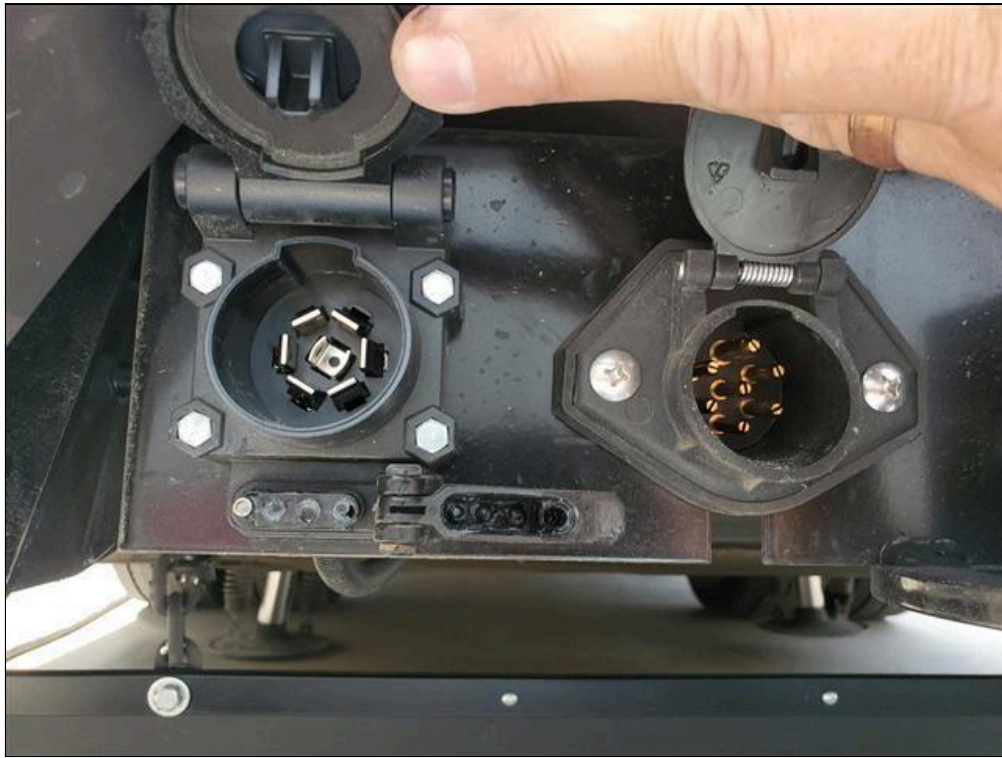
10.1 Connector (4-Pin or 7-Pin)

7 and 4 Pins combination

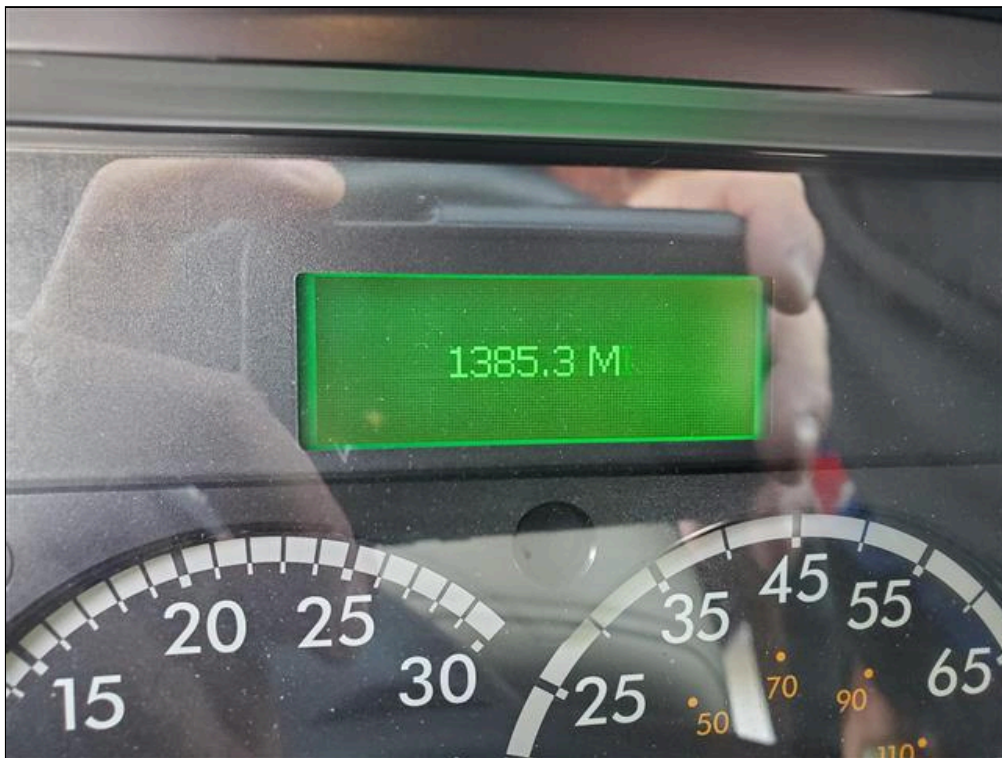
10.2 Engine Running Condition

Engine runs Good at Moment of Inspection

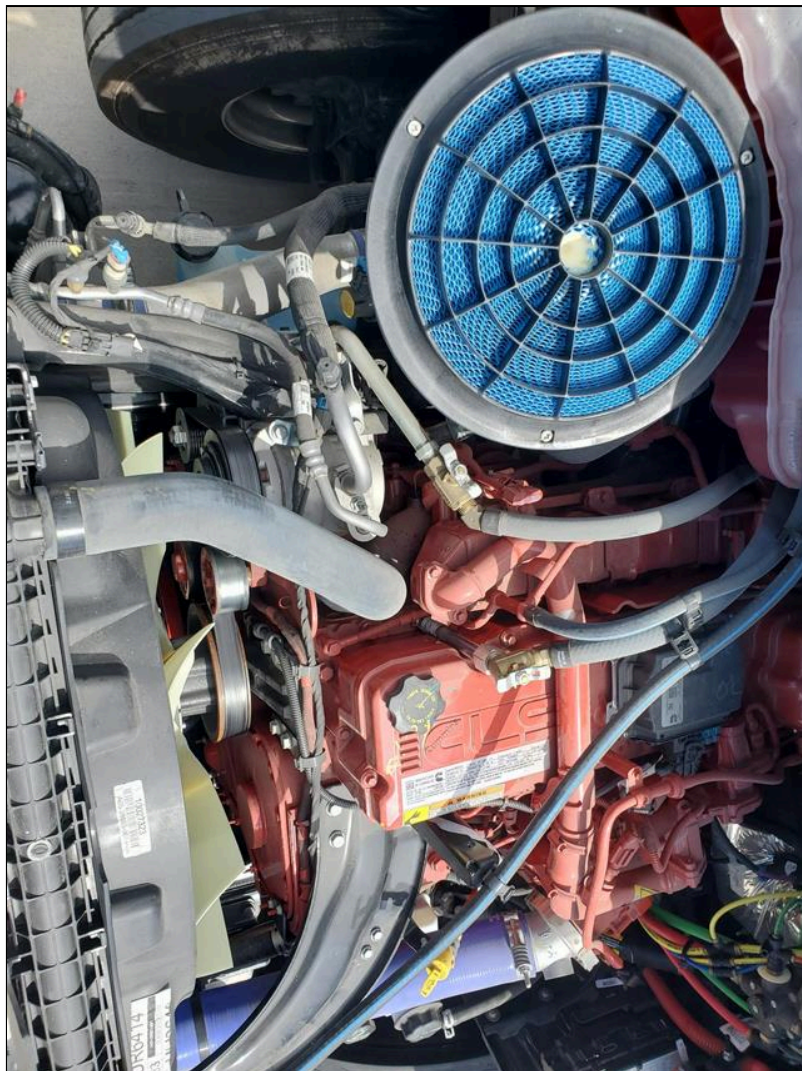
10.3 Engine Compartment Cleanliness

Engine compartment: clean condition

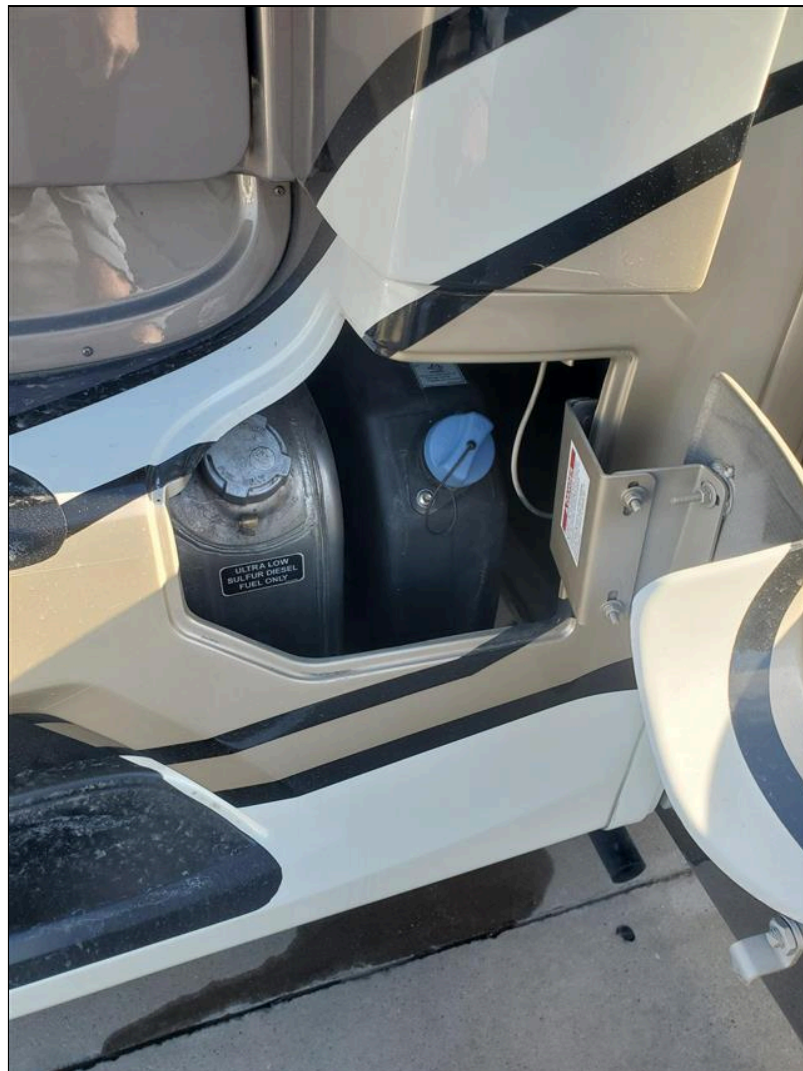
10.4 DEF Reservoir and Compartment Condition

Compartment Looked Good at Moment of Inspection

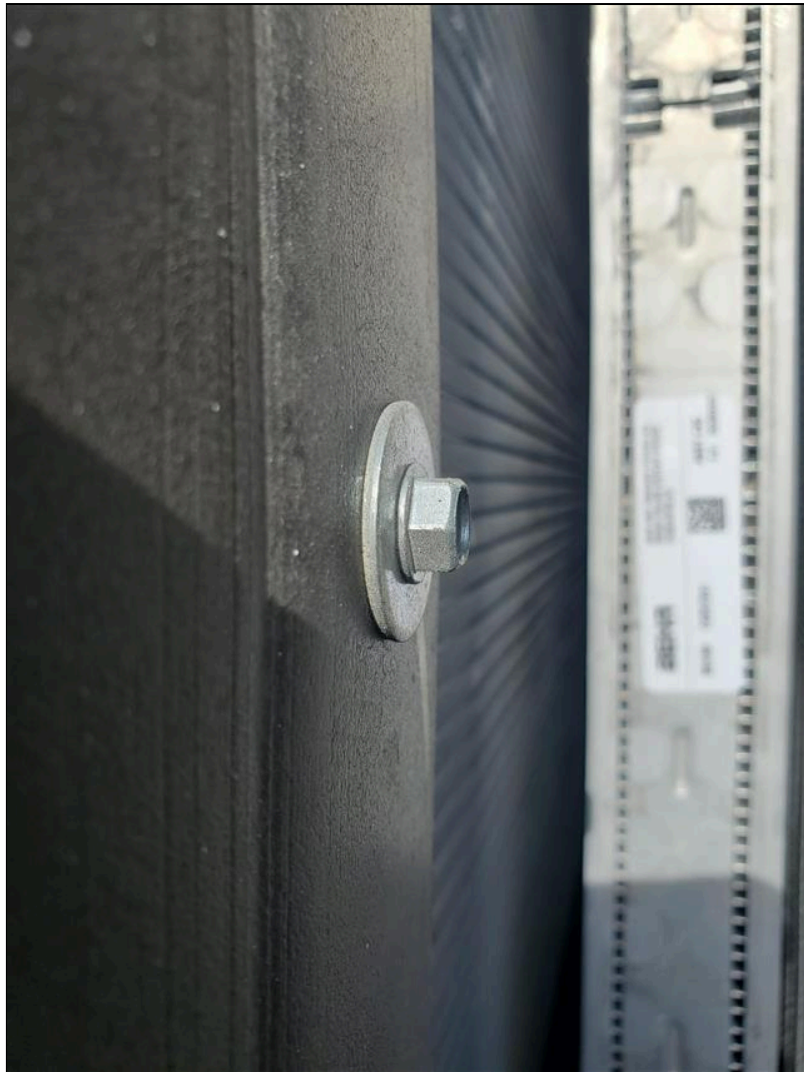
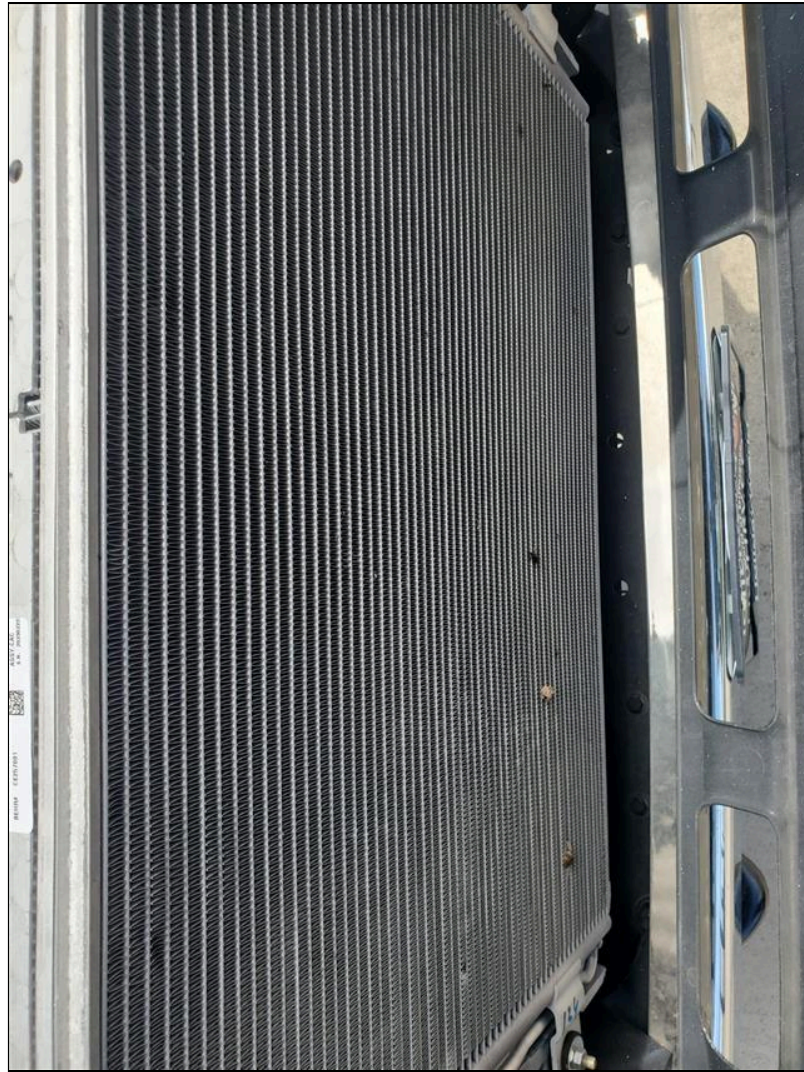
10.5 Radiator Condition

Radiator Condition: Good

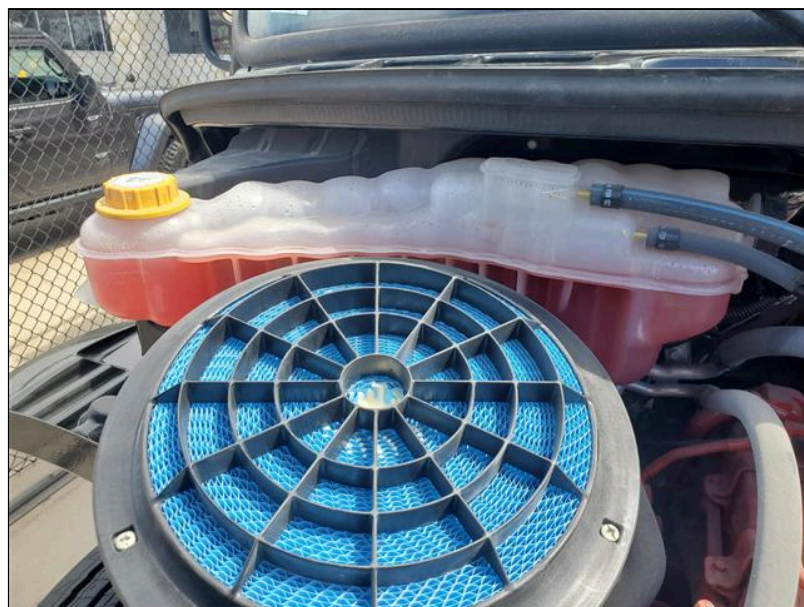
10.6 Coolant Reservoir Condition

Coolant Reservoir: In Good Condition

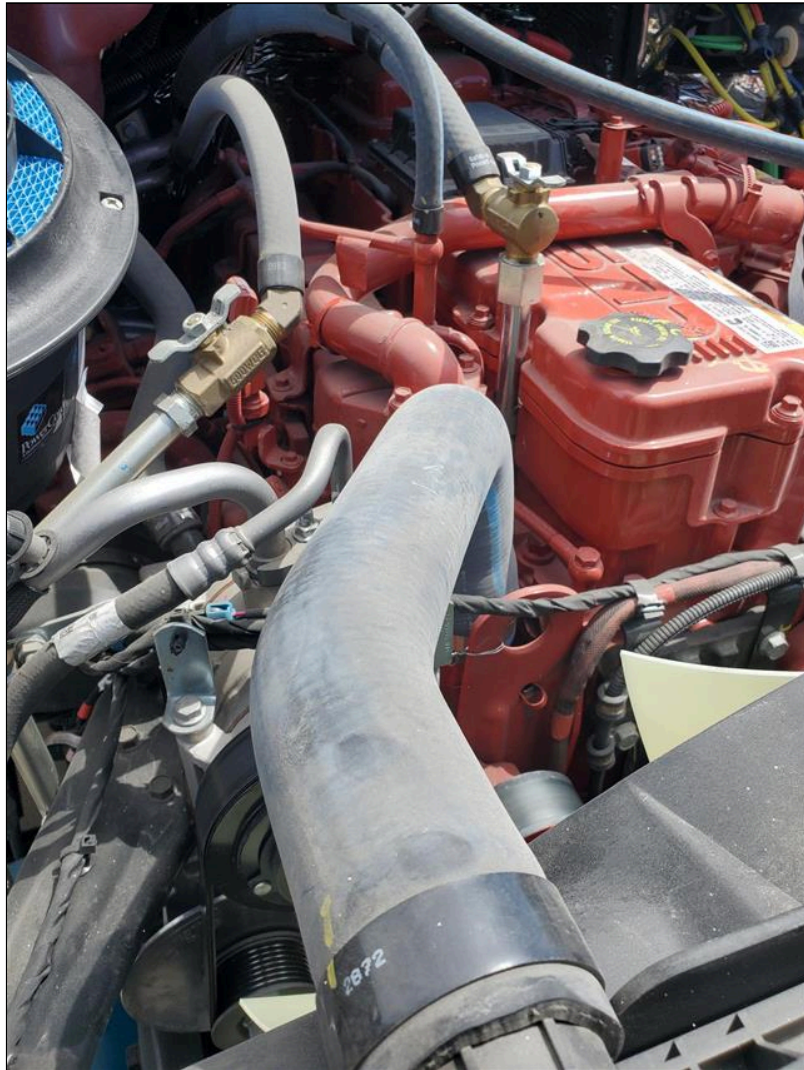
10.7 Radiator Hoses Condition

Radiator Hoses Looked in Good Condition at Moment of Inspection

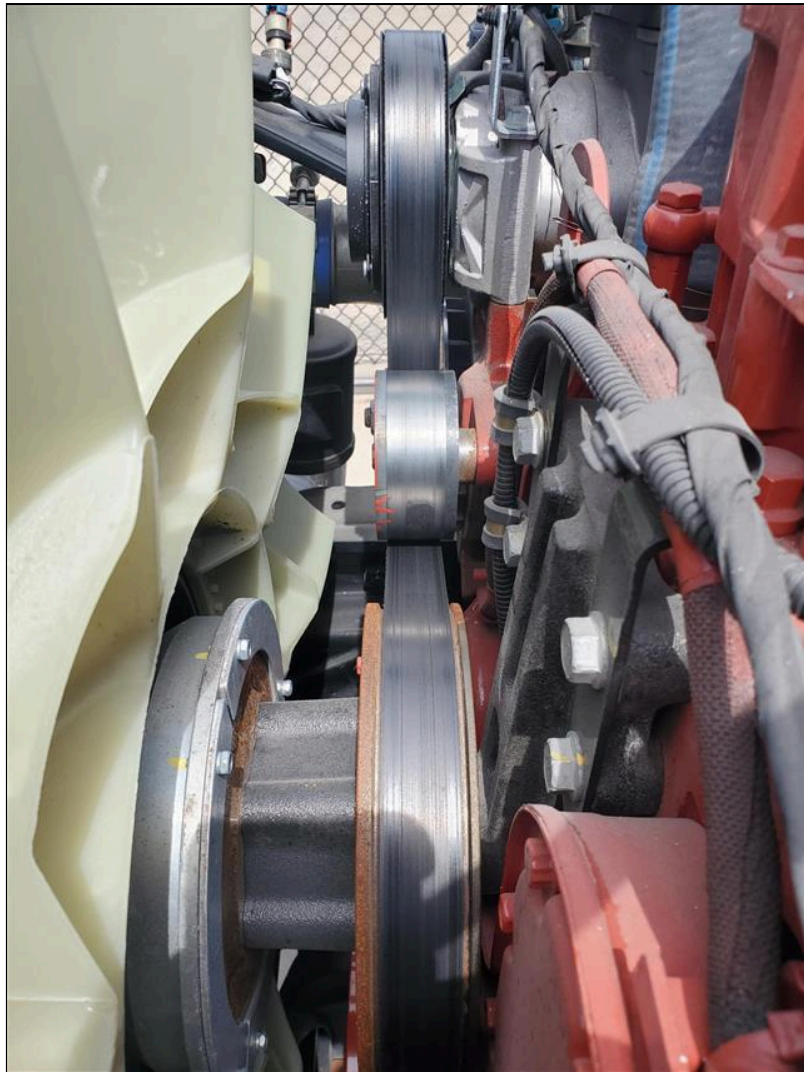
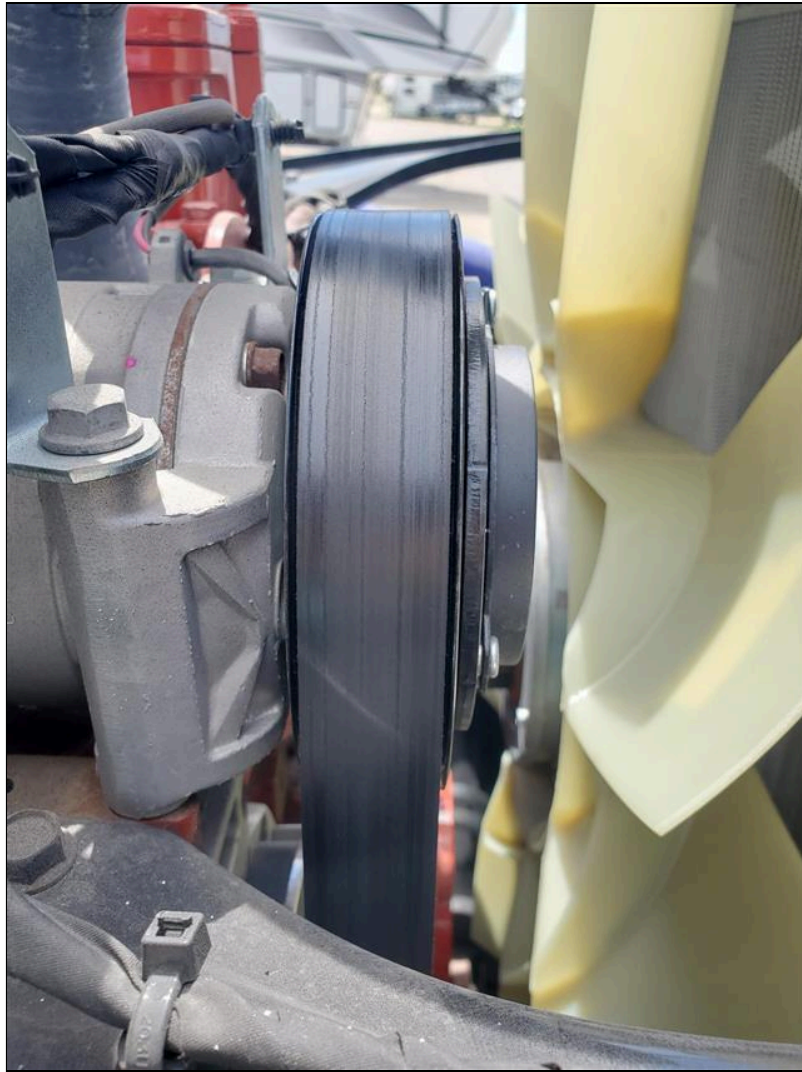
10.8 Belts Condition

Belts Looked in Good Condition at moment of Inspection

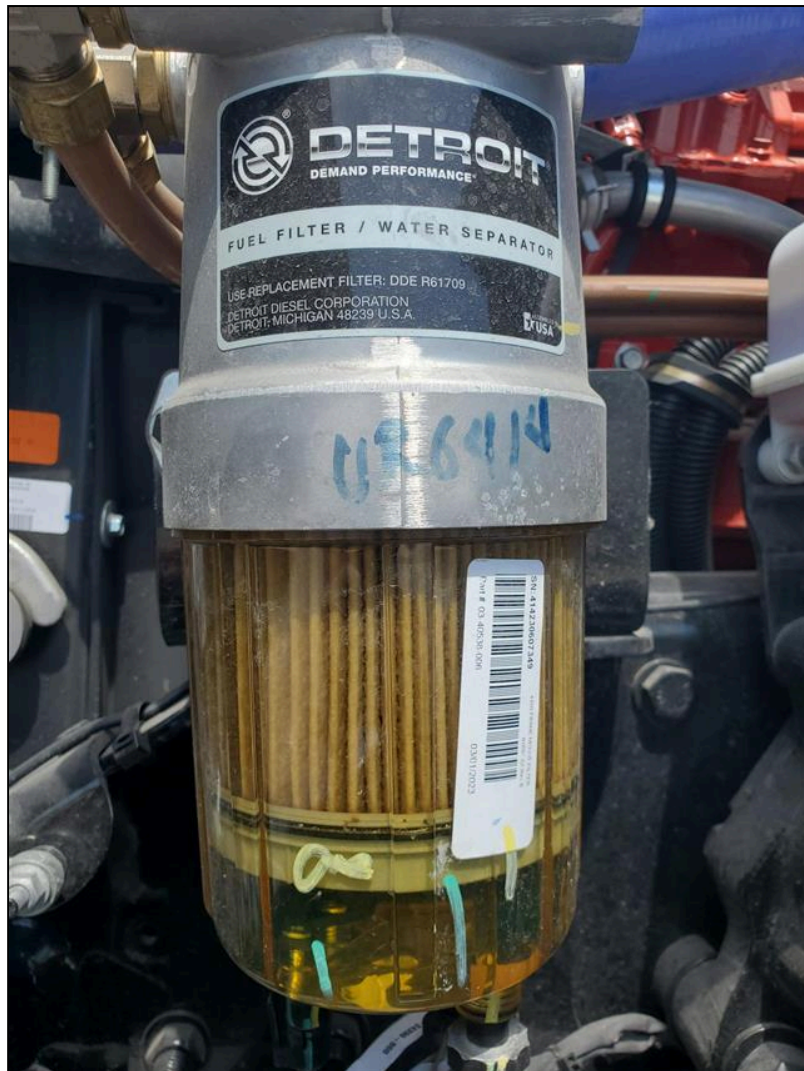
10.10 Fuel Filter / Water Separator Condition

Fuel / Water Filter Separator didn't show signs of Water present

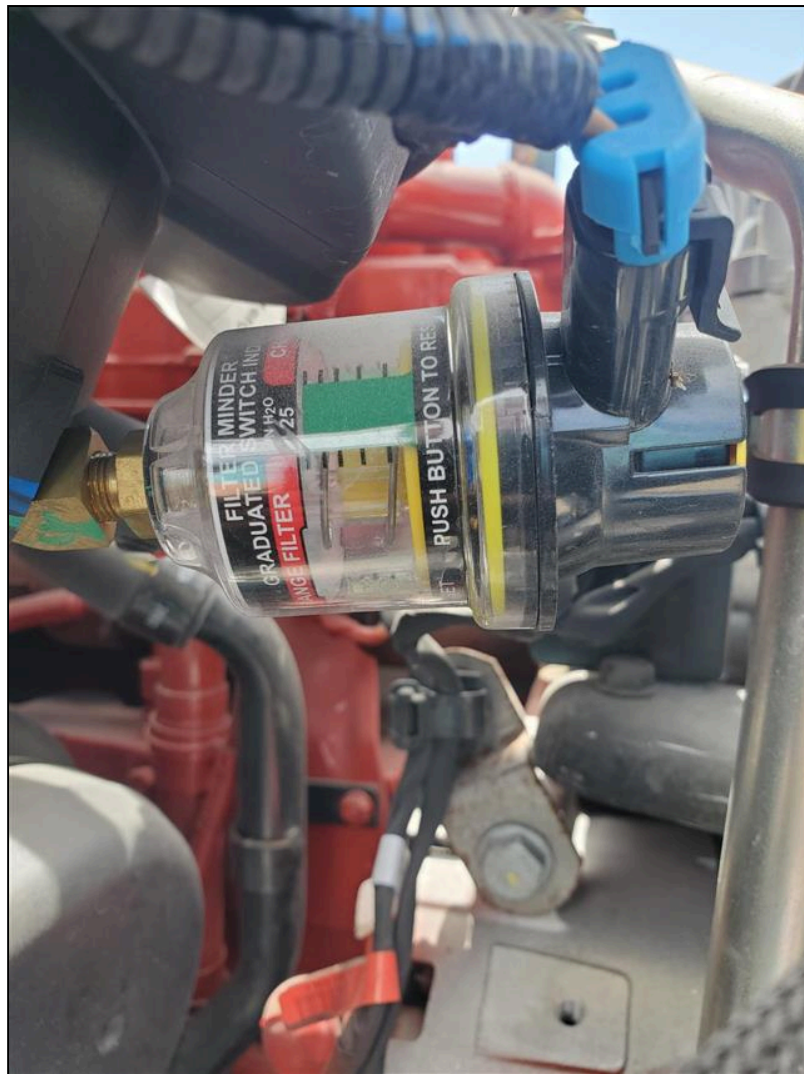
10.11 Air filter Reading

As a New Unit , We assume it is performing as intended.

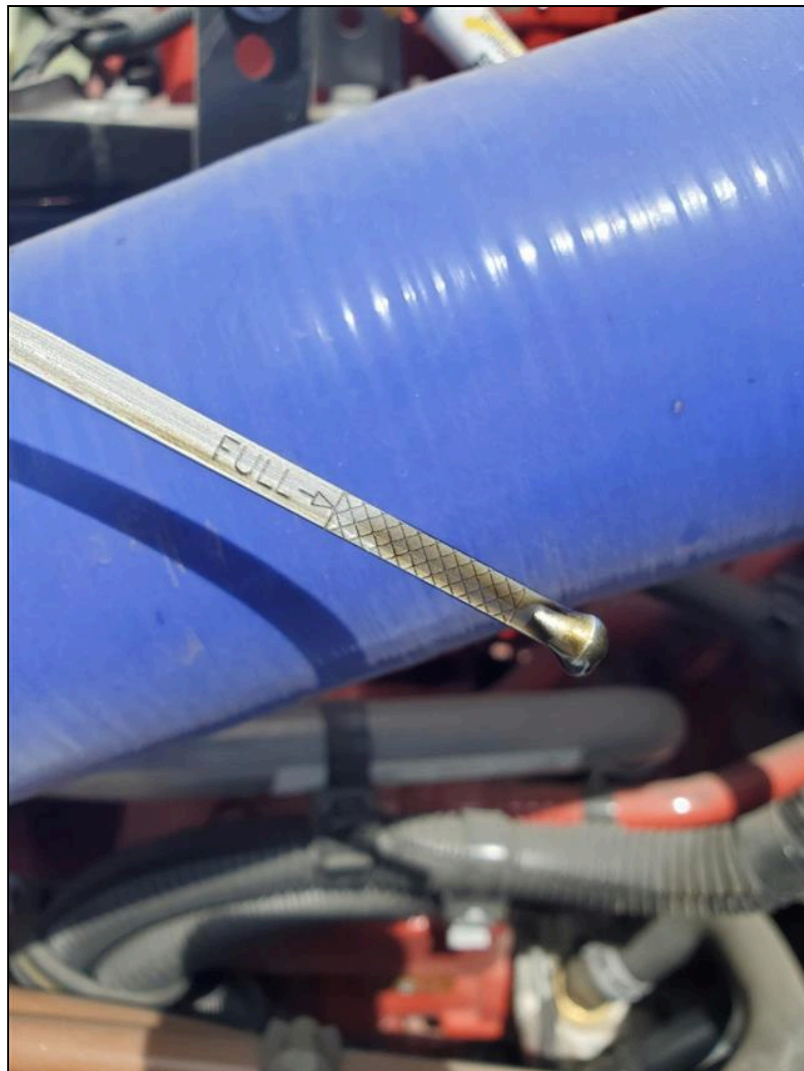
Engine Oil Level is Normal at Moment of Inspection

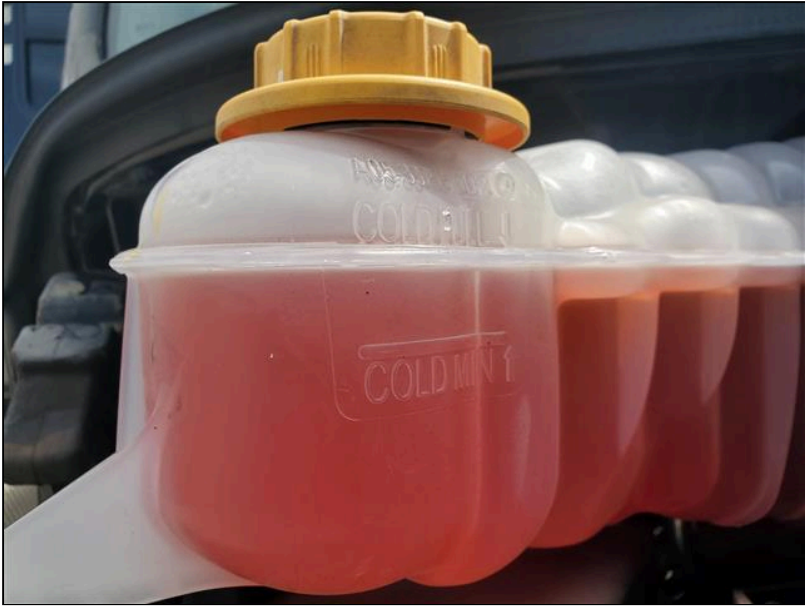
10.15 Engine Coolant Level

Acceptable
Coolant Level Normal

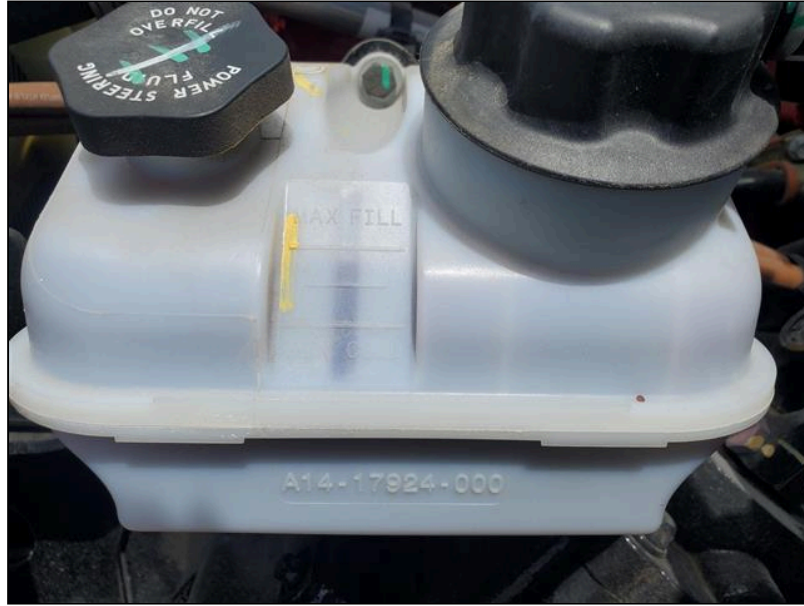
10.16 Power Steering Level

Power Steering Fluid Level

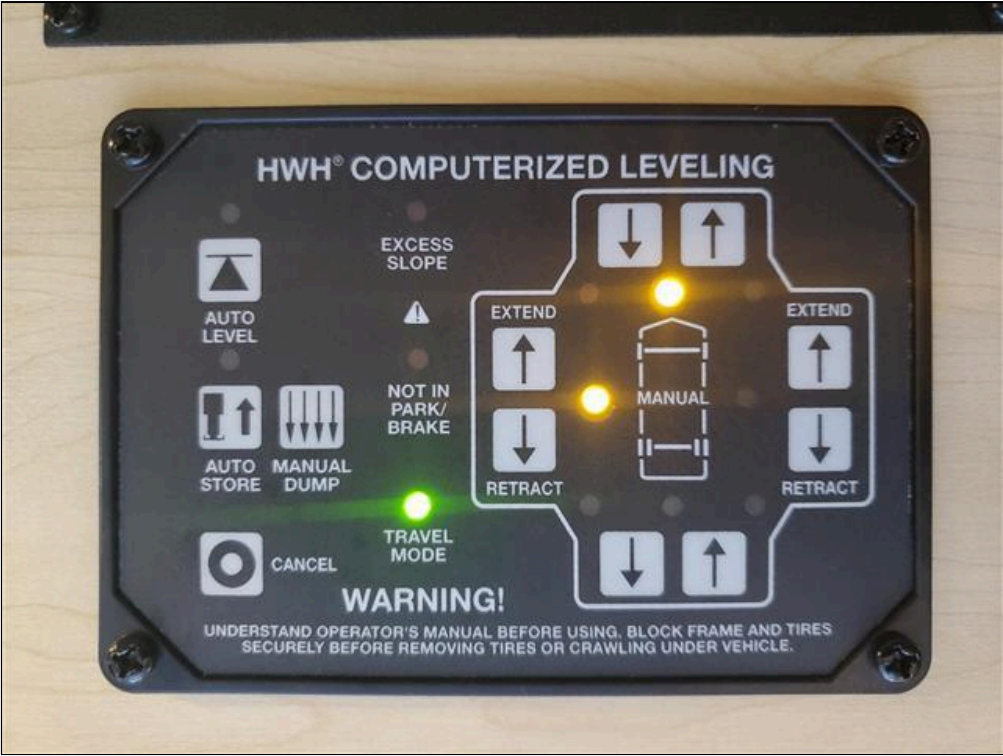
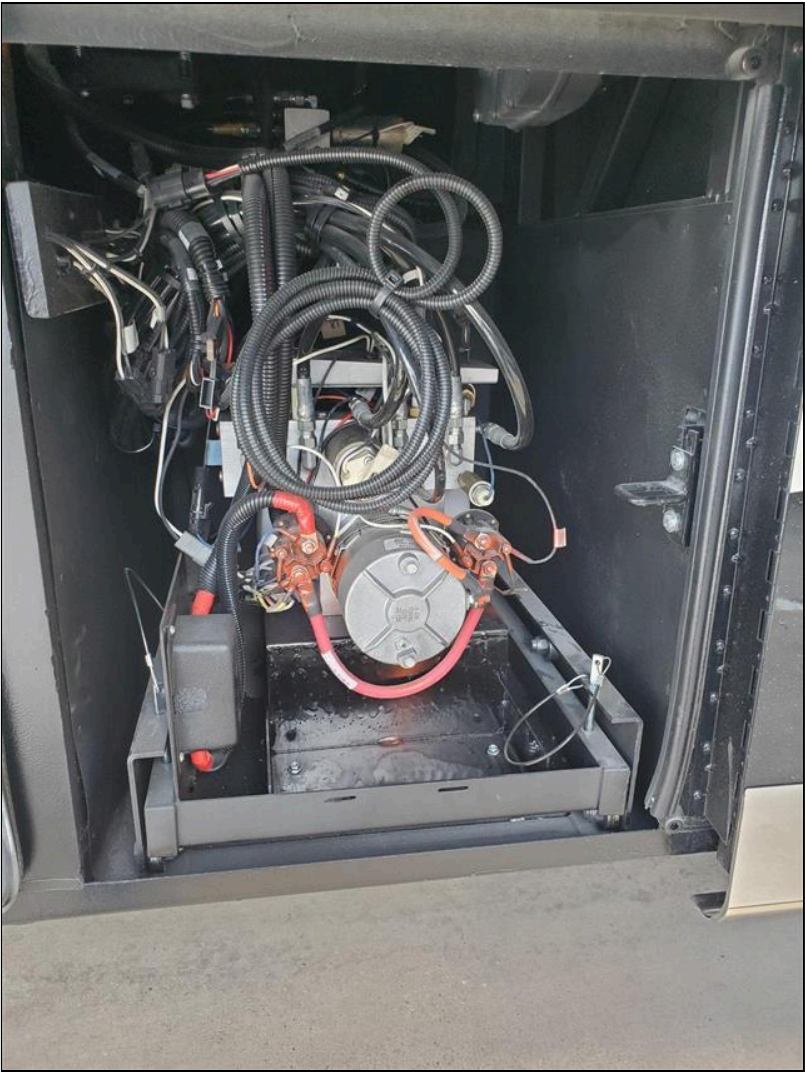
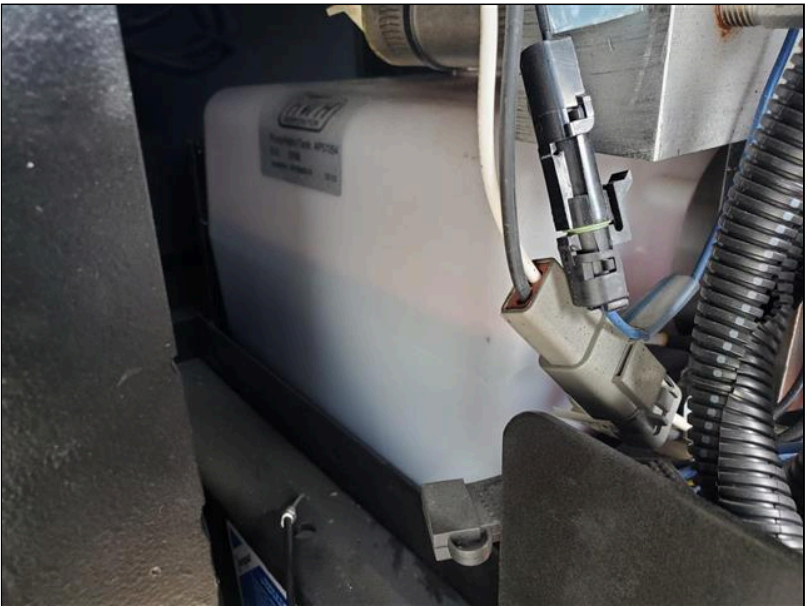
11.0 Leveling System Condition

Leveling system Operated as intended at moment of Inspection

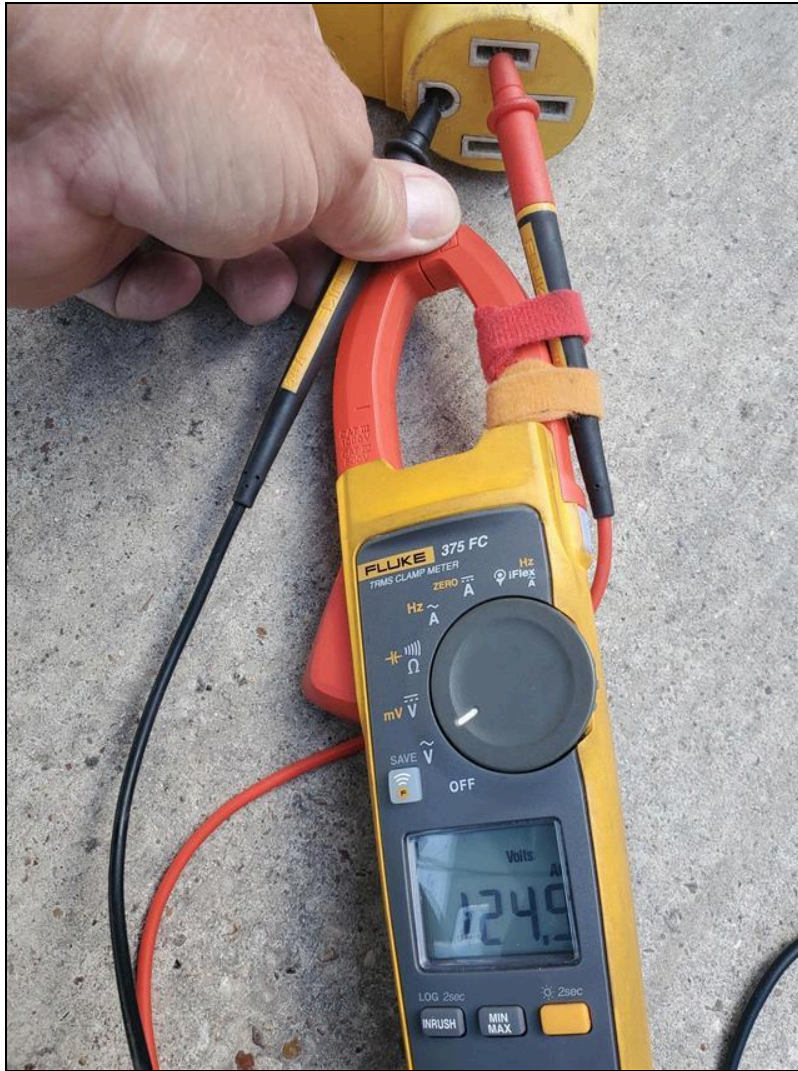
Power at Pedestal Verified Before Testing Unit

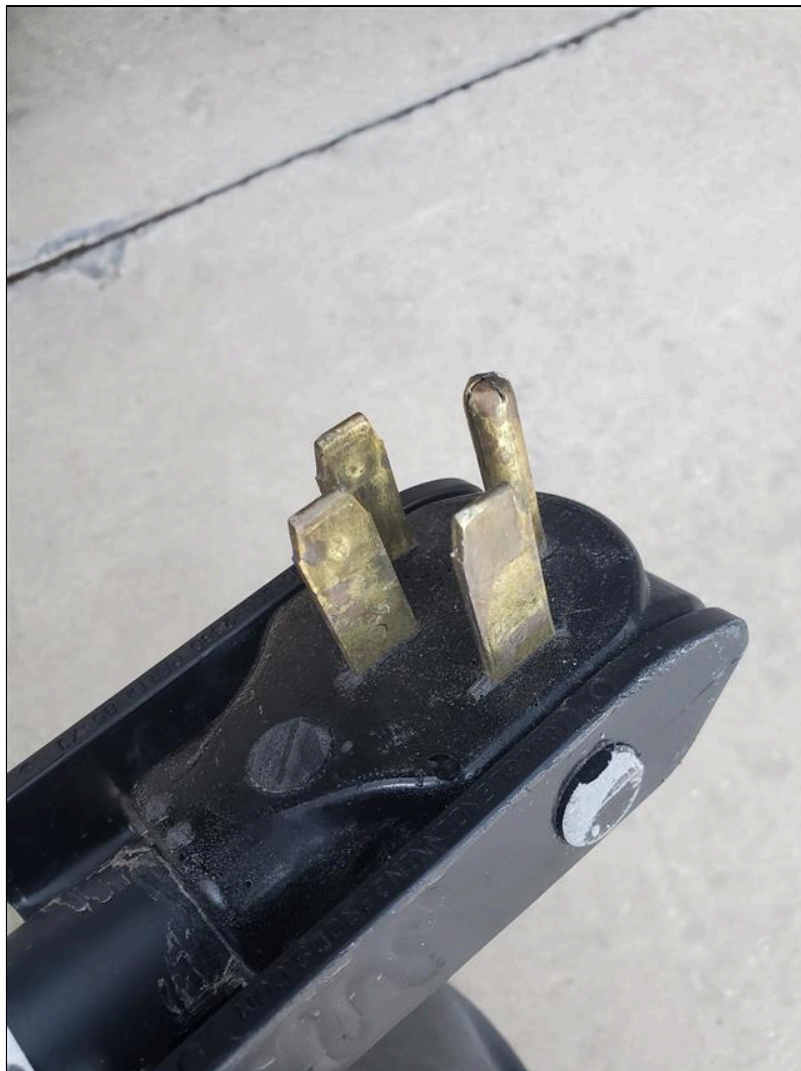
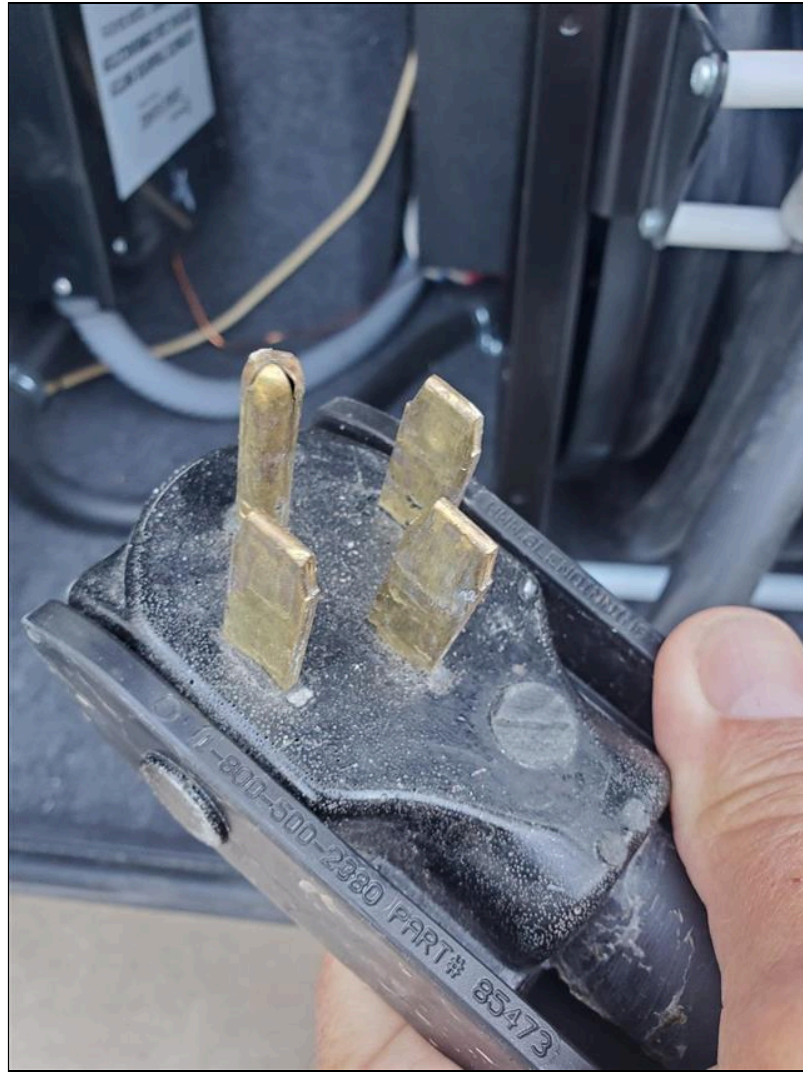
Power cord looked in good condition at moment of inspection.

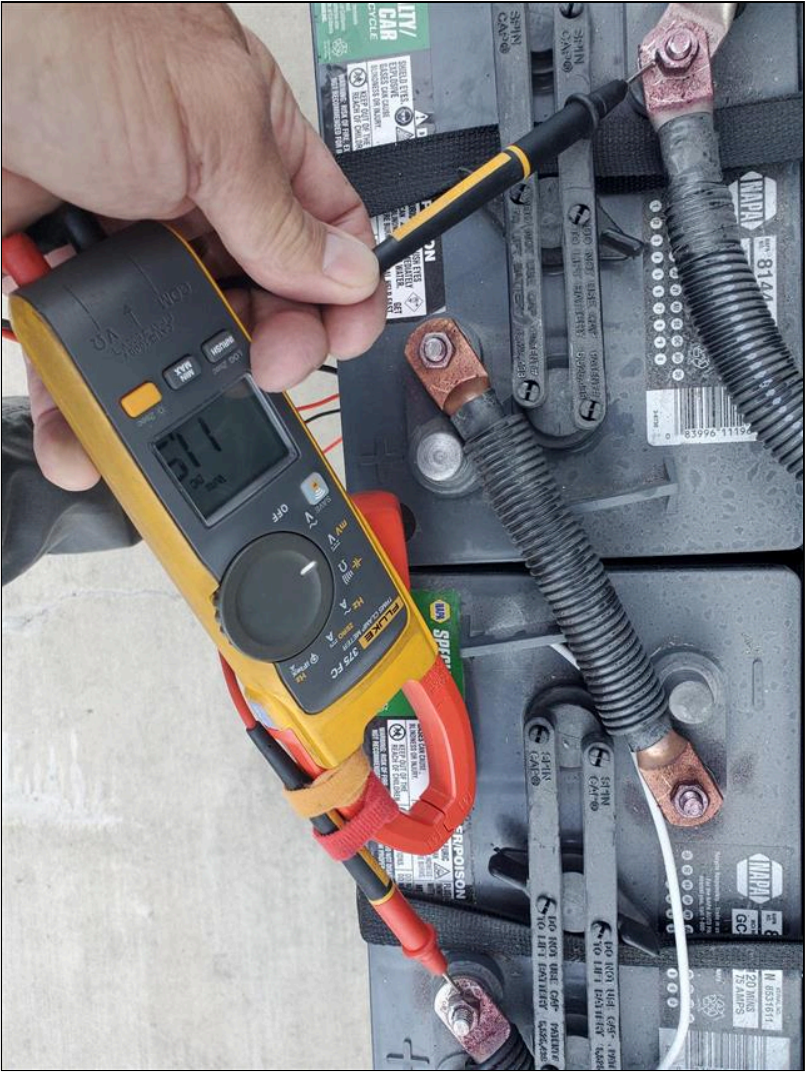
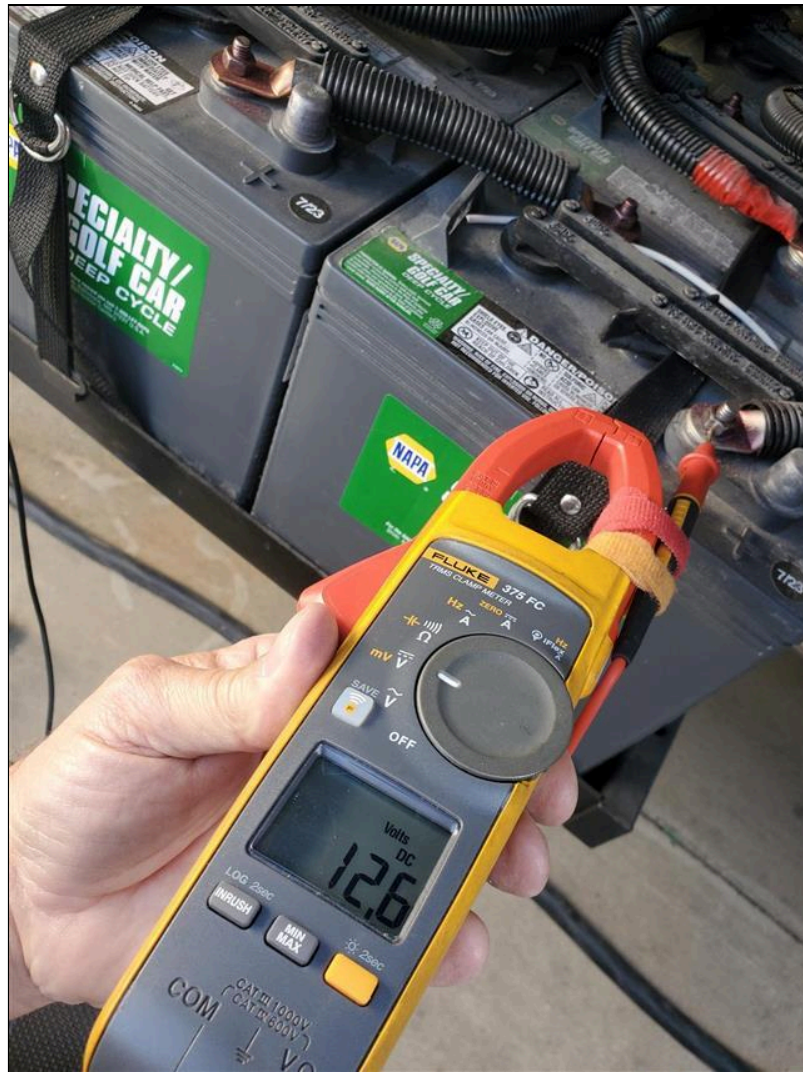
Power Converter worked as intended at moment of inspection
