RV Inspection Report

**Inspection Date / RV Model:
Newmar Superstar 4065 2023**

**Pierre Fortin
5753 Highway 85 N Lot 8511
Crestview, Florida, 32536**

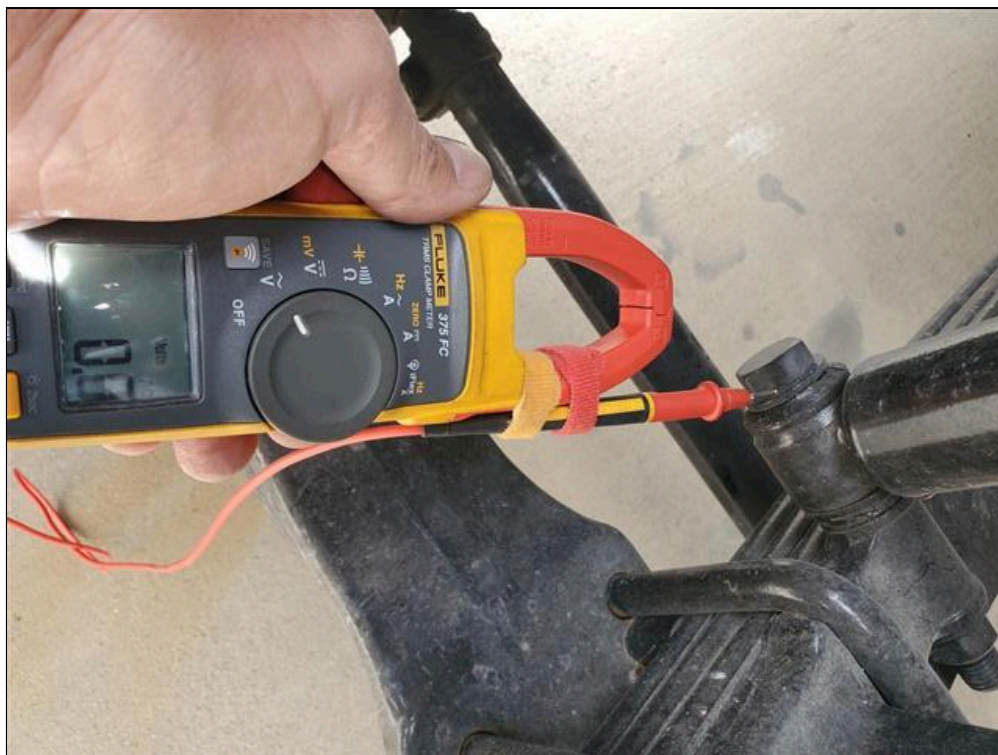
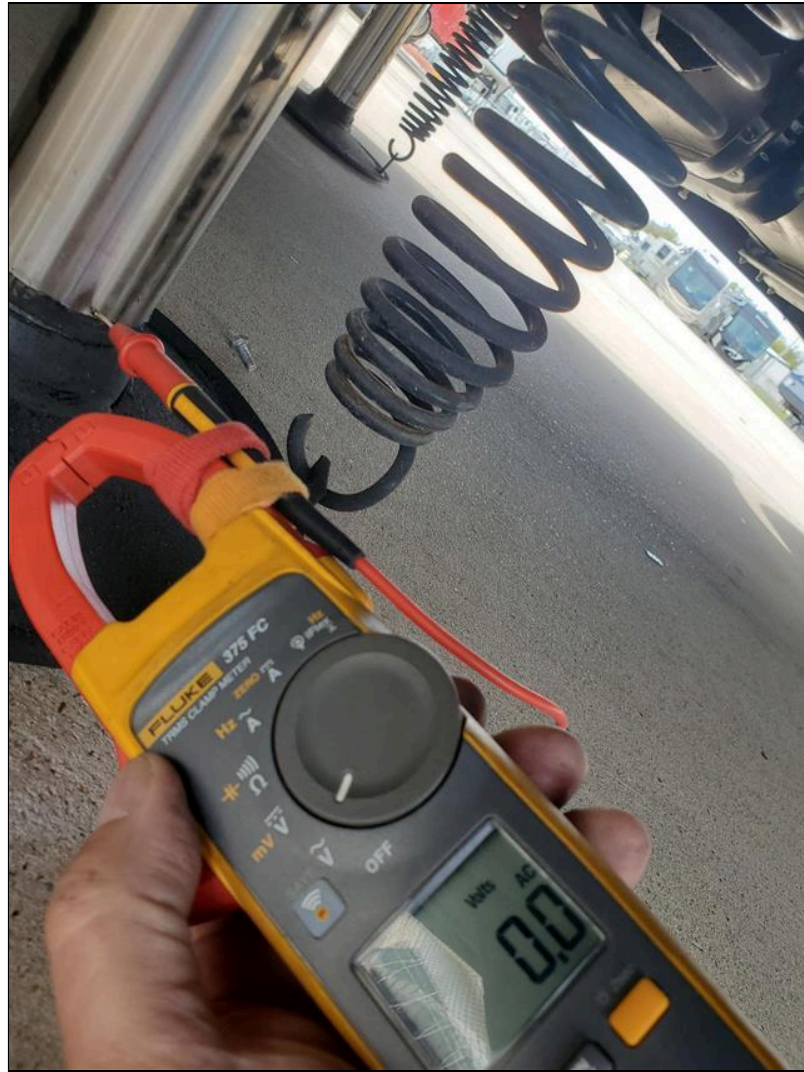
13.3 Hot Skin Test - Was any Frame and Running Gear Voltage Recorded

No frame readings on any frame or running gears

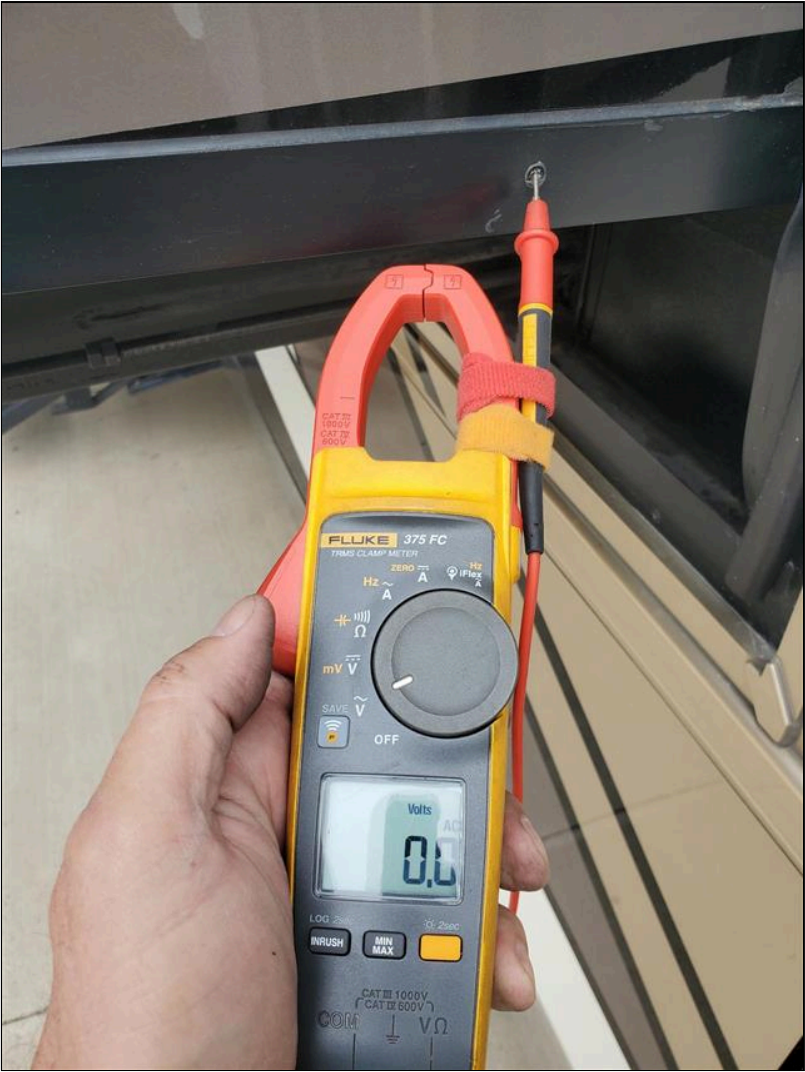
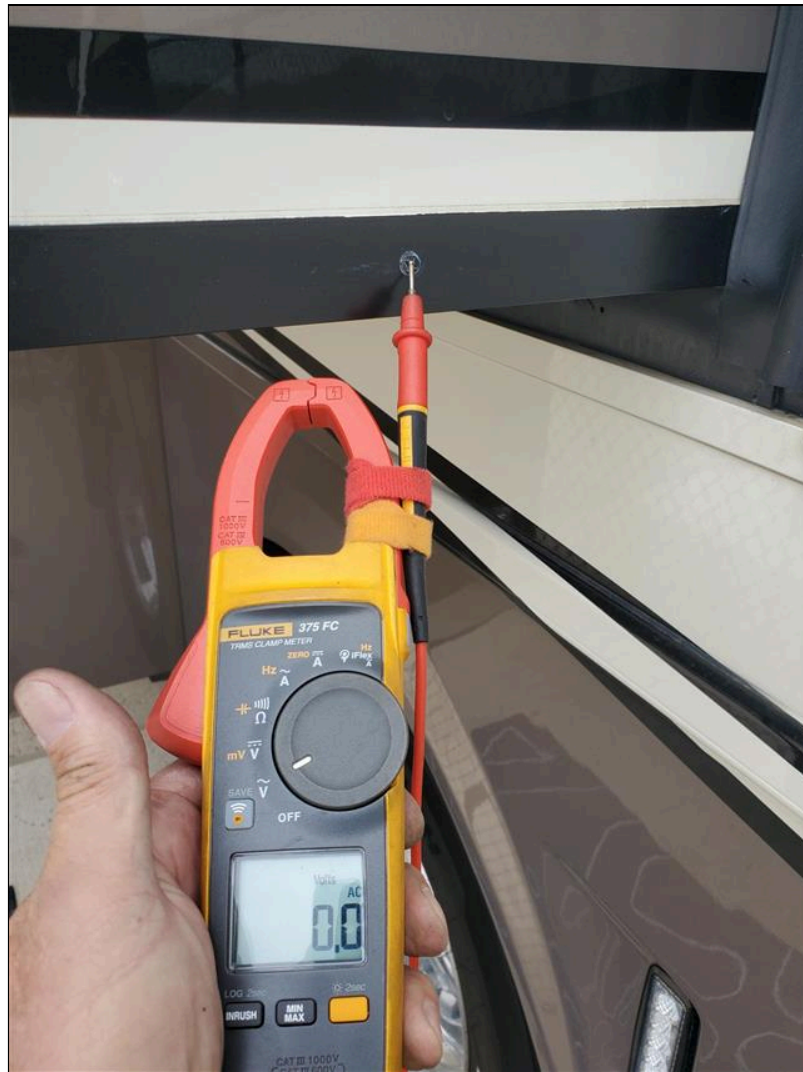
13.4 Hot Skin Test - Was any Exterior Wall Surface Voltage Recorded

No exterior walls or brackets surface readings

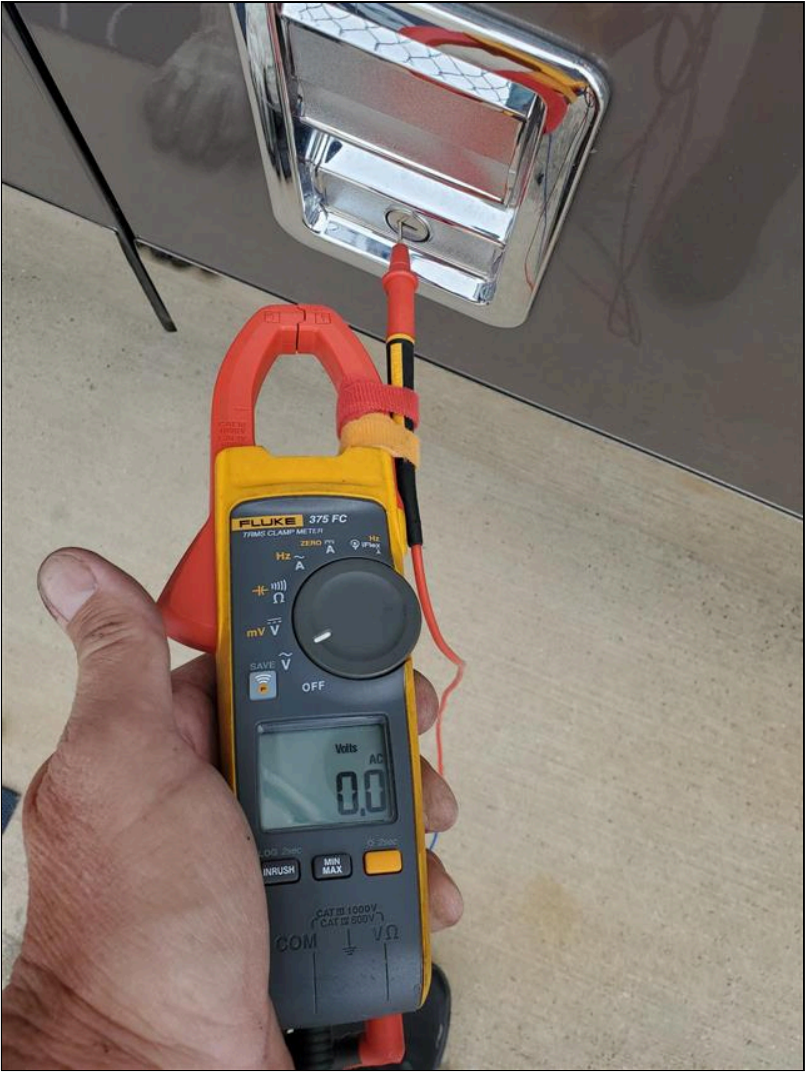
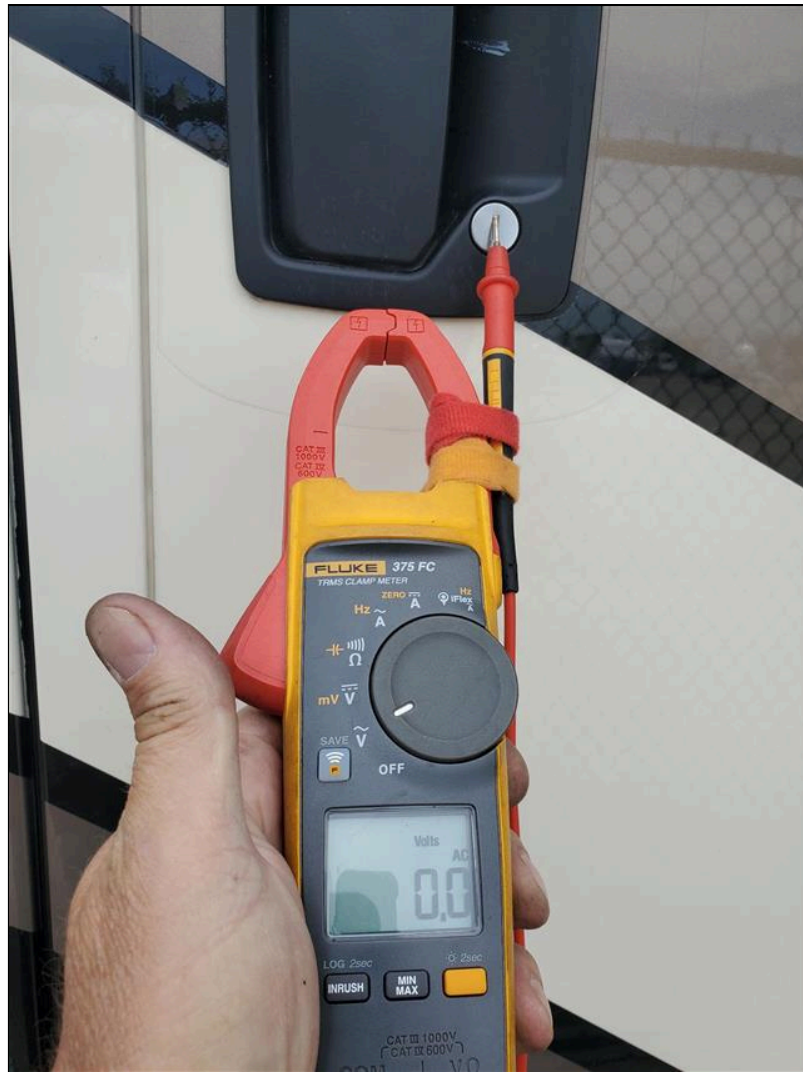
13.5 Hot Skin Test - Was any Door Handles and Frames Voltage Recorded

No door handles or cargo doors readings

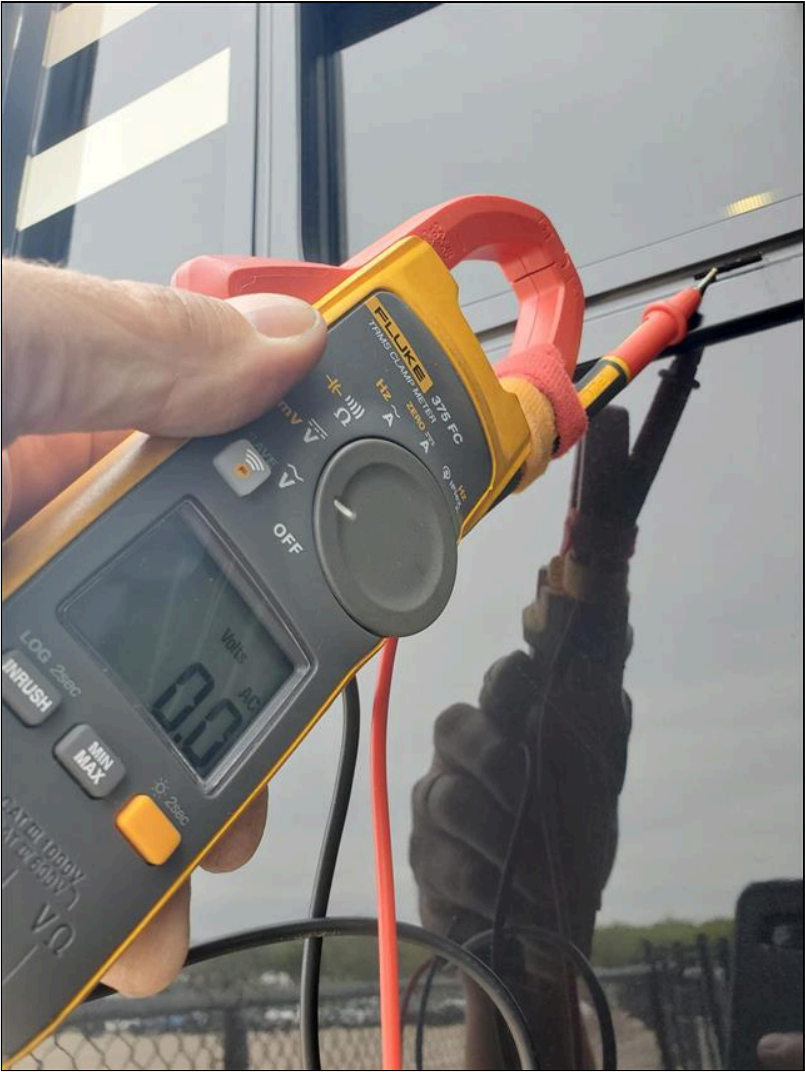
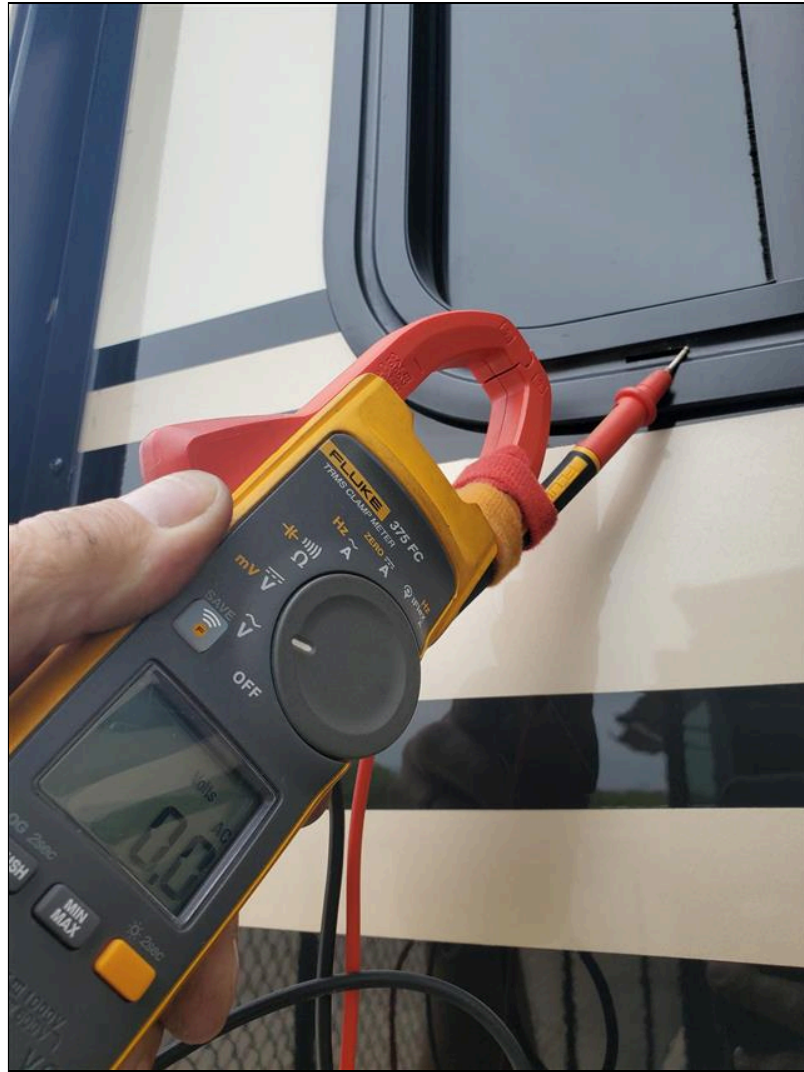
13.6 Hot Skin Test - Was any Window Frames and Trim Voltage Recorded

No Window Frames or Trims Voltage readings

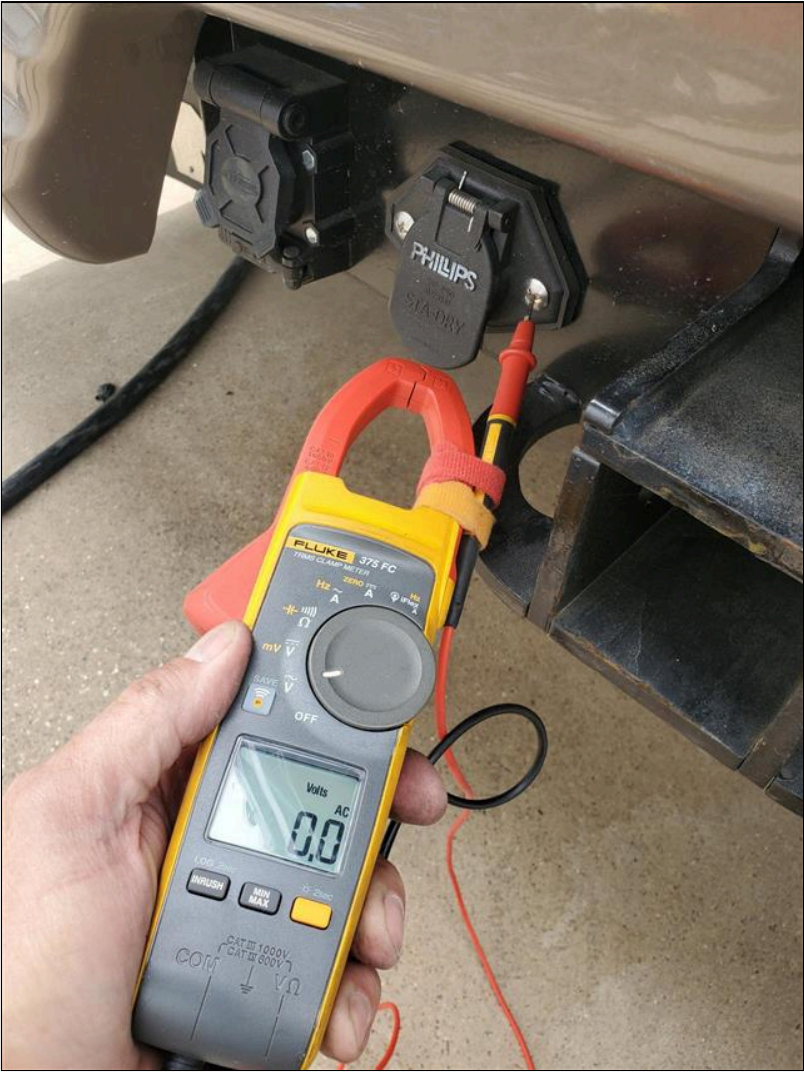
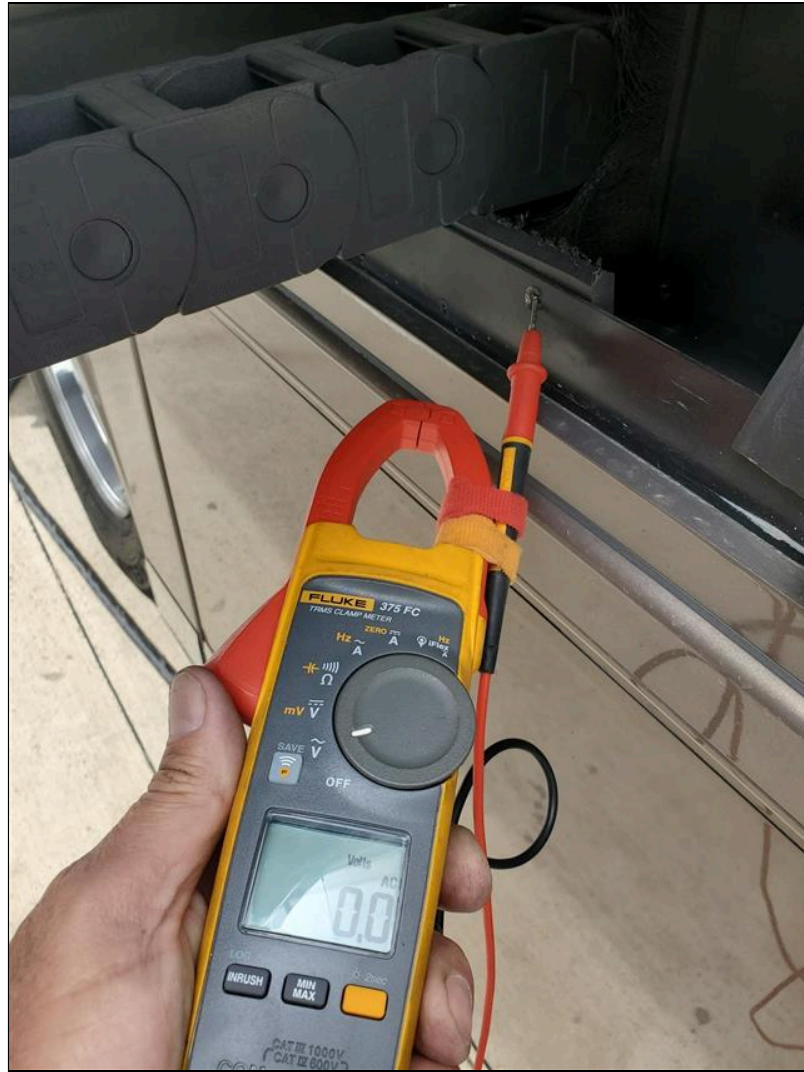
13.7 Hot Skin Test - Was any Other Voltage Recorded

No readings on steps, receiver or any other surfaces at moment of inspection.

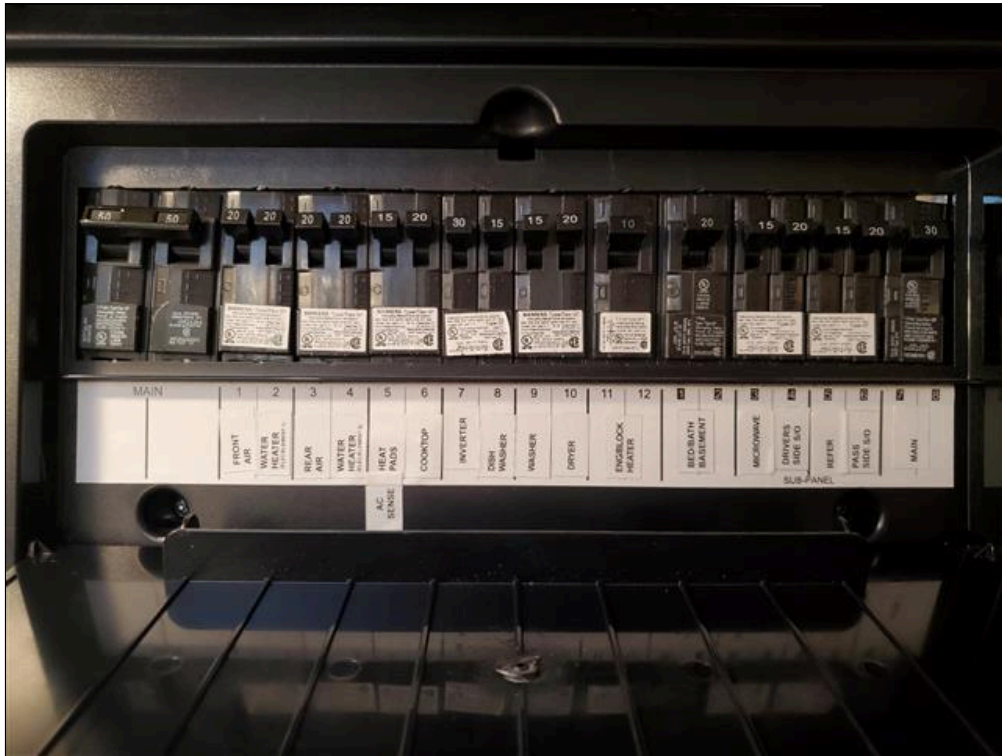
Electrical panel circuit breaker in place.

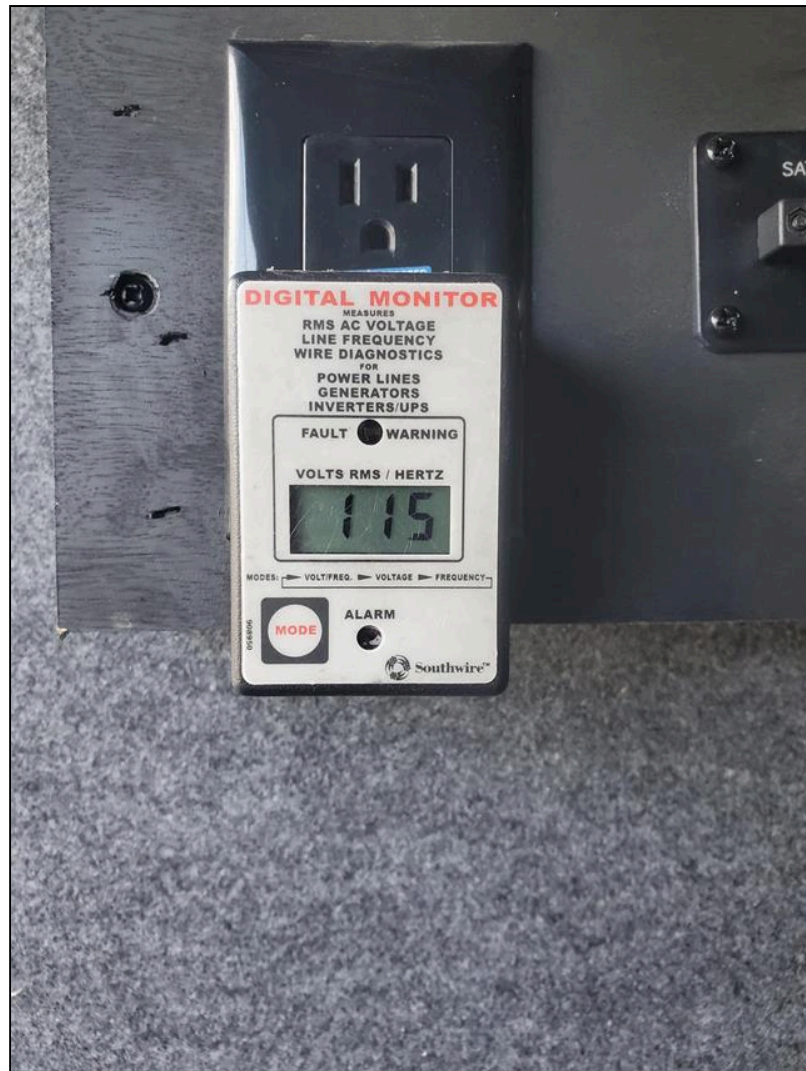
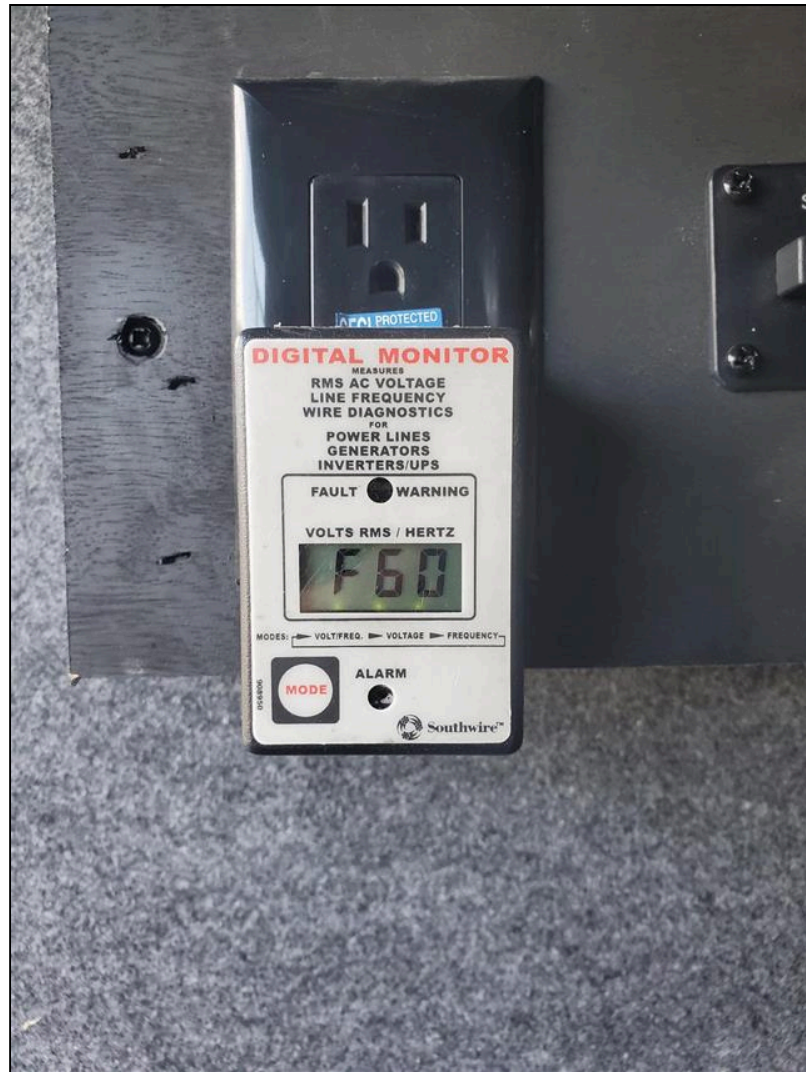
Receptacles in Basement Tested and Verified

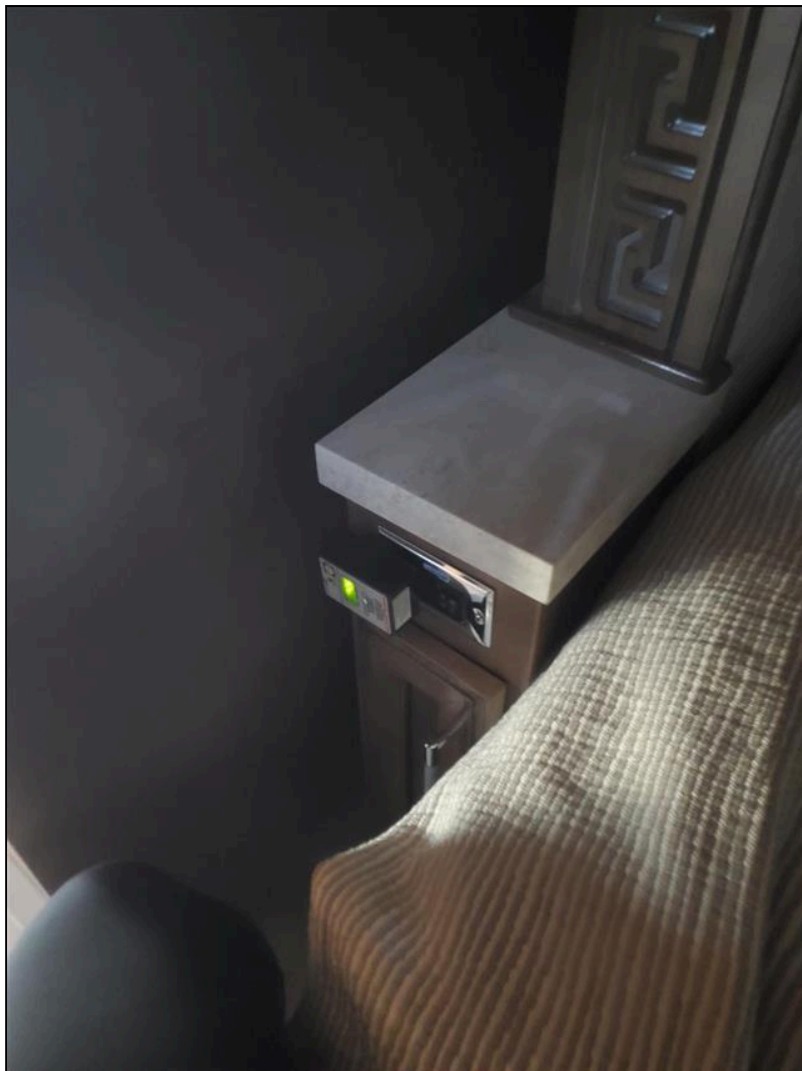
13.16 Polarity / Voltage Test - Bedroom Receptacles

All bedroom receptacles were tested for Voltage, Hertz and 12 V capabilities.

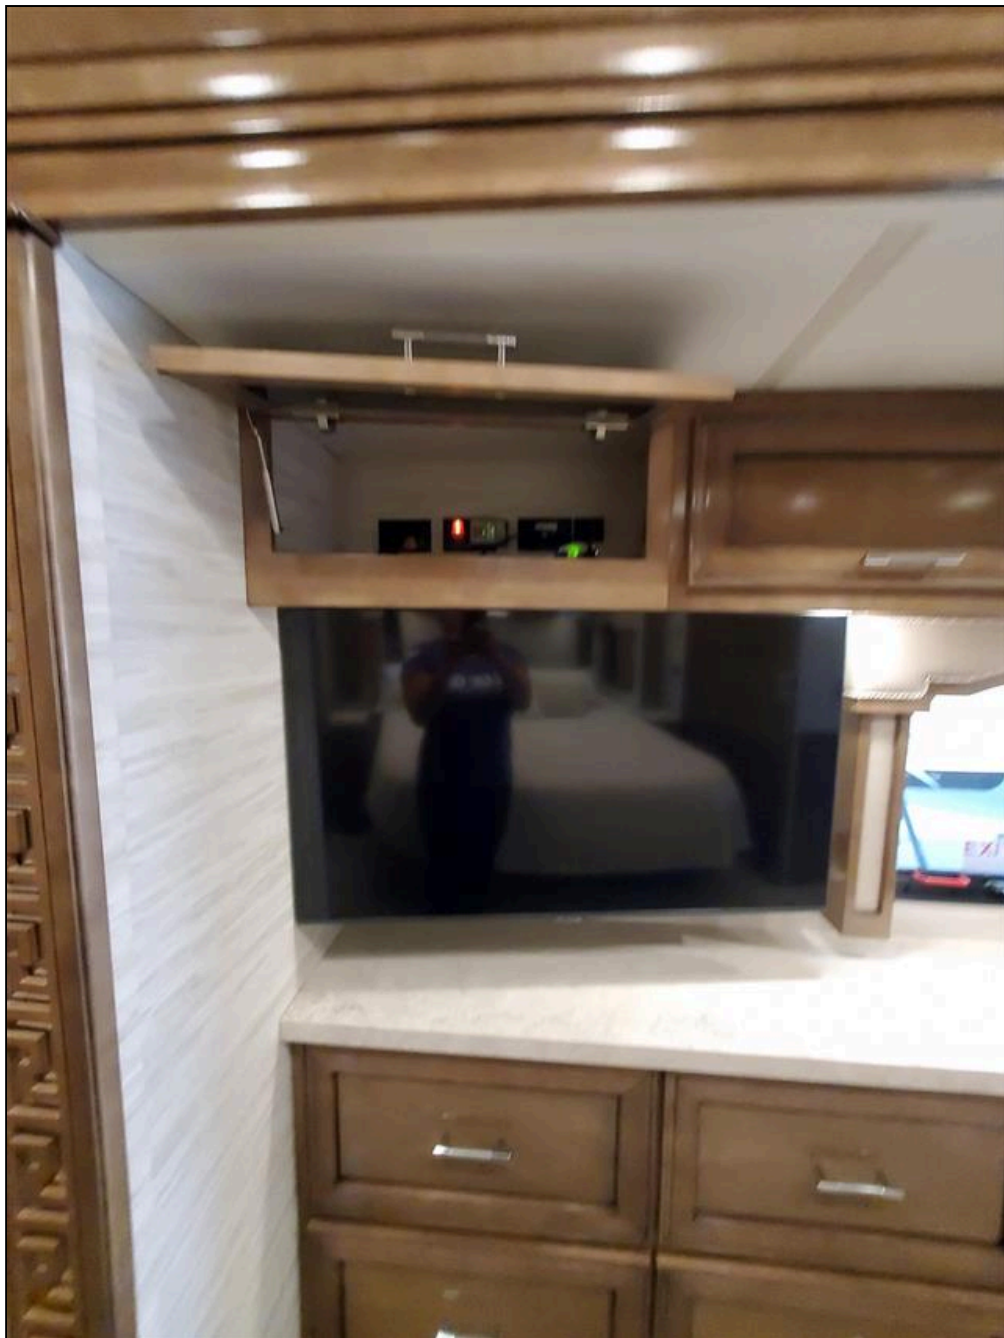
13.22 Polarity / Voltage Test - Receptacles Behind all Electronics and Appliances

Polarity / Voltage Verified Behind TV or Appliance

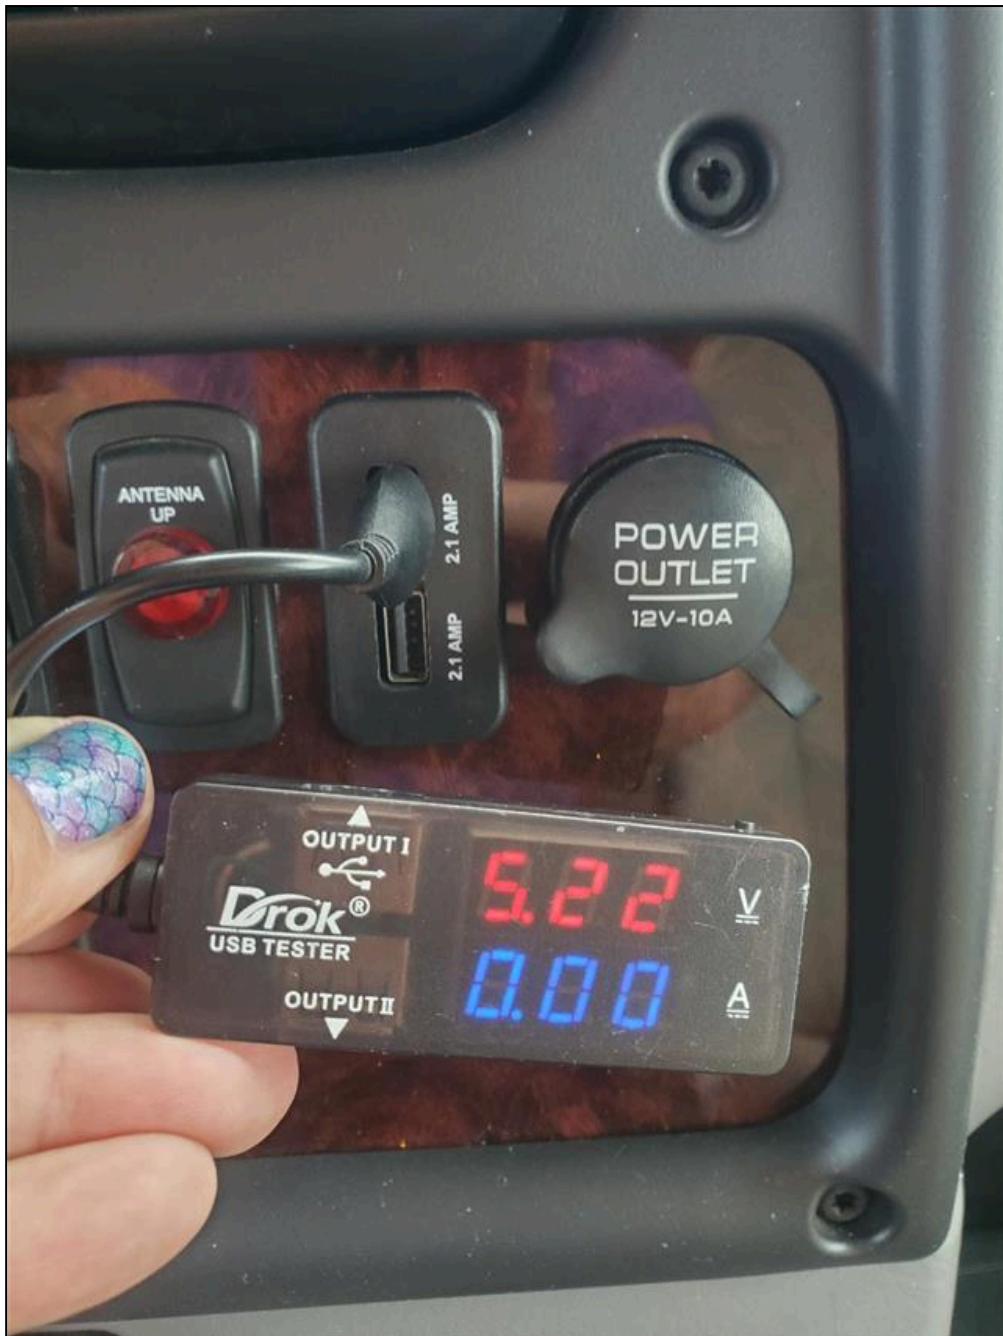
13.23 Voltage Test - USB Ports / 12-Volt Plugins

USB ports all tested and in operating condition

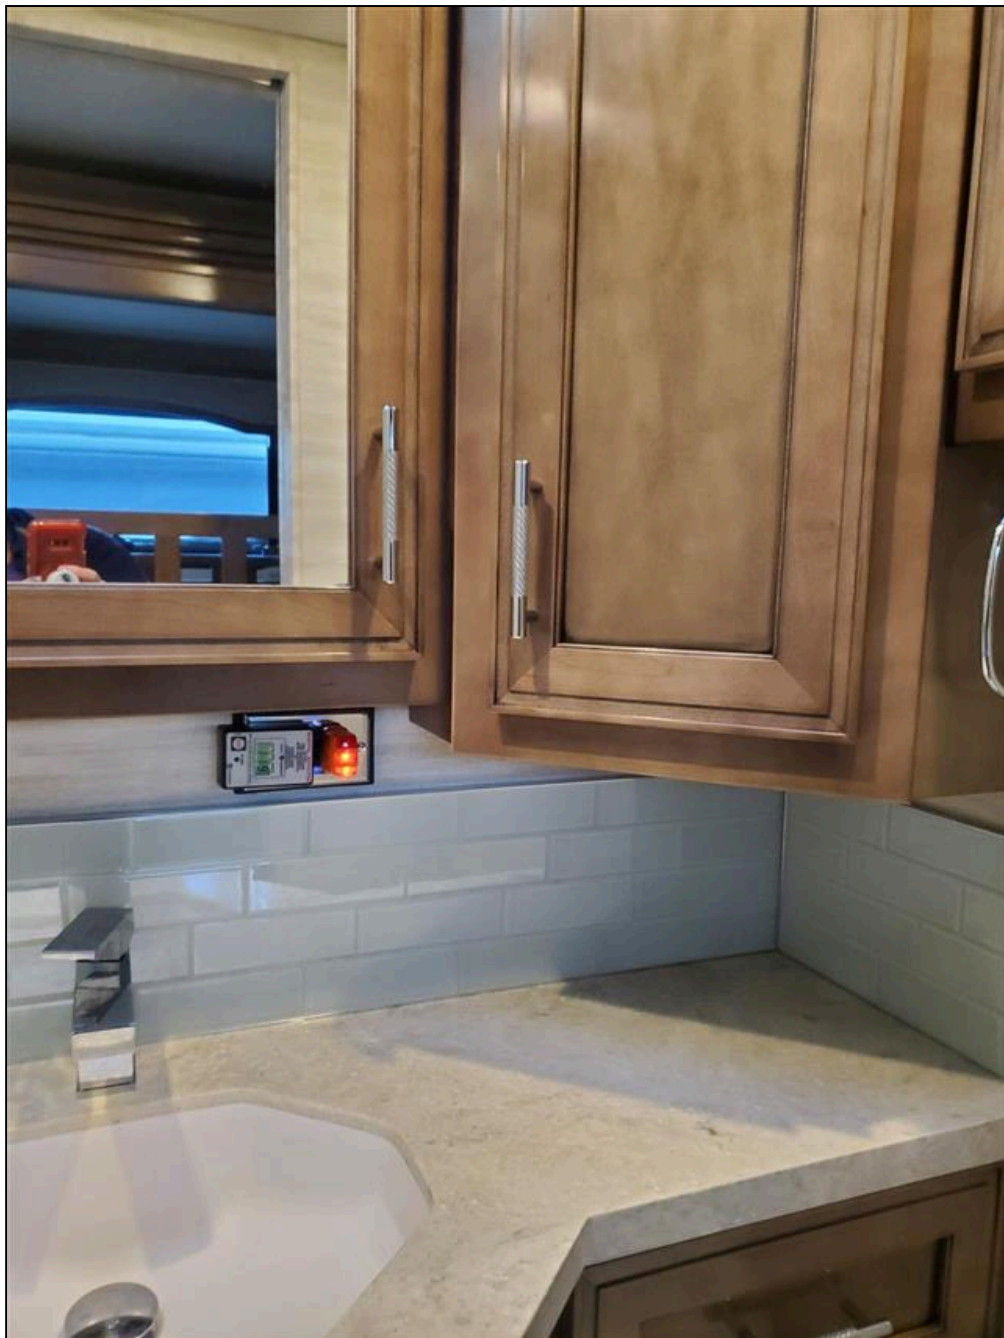
Every Bathroom GFCI outlets were tested

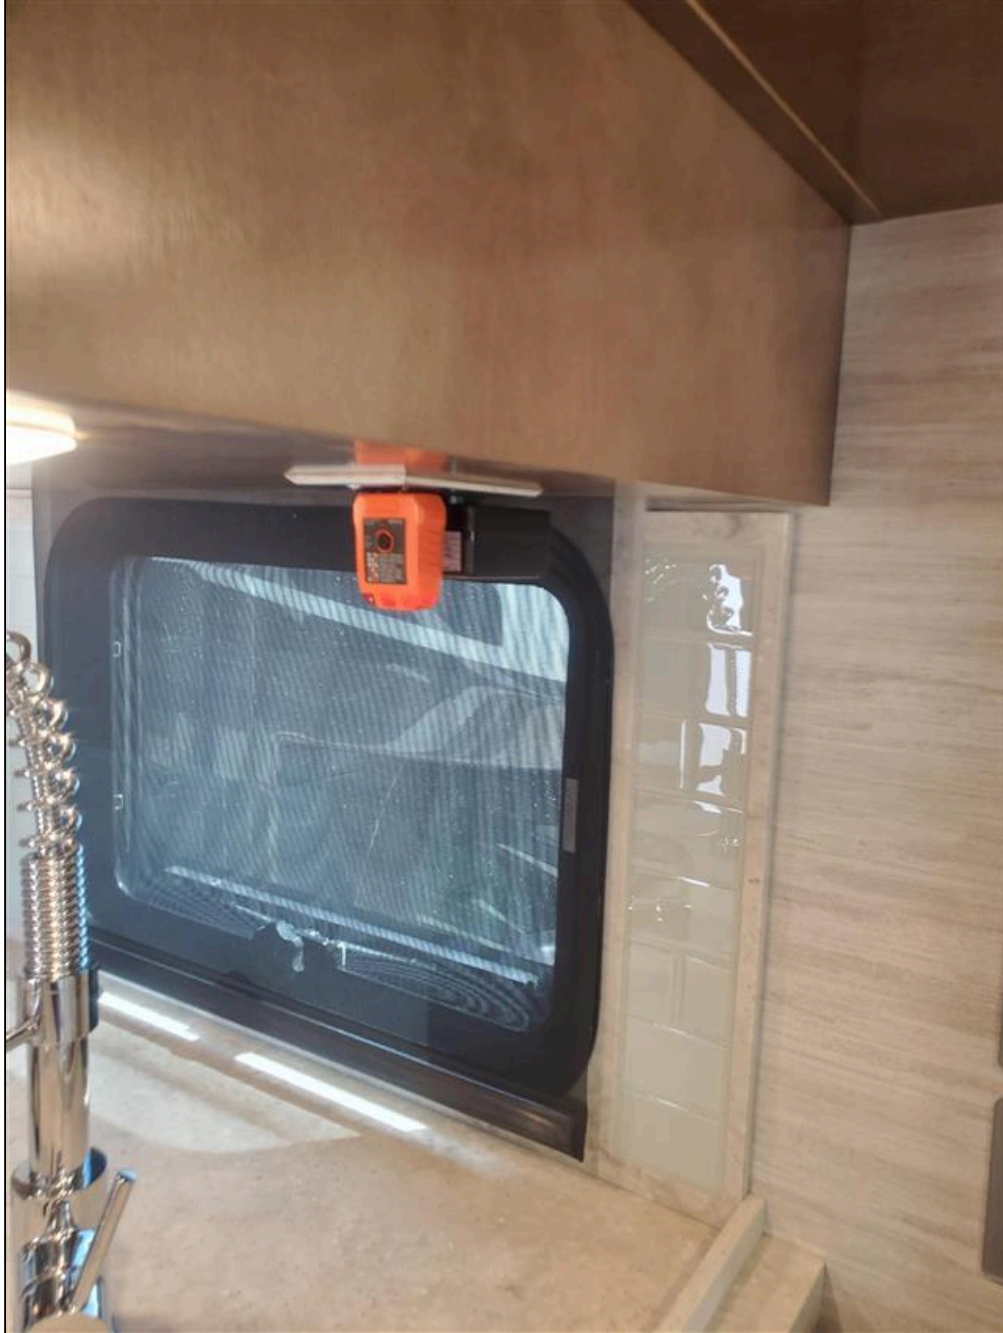
13.26 GFCI Trip Testing - Kitchen Receptacles

All Kitchen Receptacles Tested on GFCI

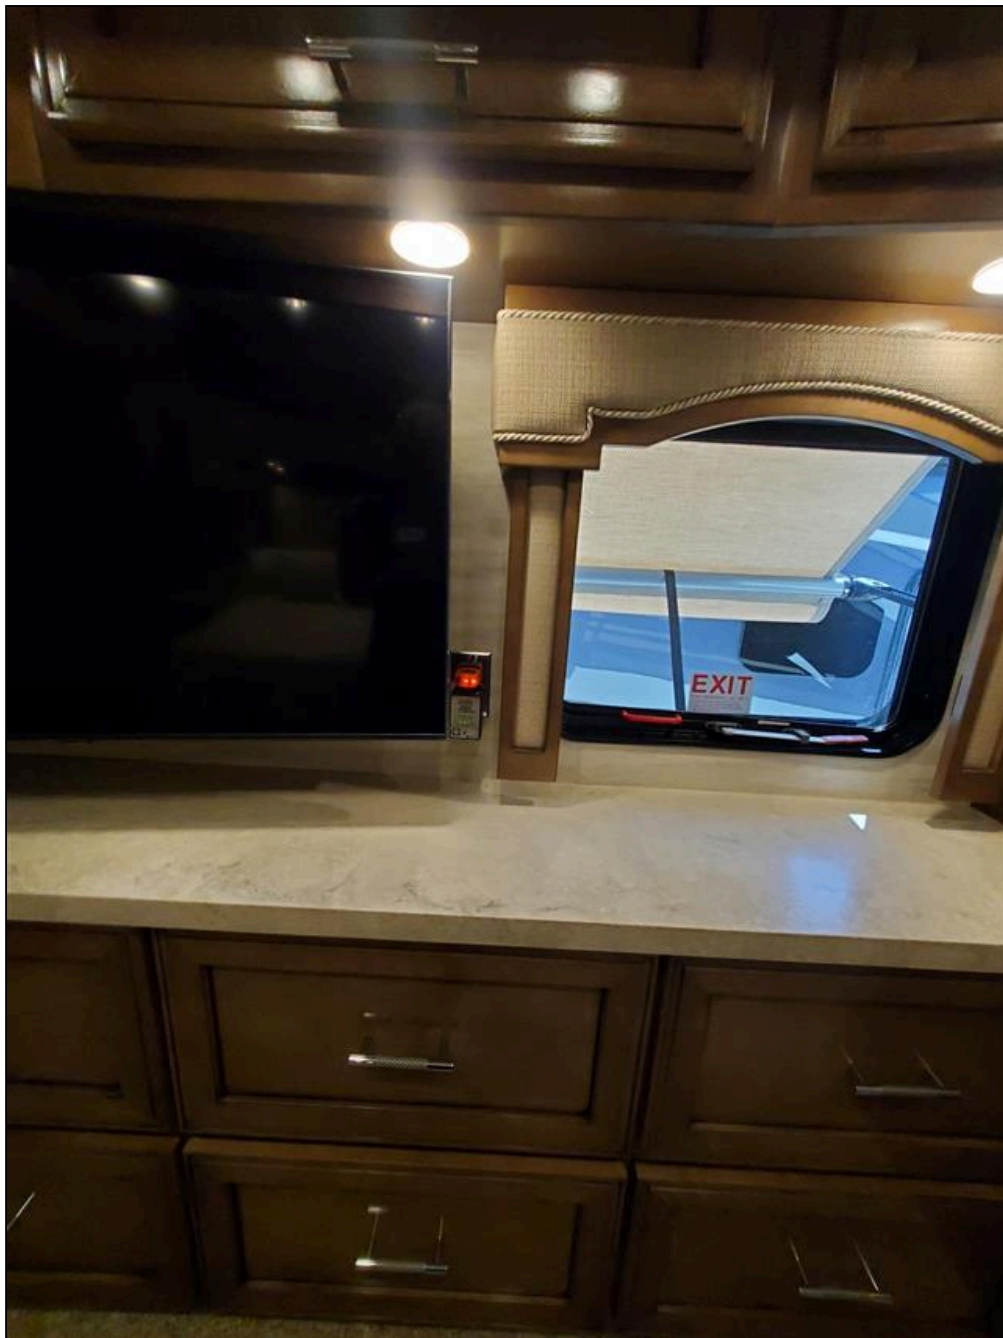
13.27 GFCI Trip Testing - Bedroom Receptacles

Bedroom Testing on GFCI all operated

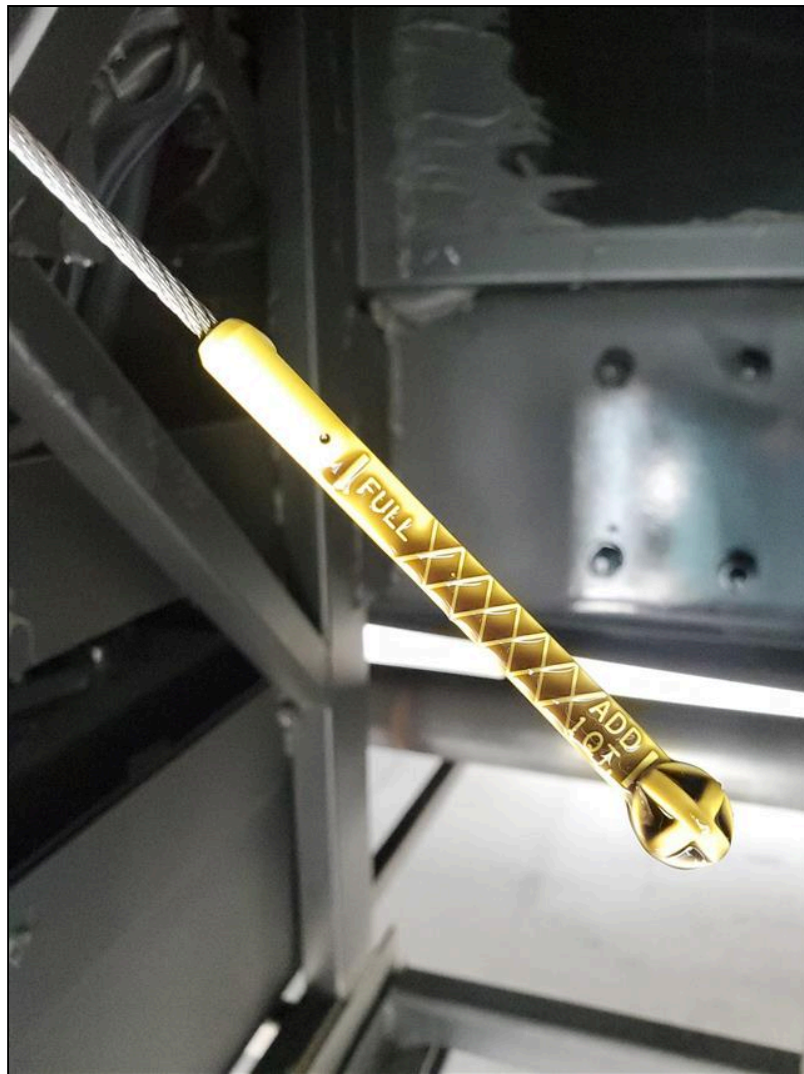
Oil Level was normal at moment of inspection

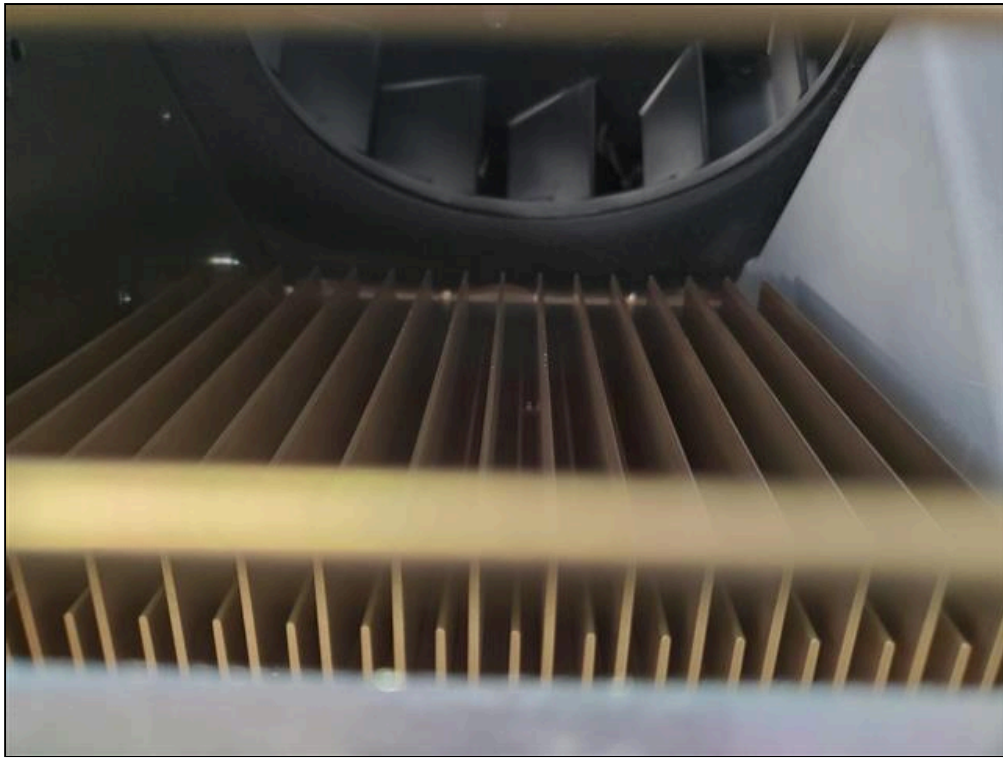
13.36 Generator - Radiator in Good Condition

Generator Radiator looks in good condition and doesn't have any Leaks at moment of Inspection

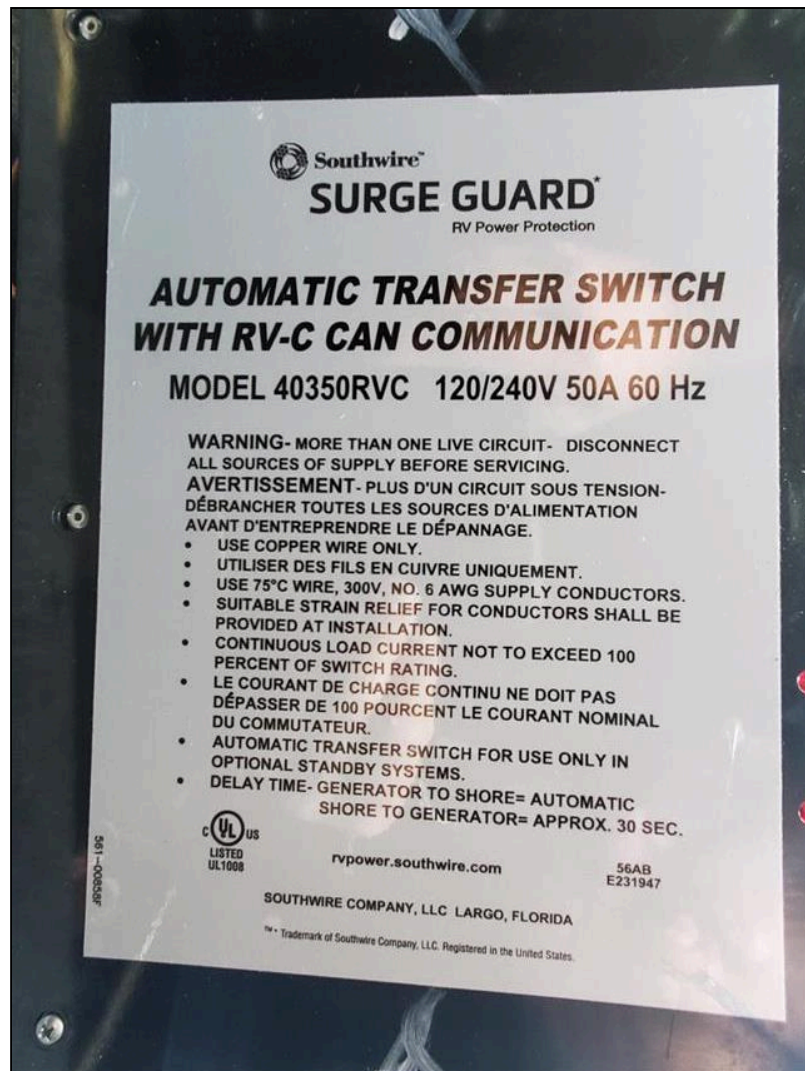
13.40 Transfer Switch Tested

Automatic Transfer Switch Worked as Intended at moment of Inspection

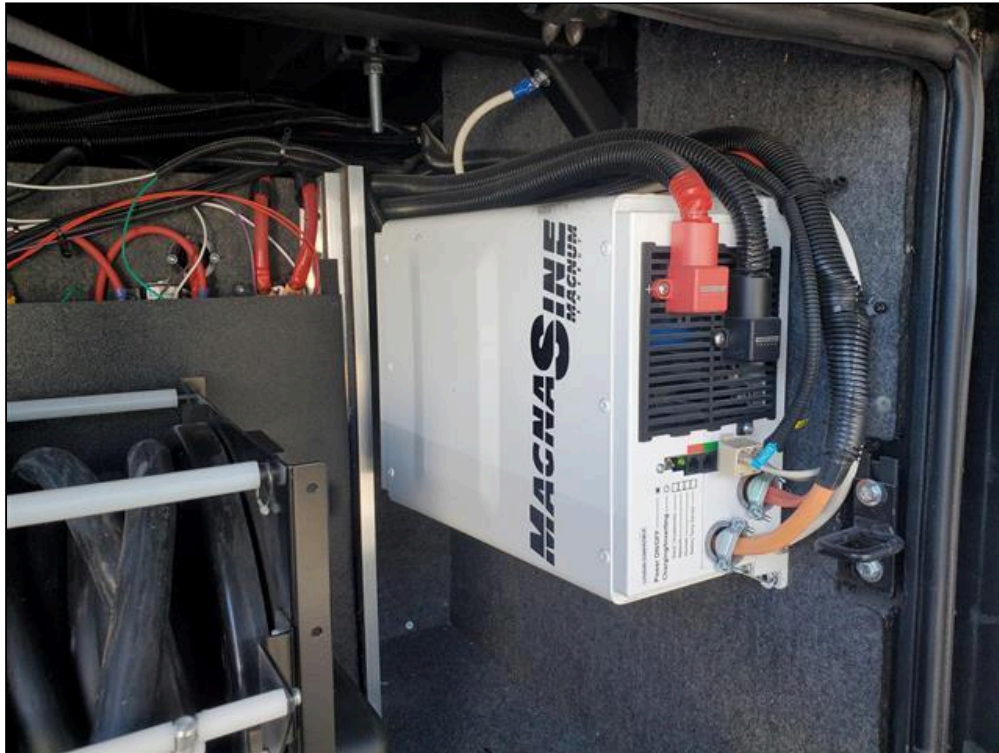
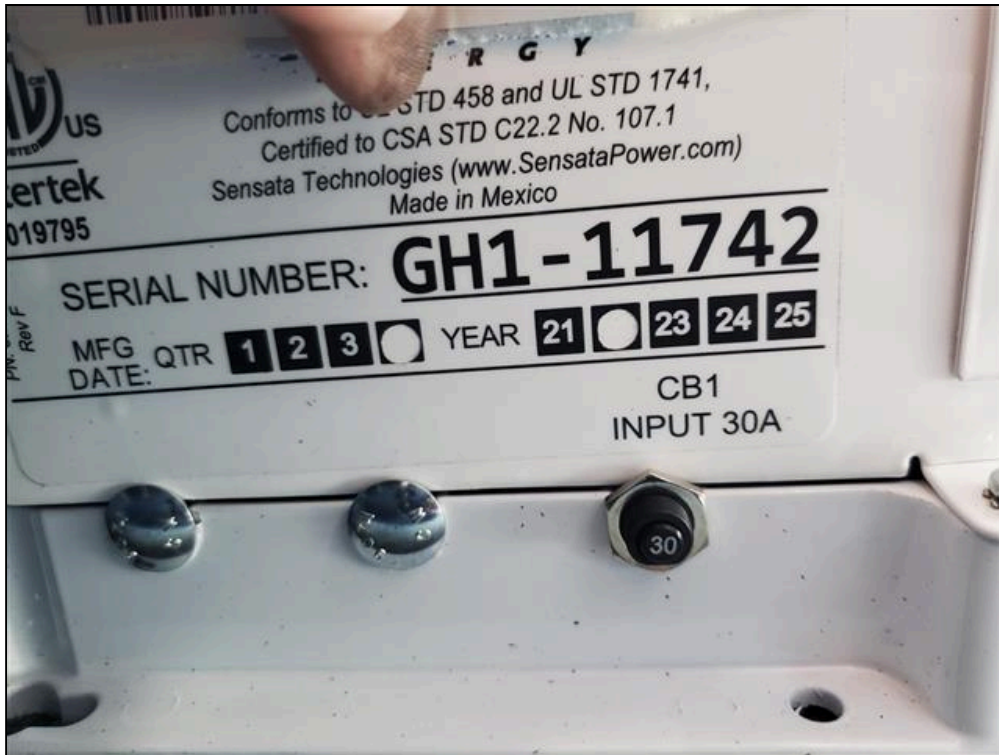
13.41 Inverter - Installed

Maybe the Charger side of the Inverter doesn't operate as intended or possibly a ground short in the system.

Batteries don't charge as Intended and are drawn quickly if under no charge to support them.
