RV Inspection Report

**Inspection Date / RV Model:
Newmar Superstar 4065 2023**

**Pierre Fortin
5753 Highway 85 N Lot 8511
Crestview, Florida, 32536**

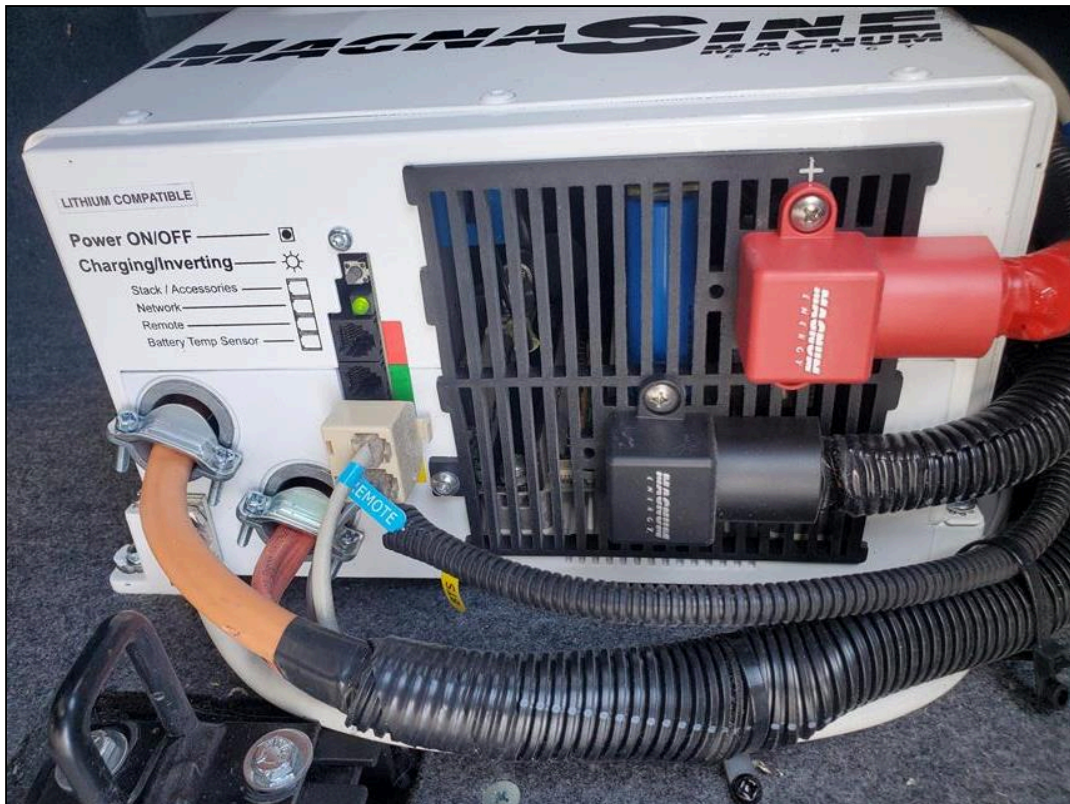
13.42 Inverter - Inspected Cables, Wiring and Fuses

Inverter cables and connections were solid at moment of inspection

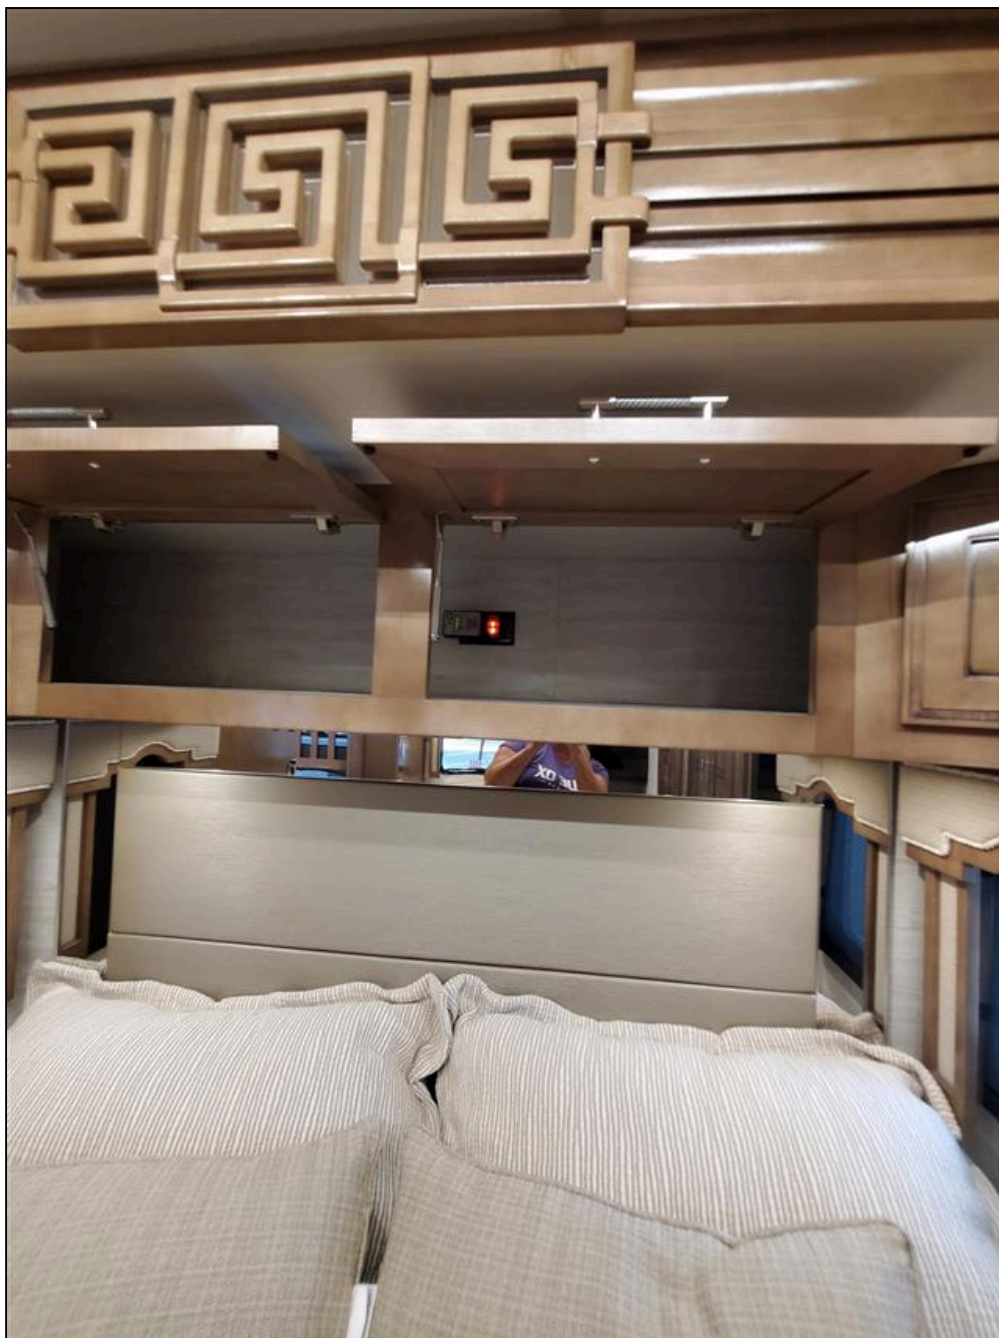
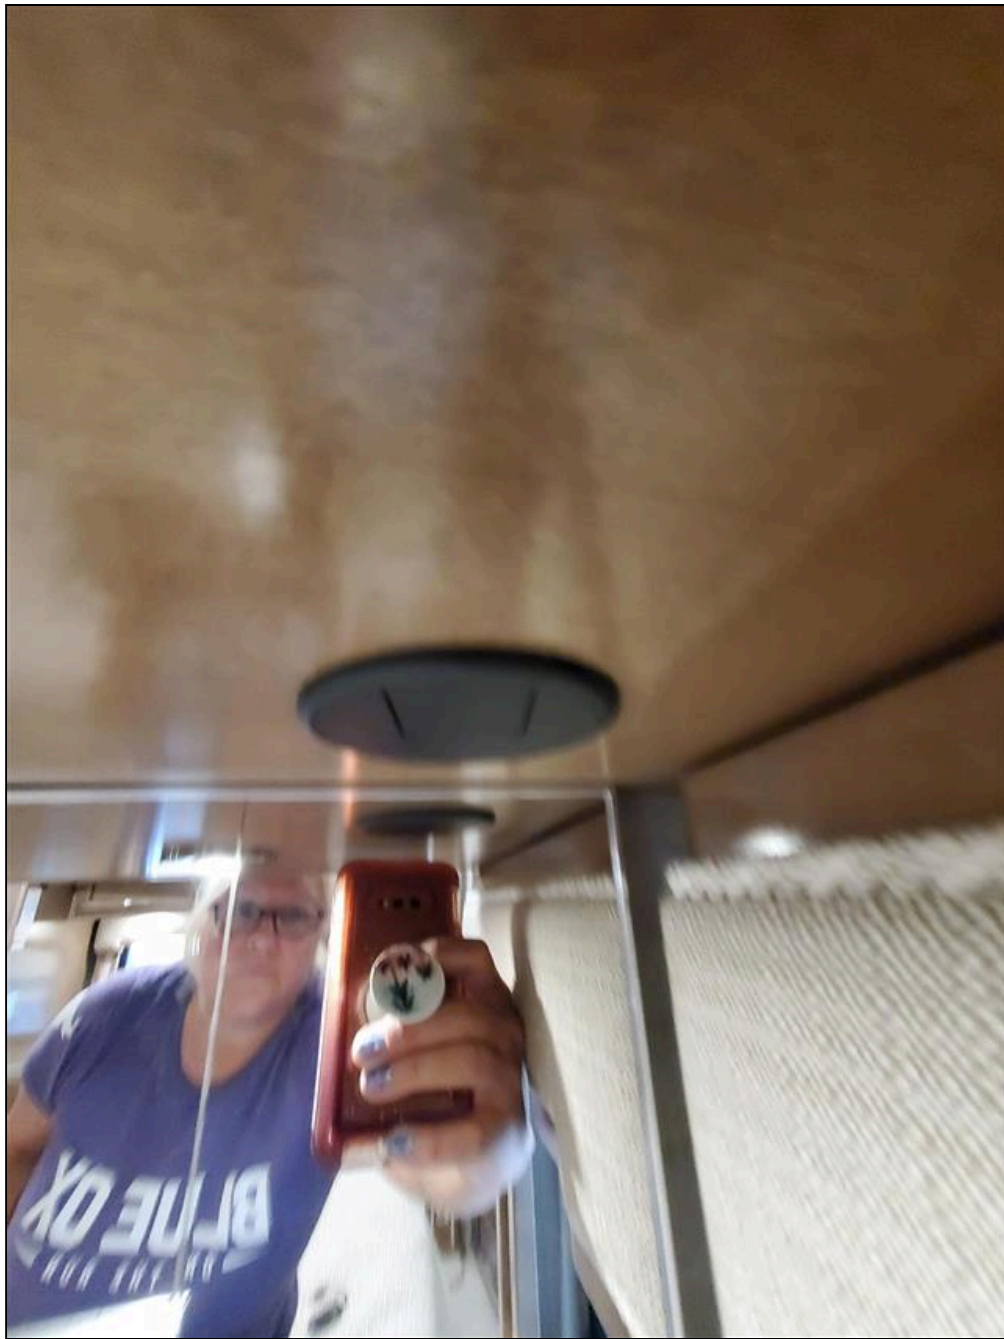
13.43 Inverter - Bedroom Outlet Operating Test For CPAP

CPAP Outlet Tested and Accessible

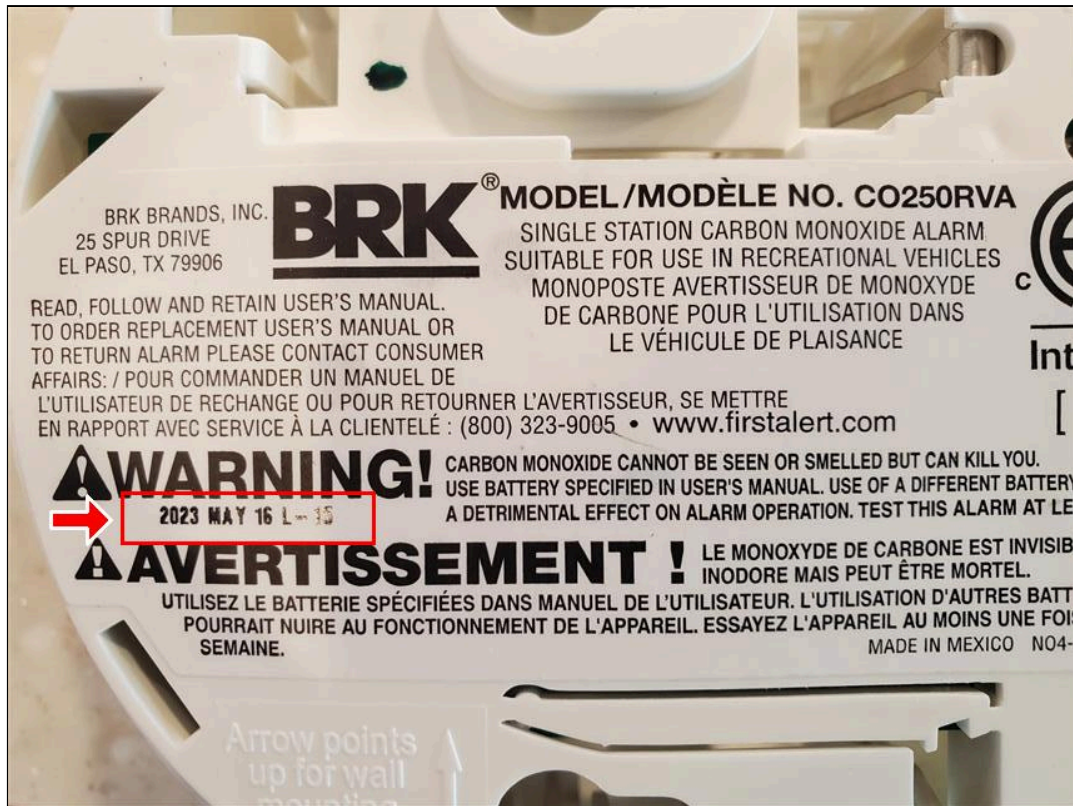
NOTE: LP / Carbon Monoxide Combo Detectors have an estimated service life of 5 years after which time it is recommended they be replaced.

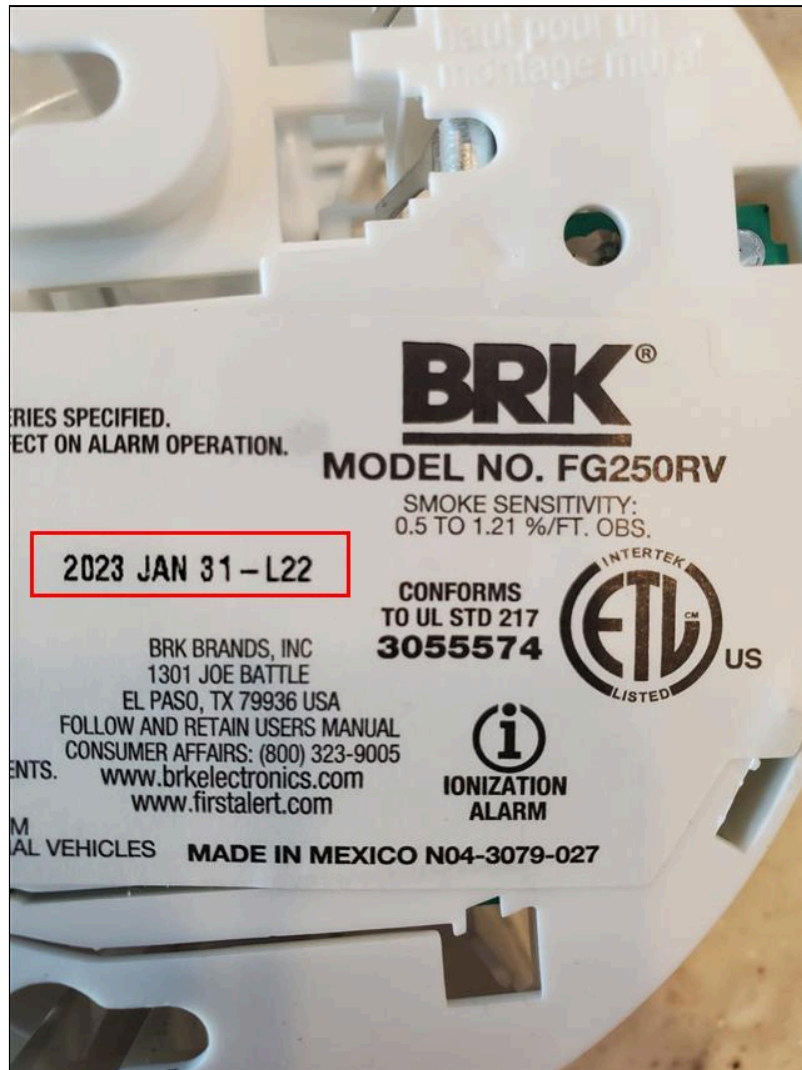
15.1 Smoke Detector

NOTE: Smoke Detectors have an estimated service life of 5 or 10 years after which time it is recommended they be replaced.

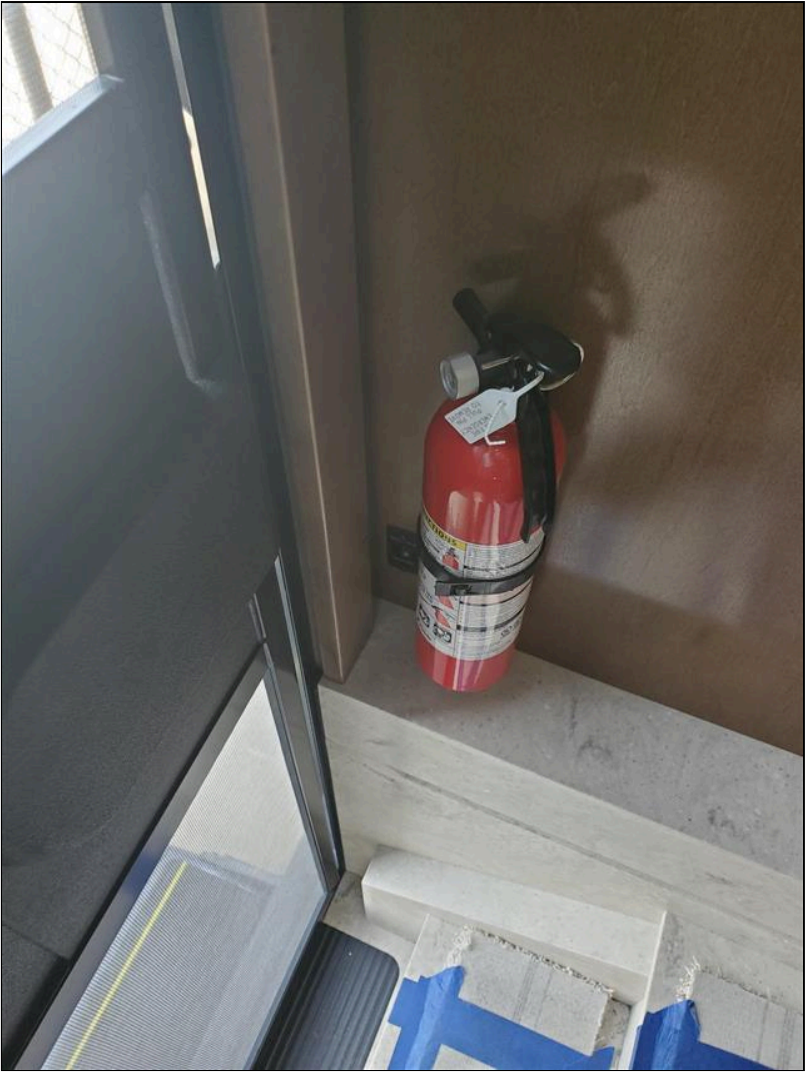
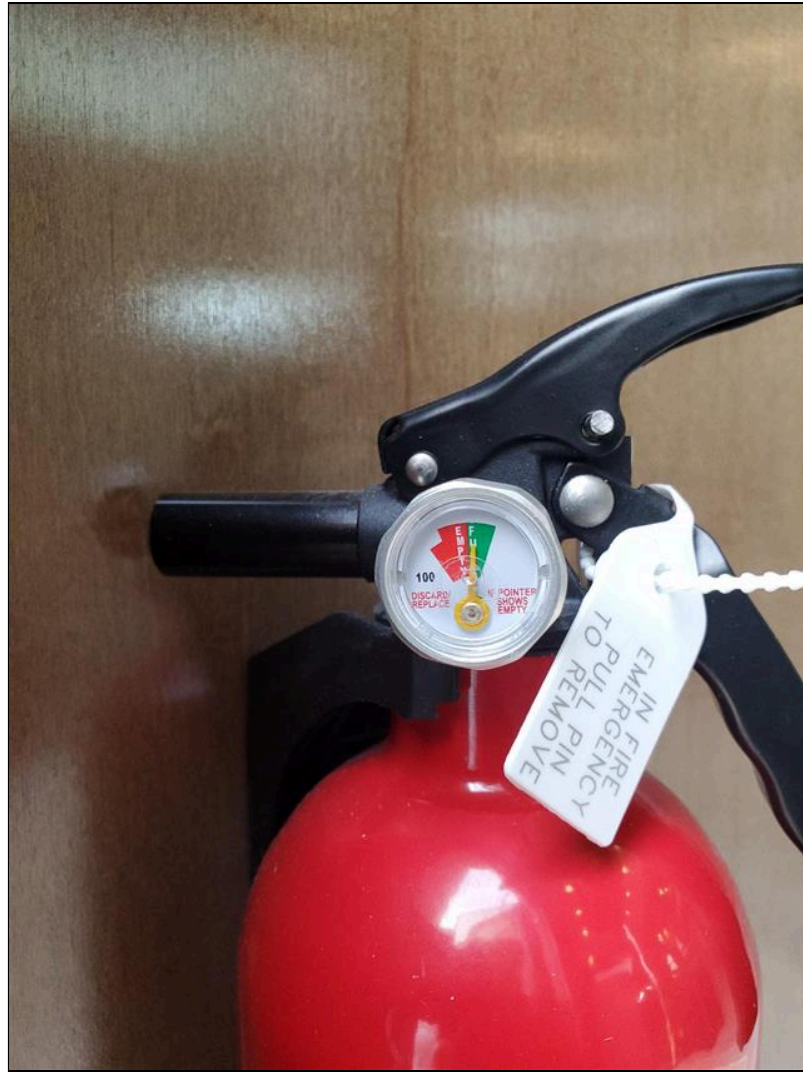
15.2 Fire Extinguisher

Fire extinguisher is anchored properly

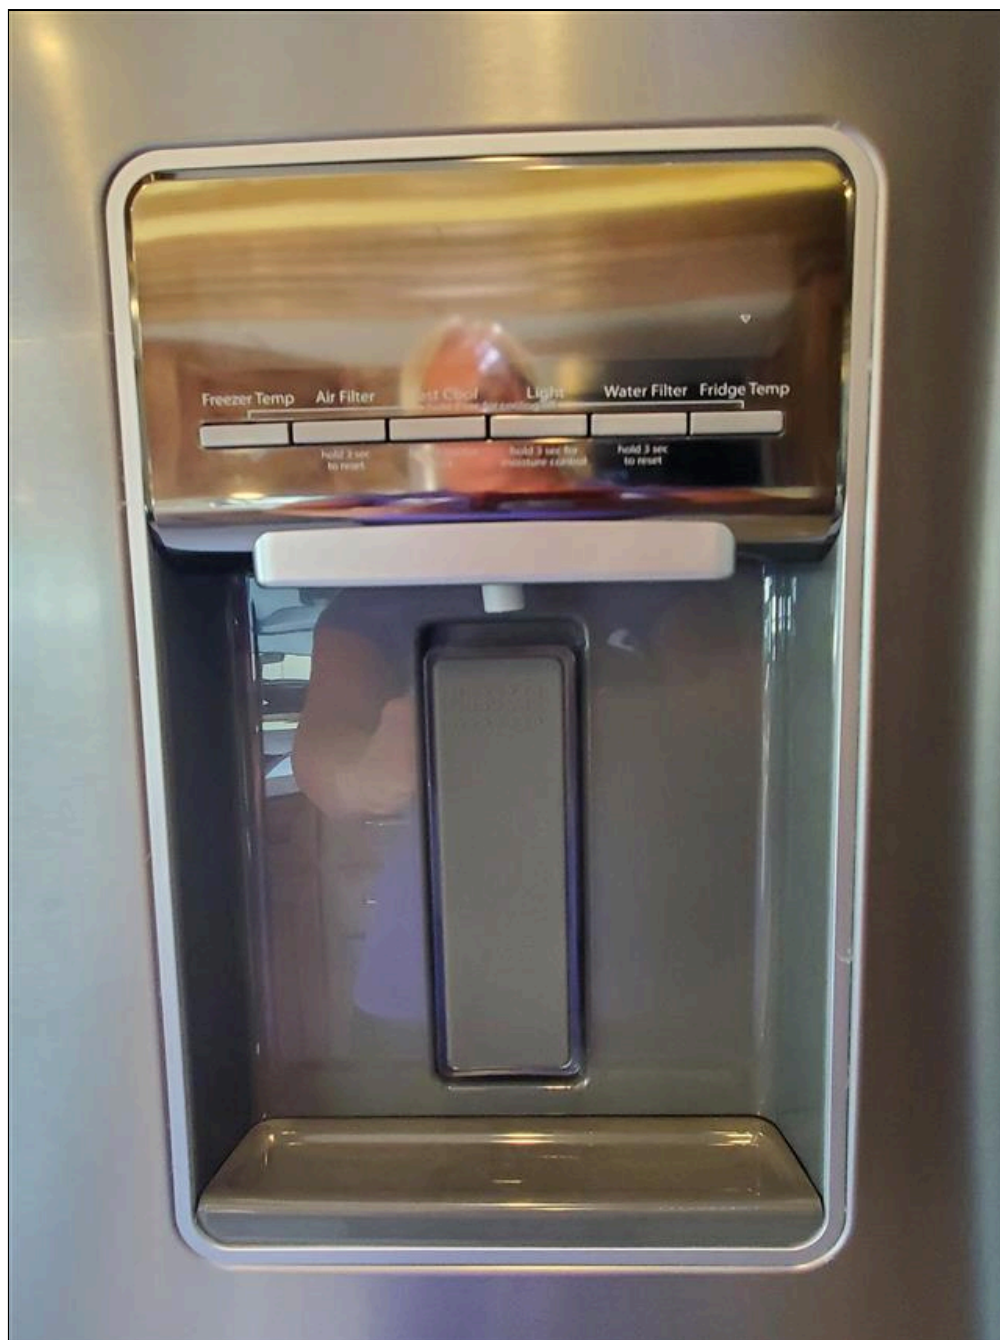
16.1 Refrigerator - Control Board

Control Board

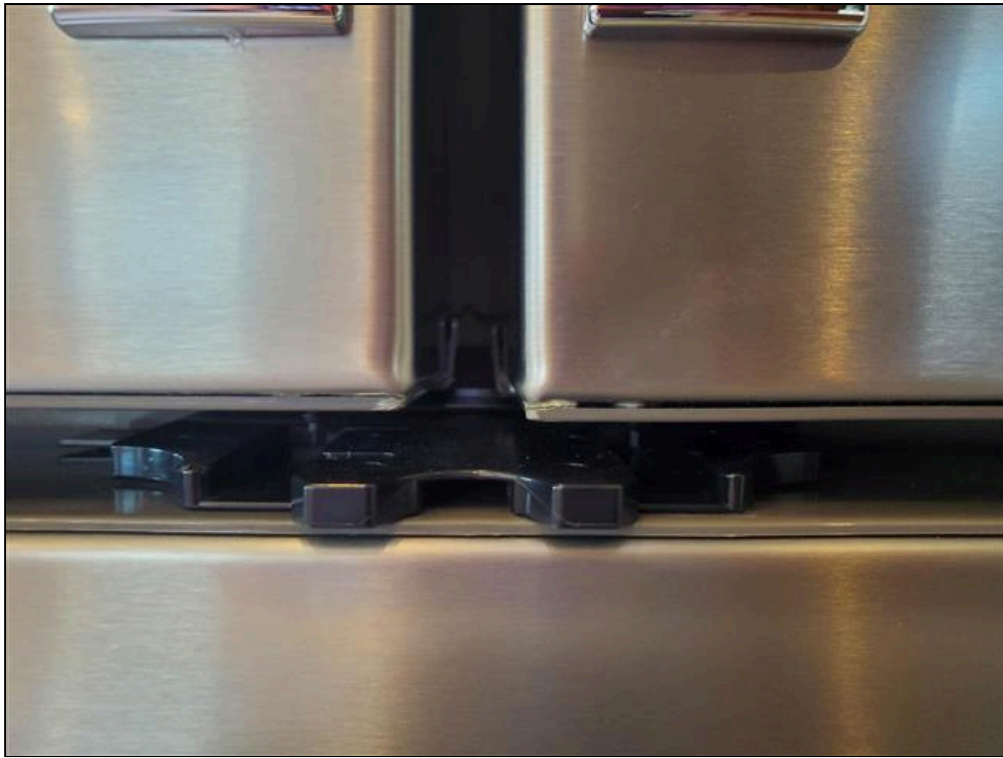
Latch Operates as Intended

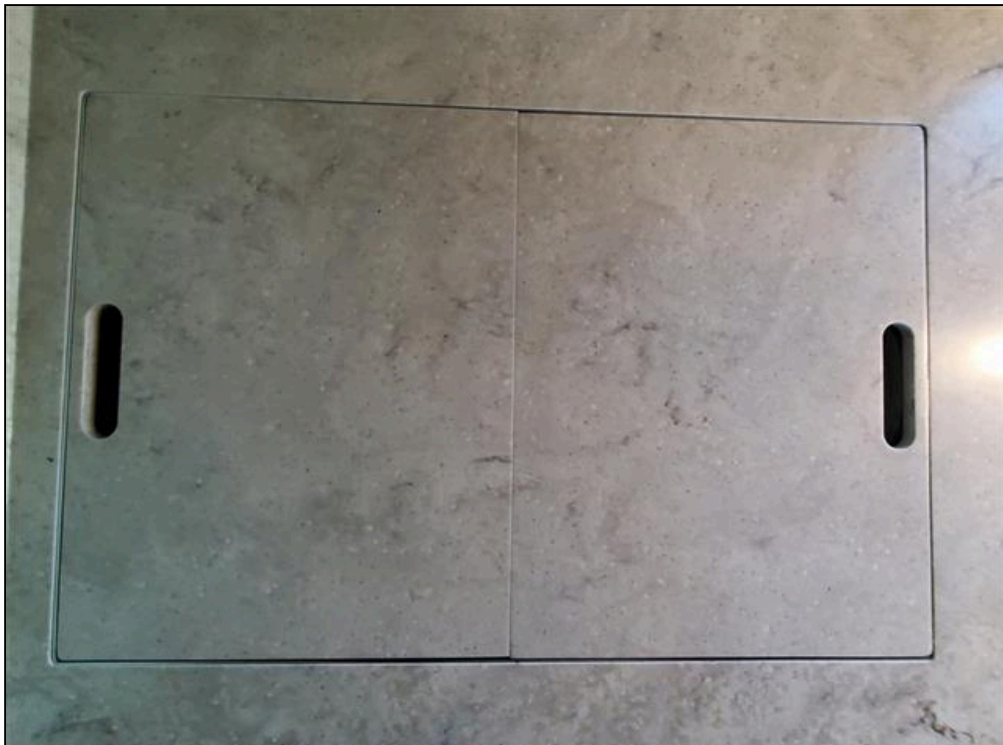
16.13 Cooktop - Condition

Cooktop cover match counter and operates as intended

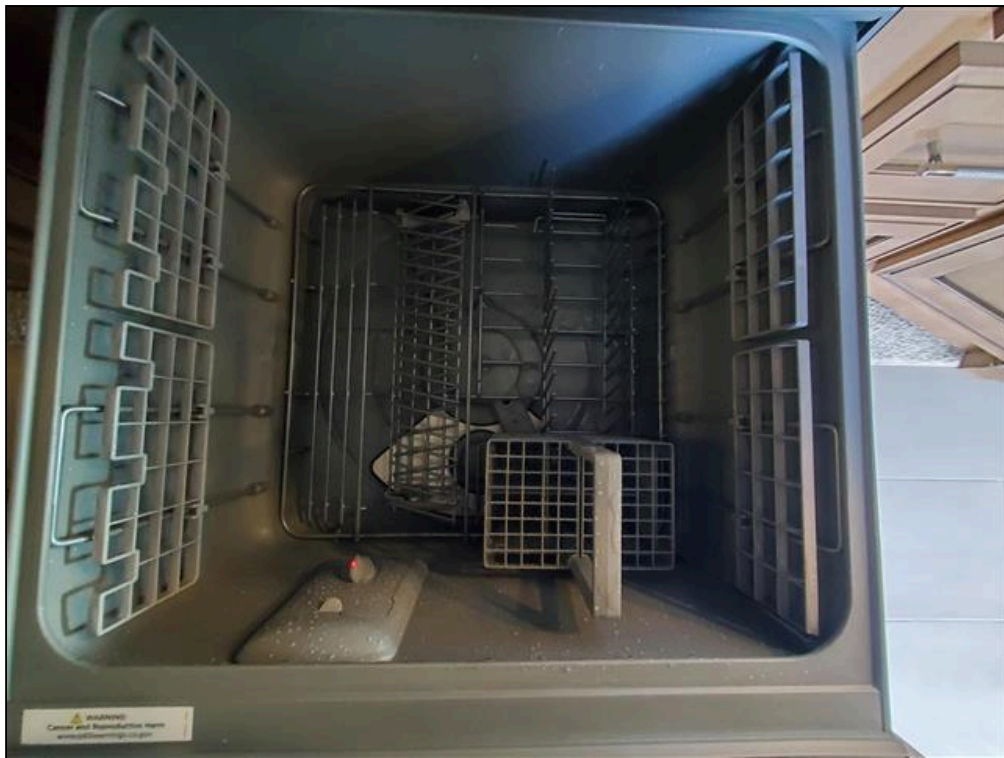
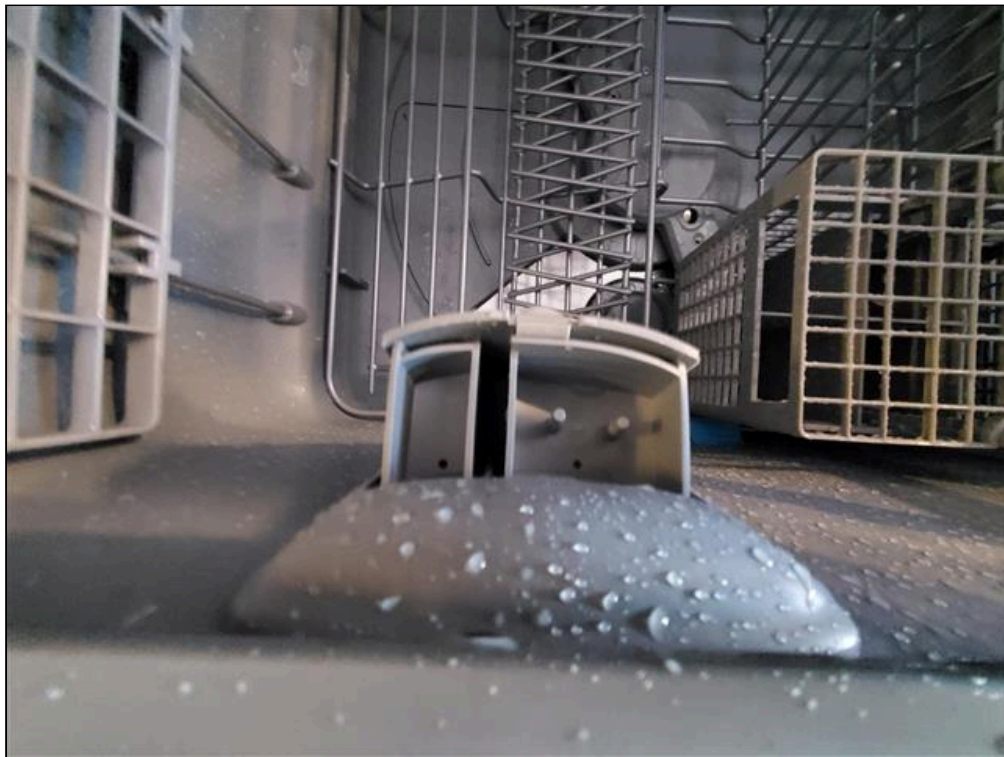
16.20 Dishwasher - Racks and Wash Bars Condition

Rack and Bars in Good Condition

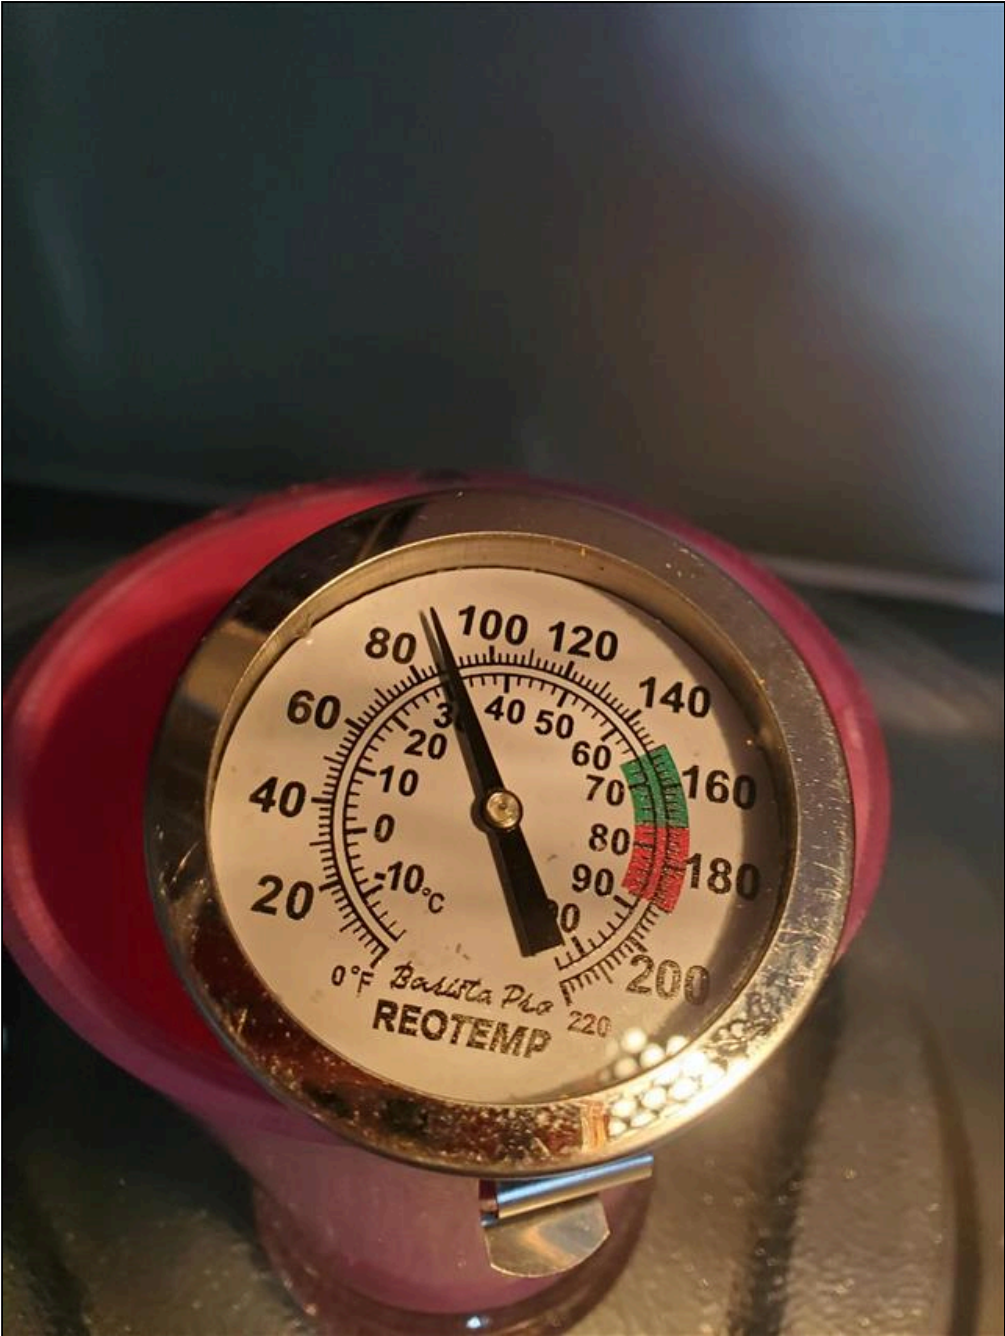
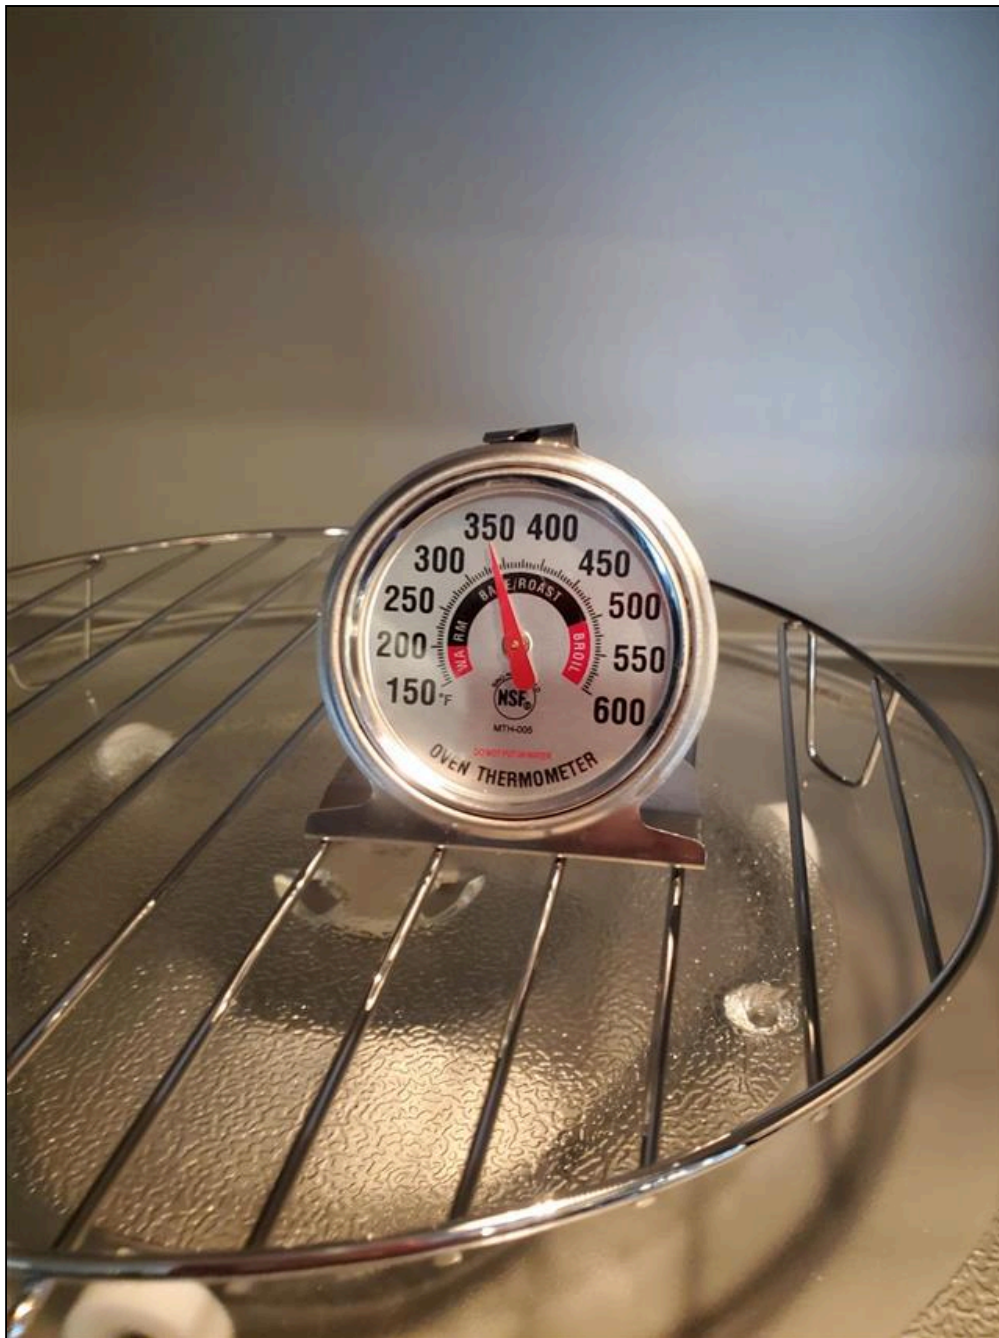
(2) Water boiling test after one minute

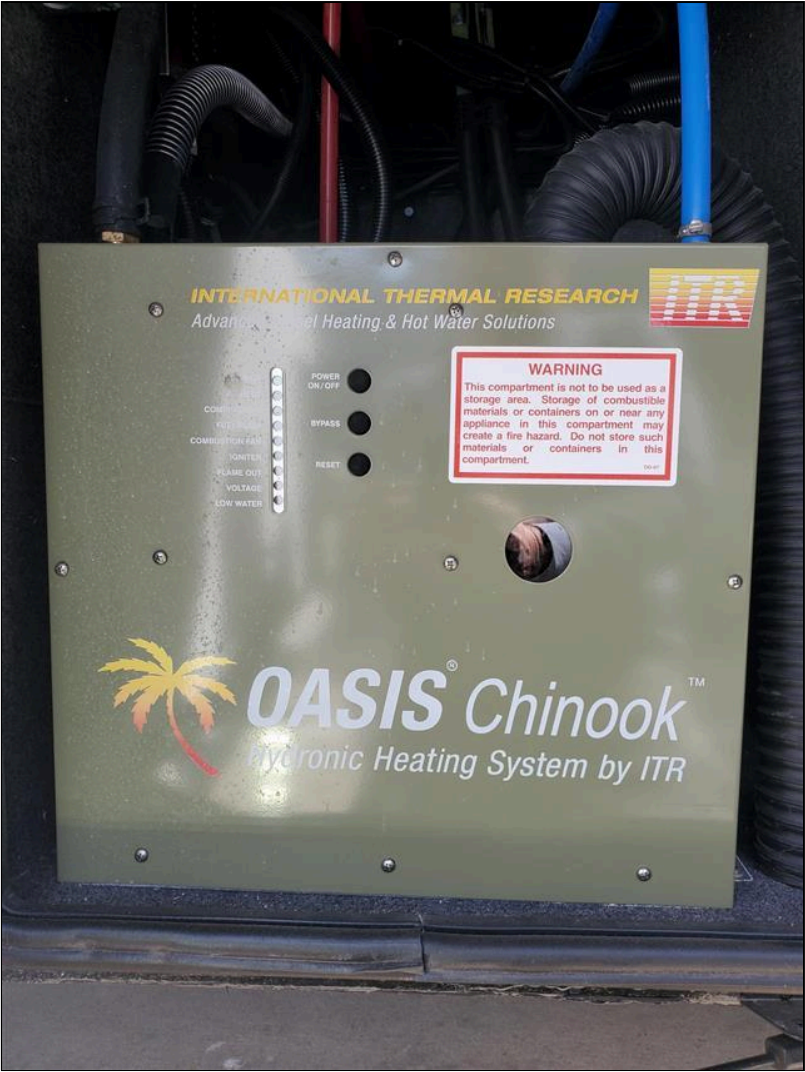
Hydronic System on Demand Operates as Intended on all Functions

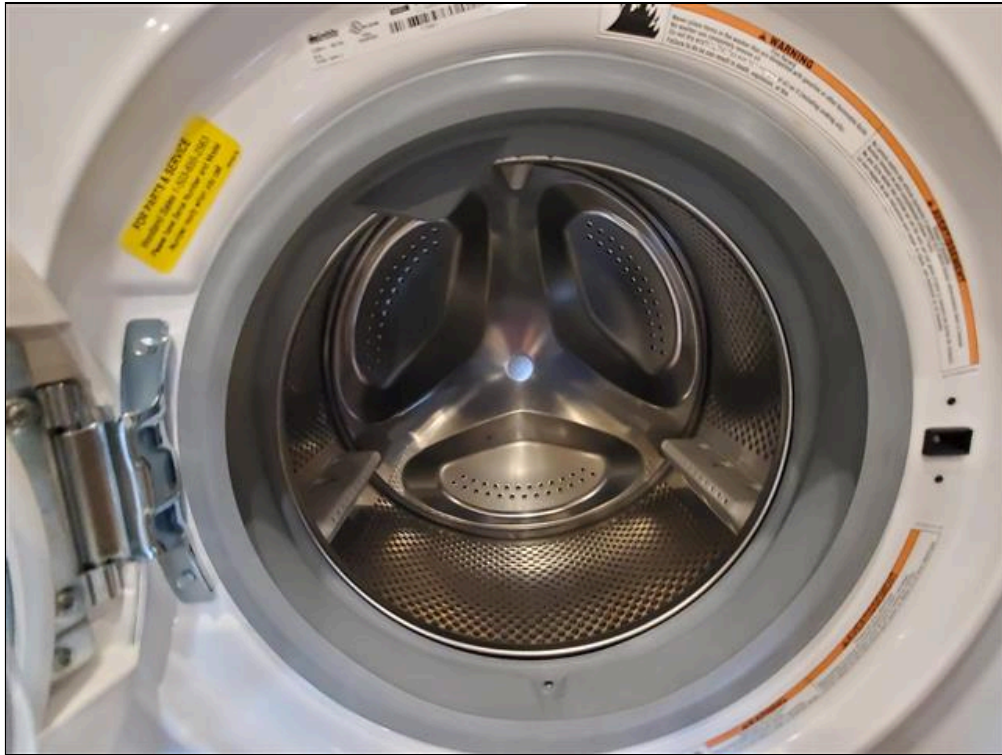
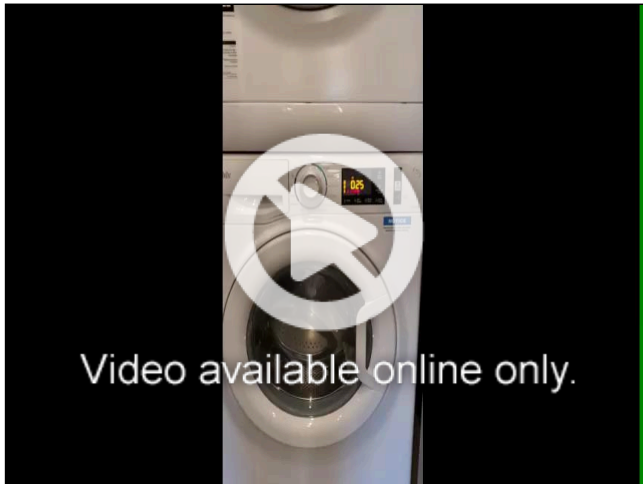
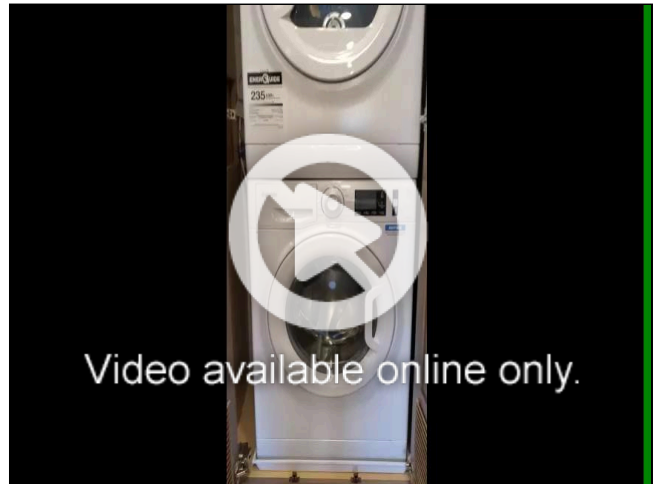
17.4 Washer / Dryer - Condition

F8 E1 code is Displayed

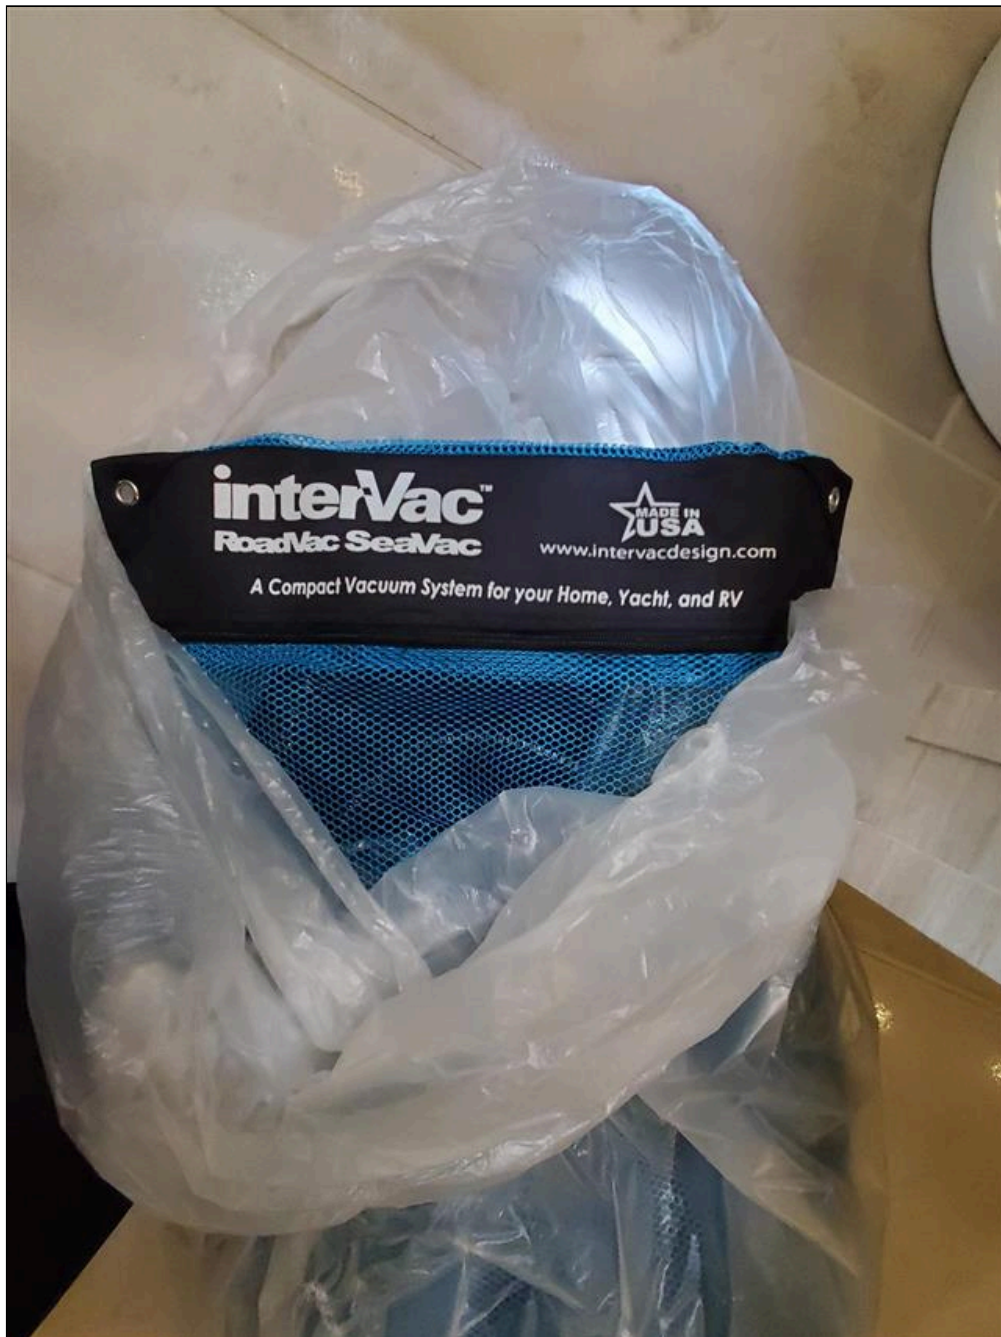
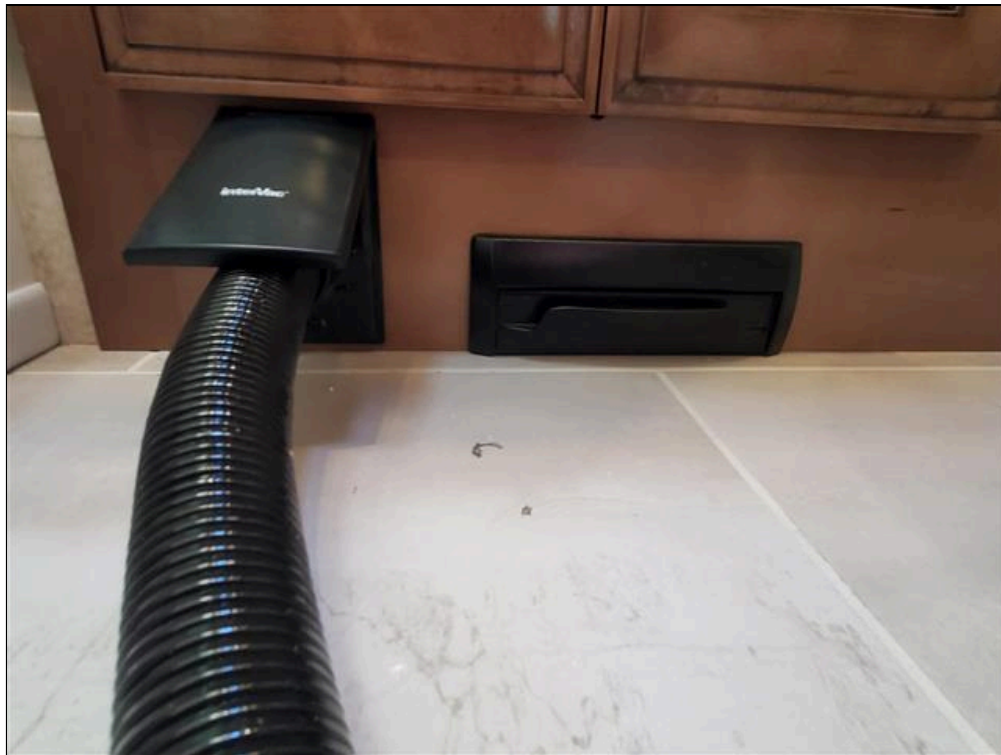
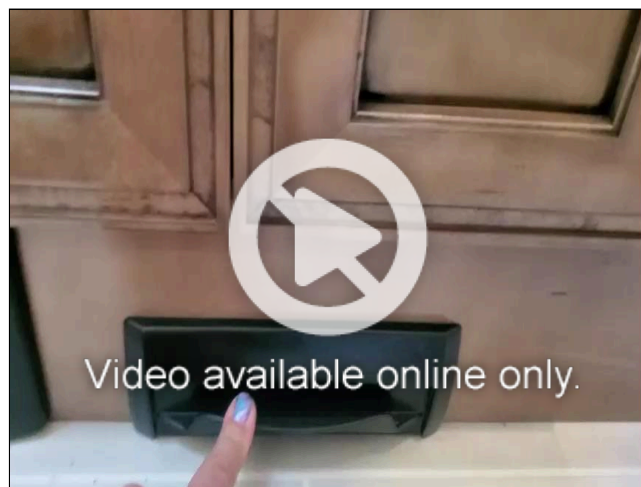
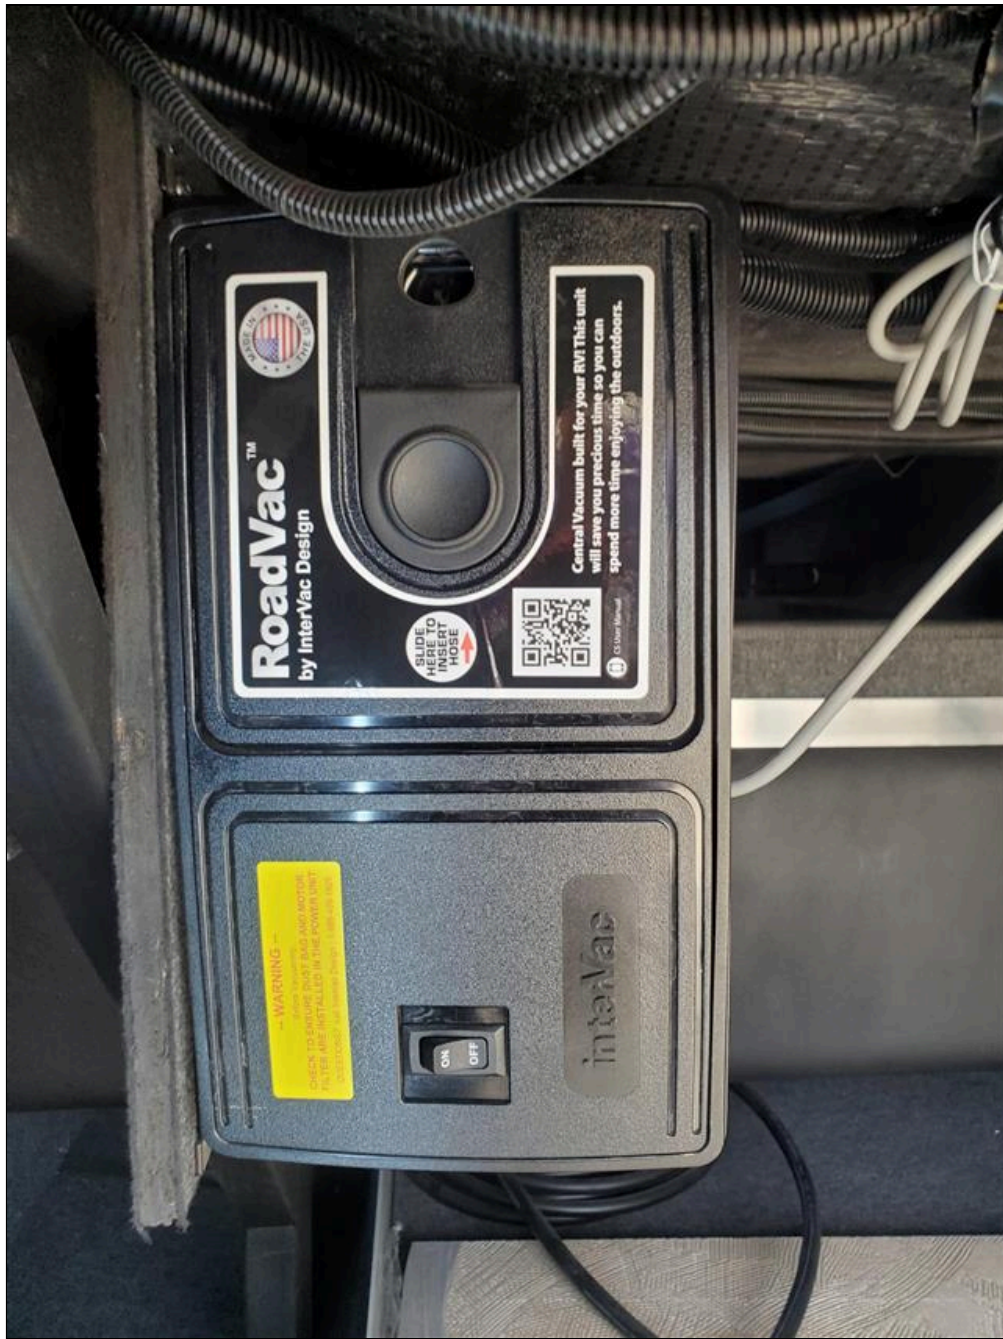
17.6 In-House Vacuum System - Condition of Unit / Accessories / Bag

Inside Wall Outlet doesn't Operate as intended when Hose is Inserted into the Receptacle.

Need to open the sweeper in order to get suction out of the hose connection. Then Motor doesn't shut off on it's own.

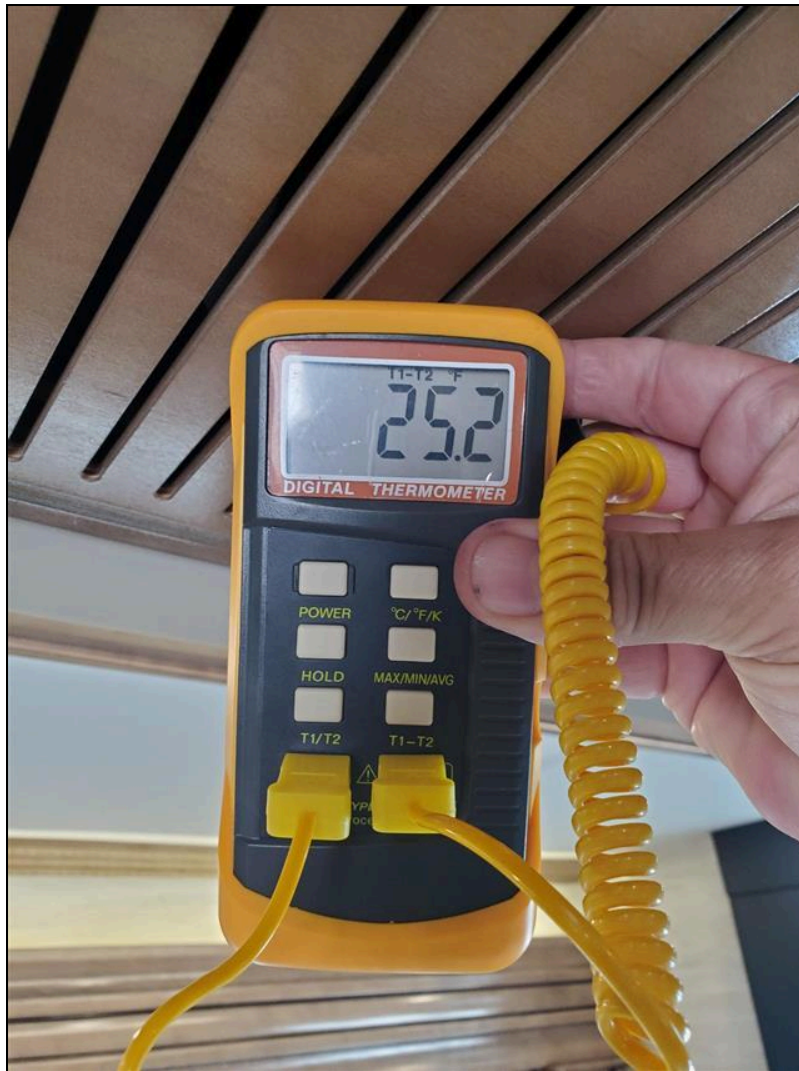
Delta T of 25.2

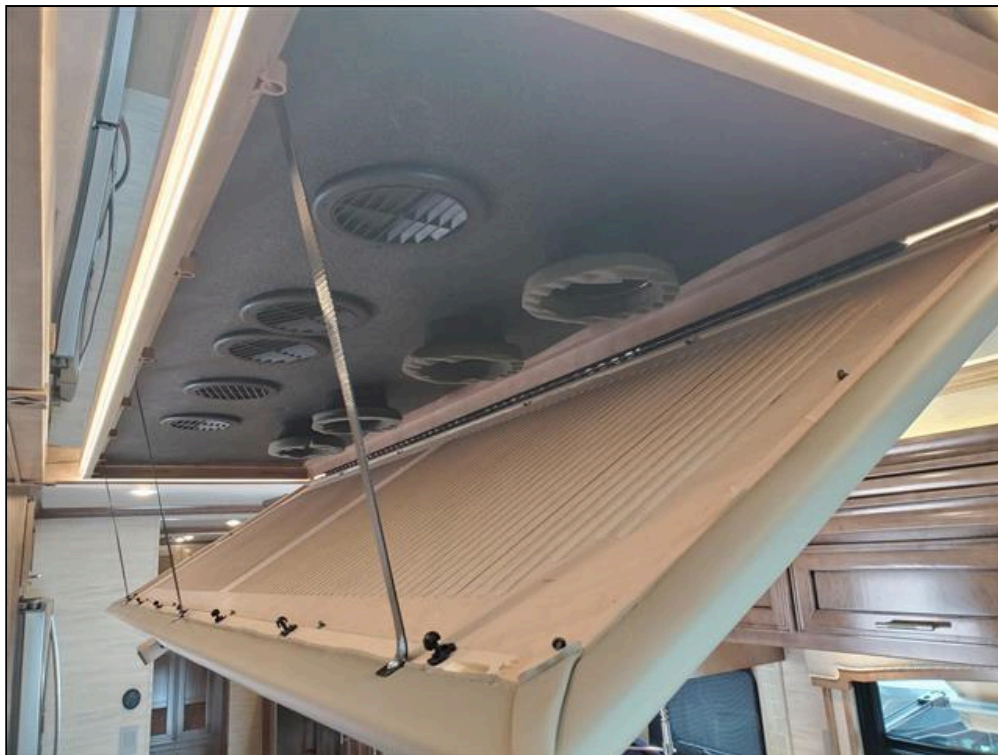
AC Filters were Clean at moment of Inspection

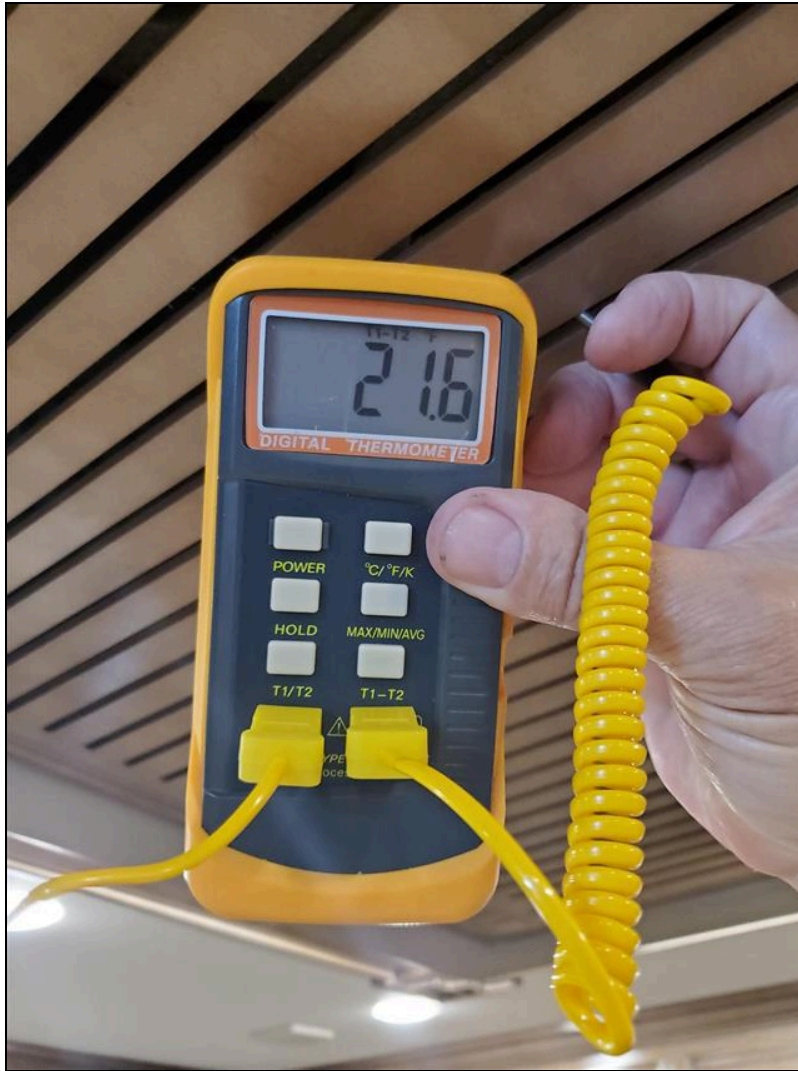
Delta T of 21.6
