RV Inspection Report

**Inspection Date / RV Model:
Newmar Superstar 4065 2023**

**Pierre Fortin
5753 Highway 85 N Lot 8511
Crestview, Florida, 32536**

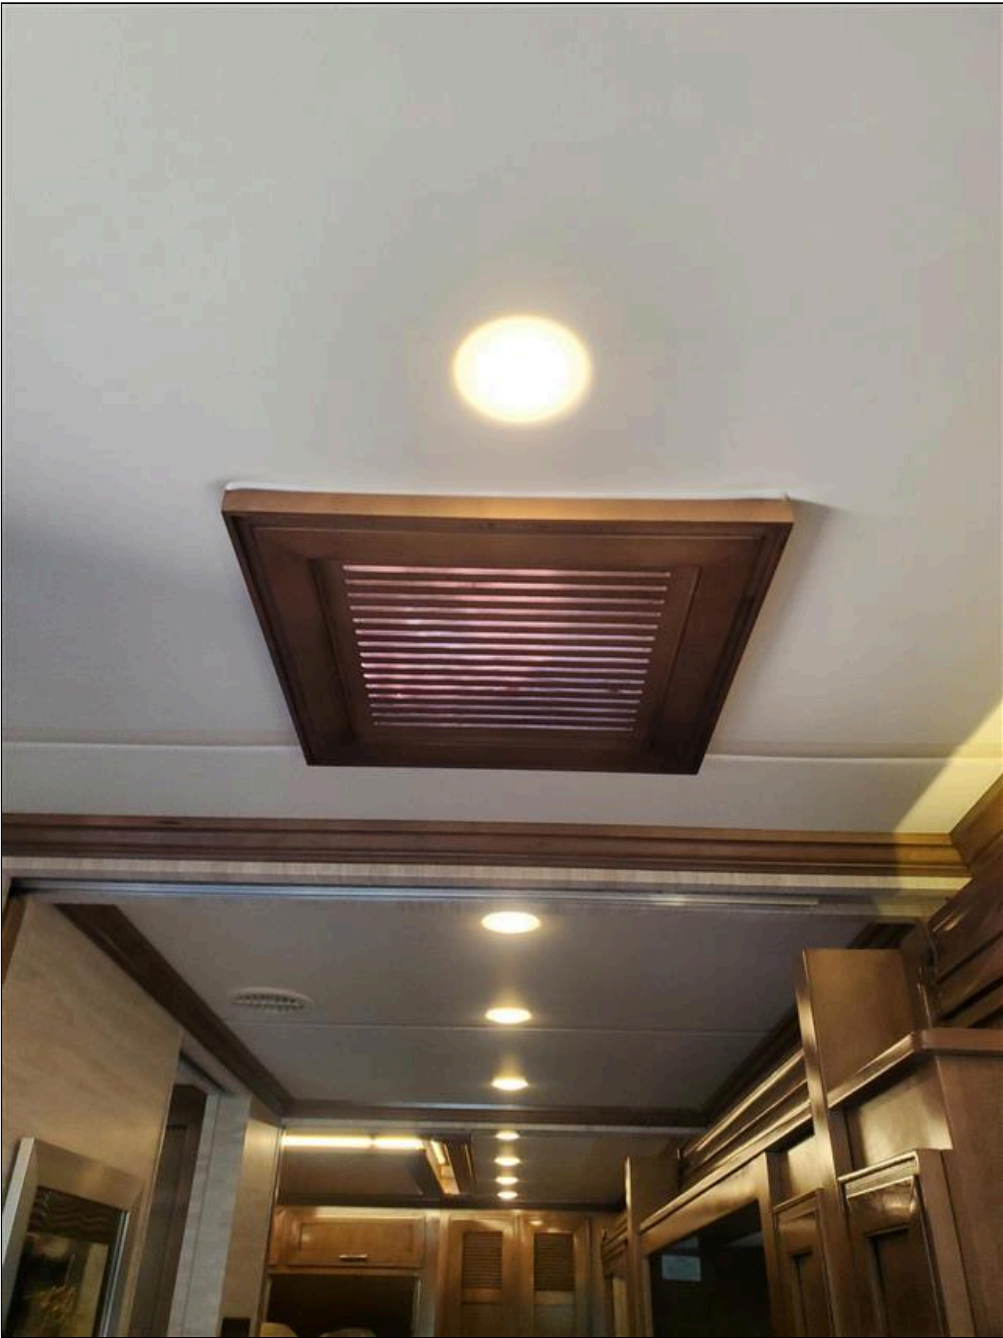
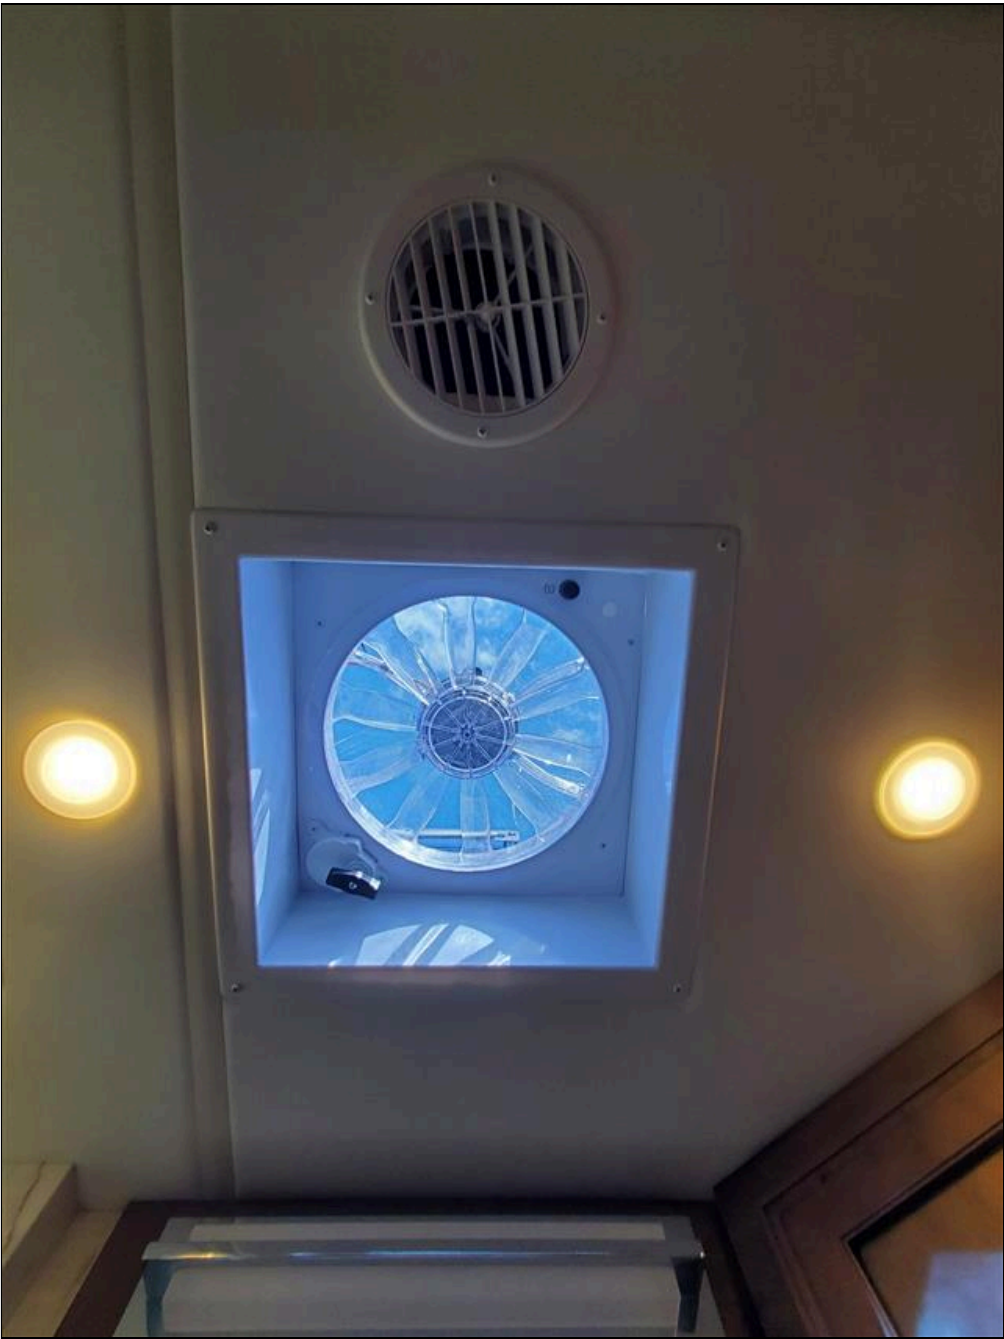
Outside Exhaust Fan Operates as intended on all Functions

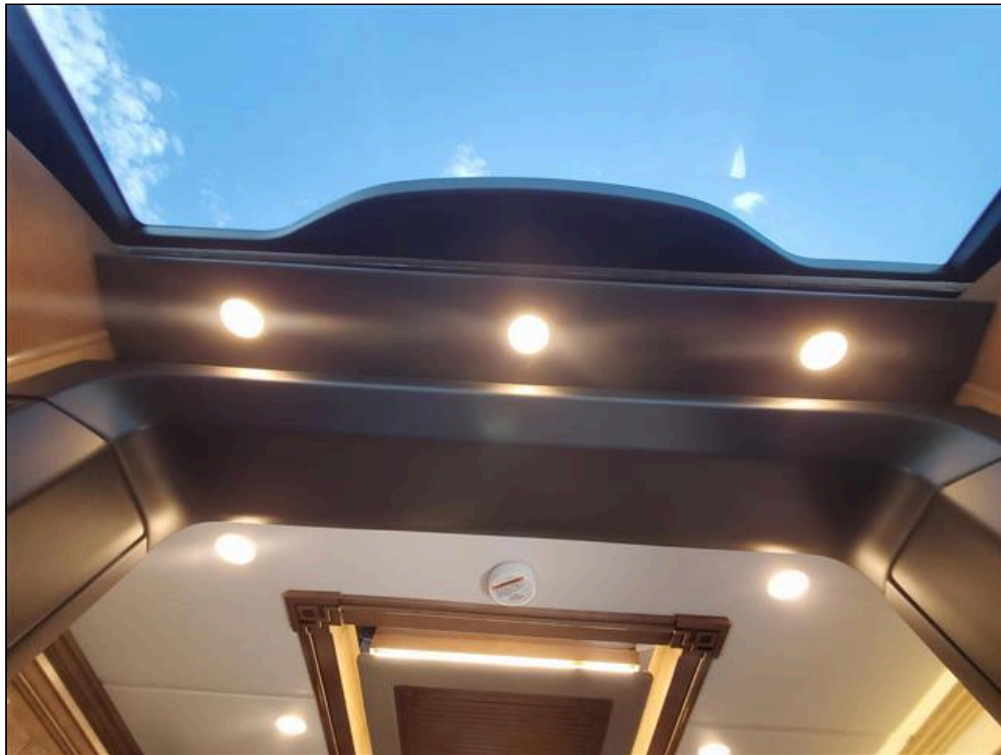
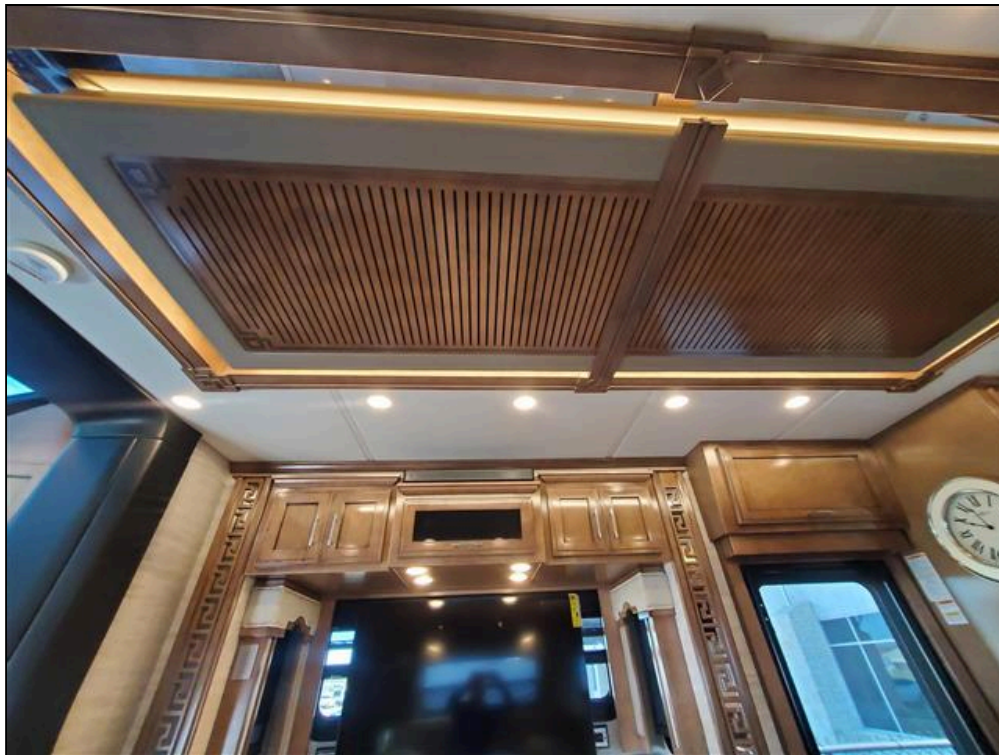
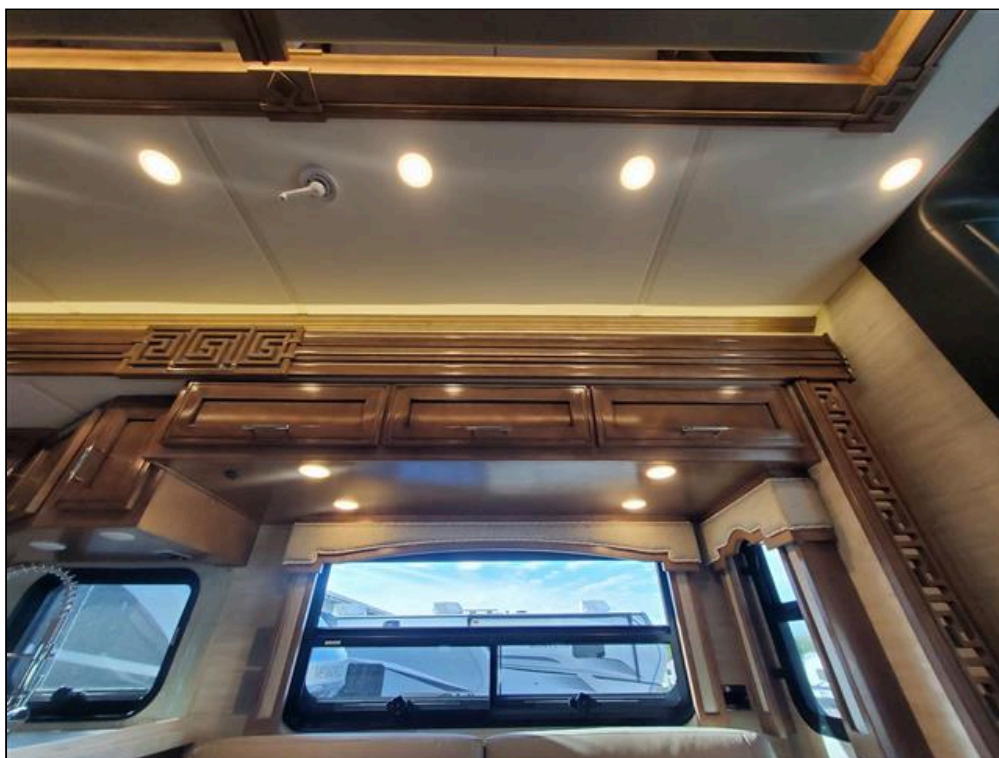
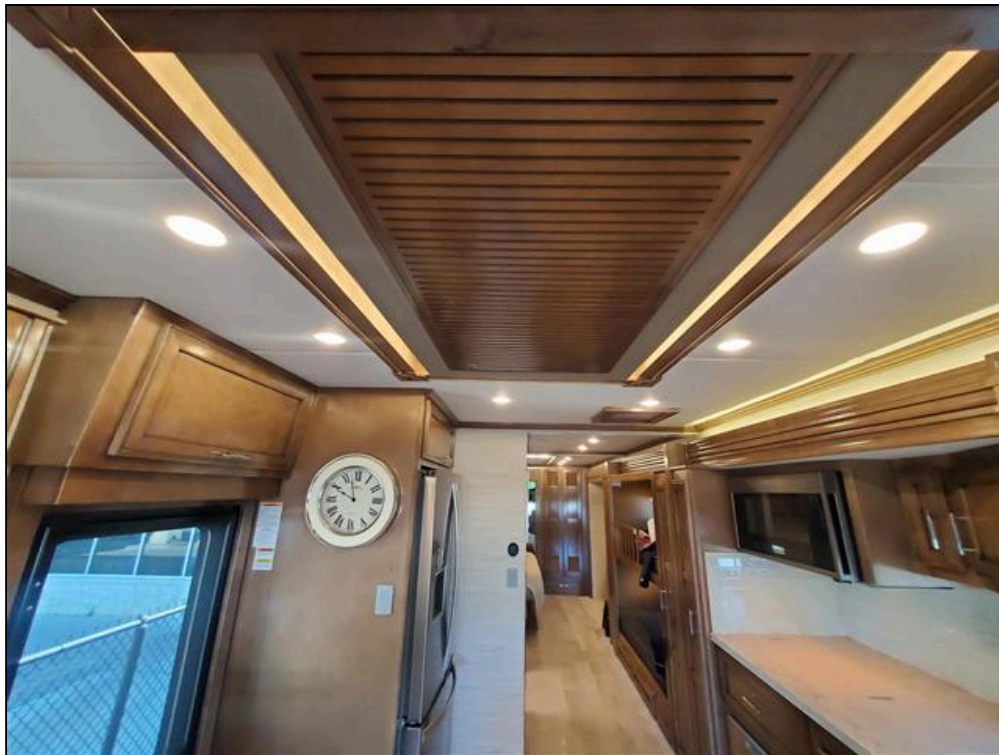
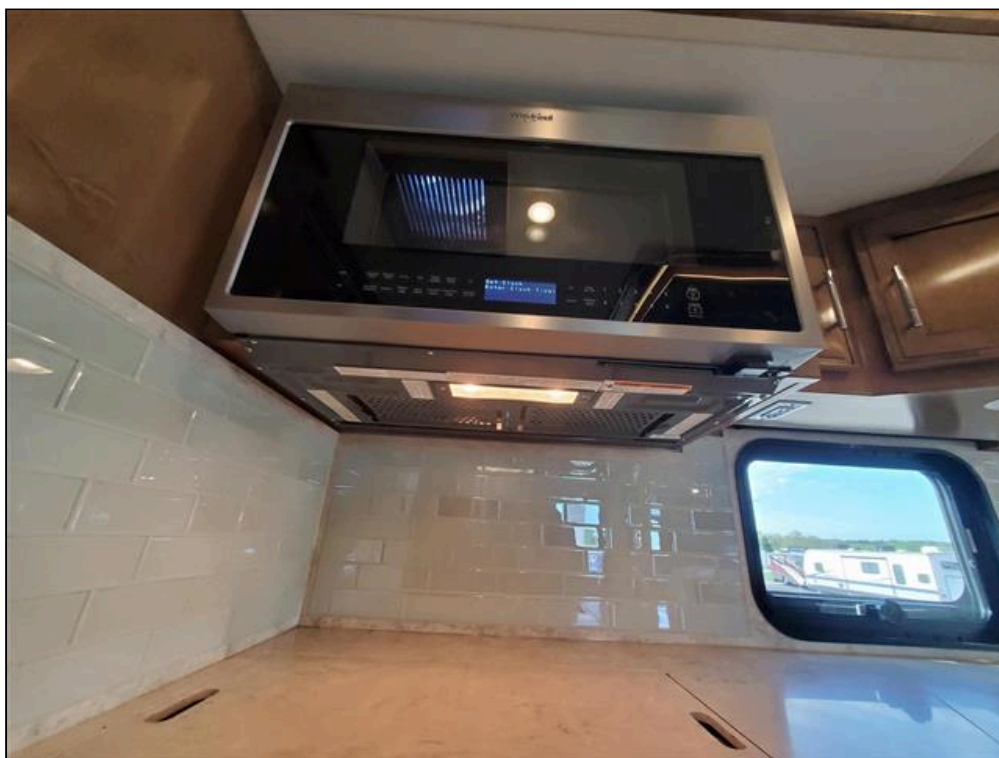
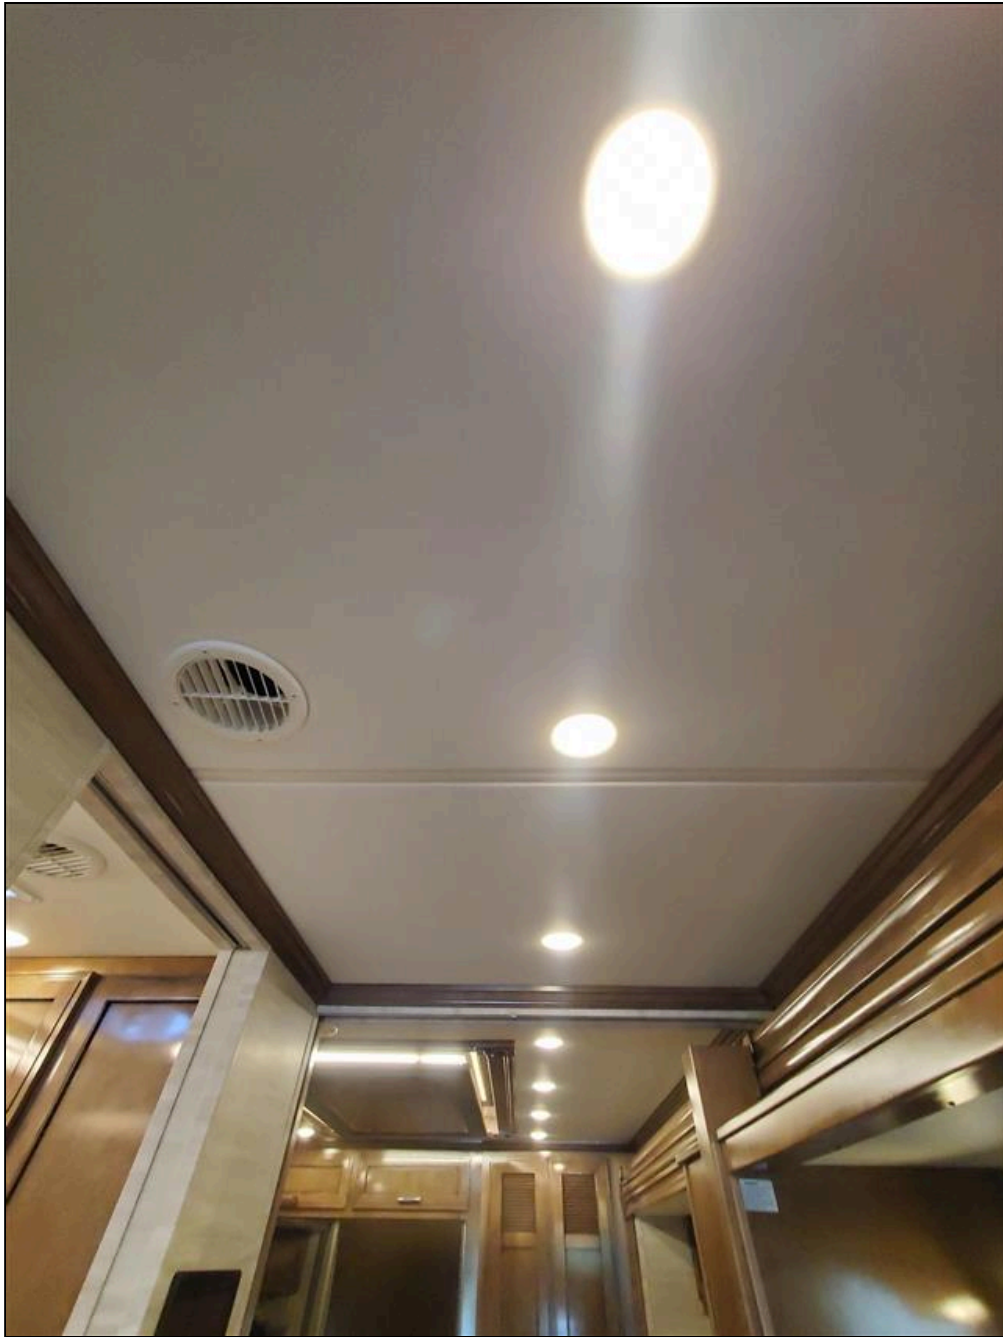
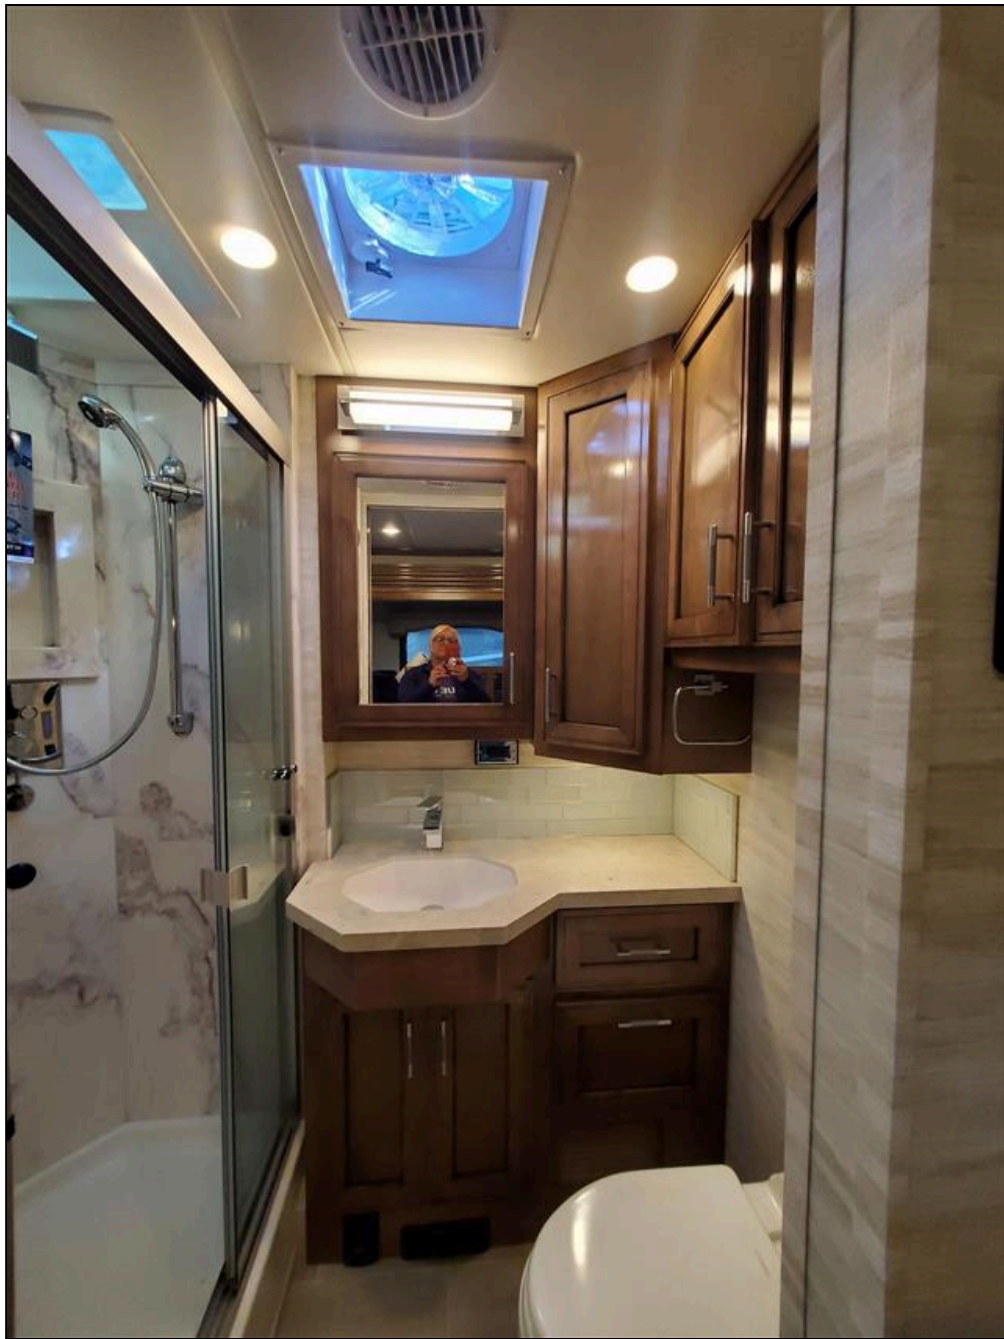
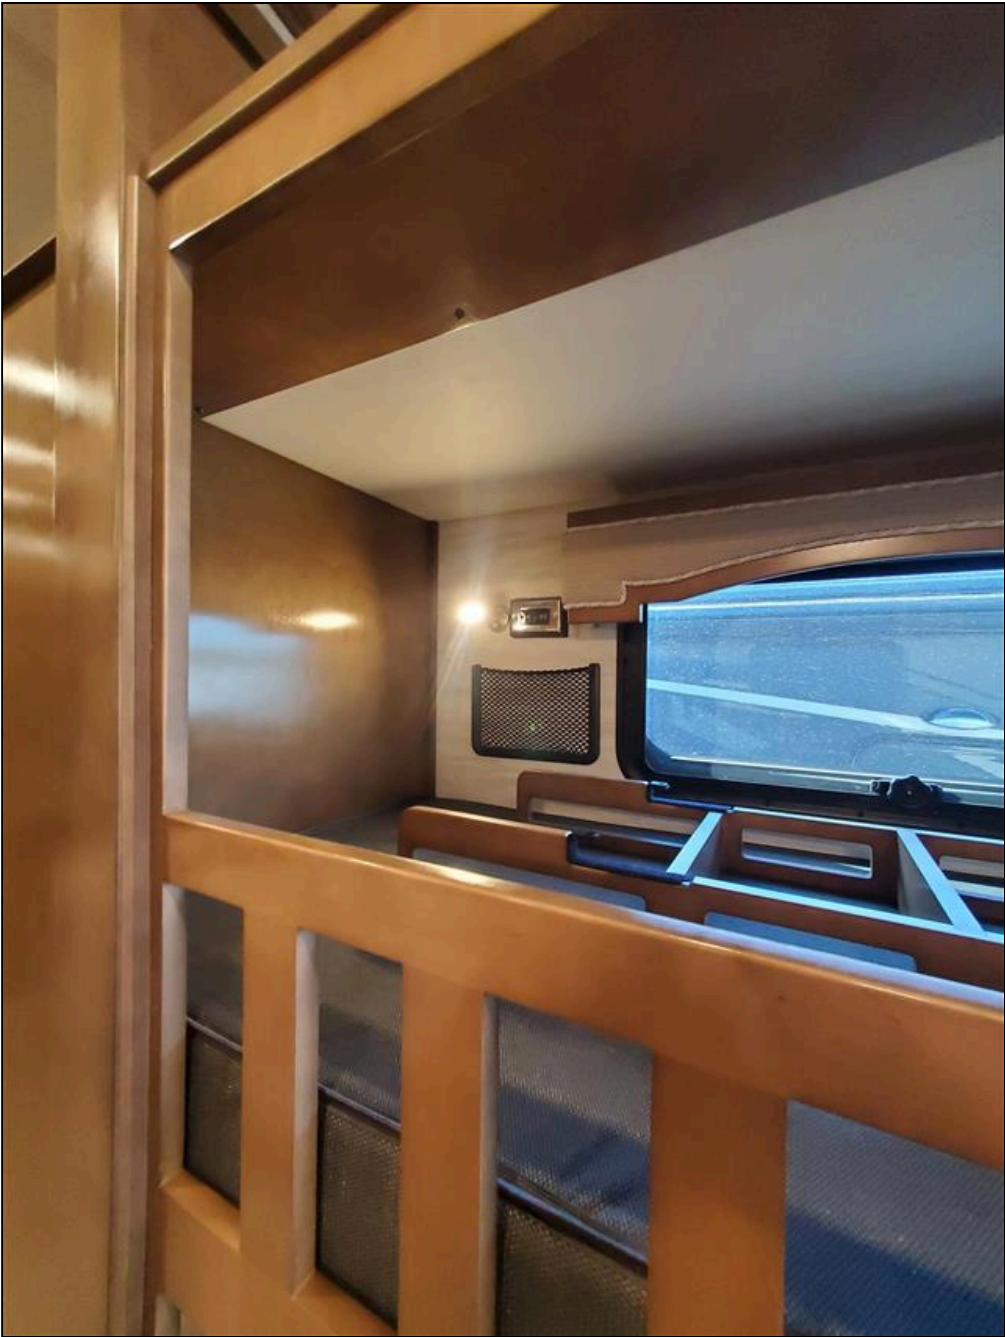
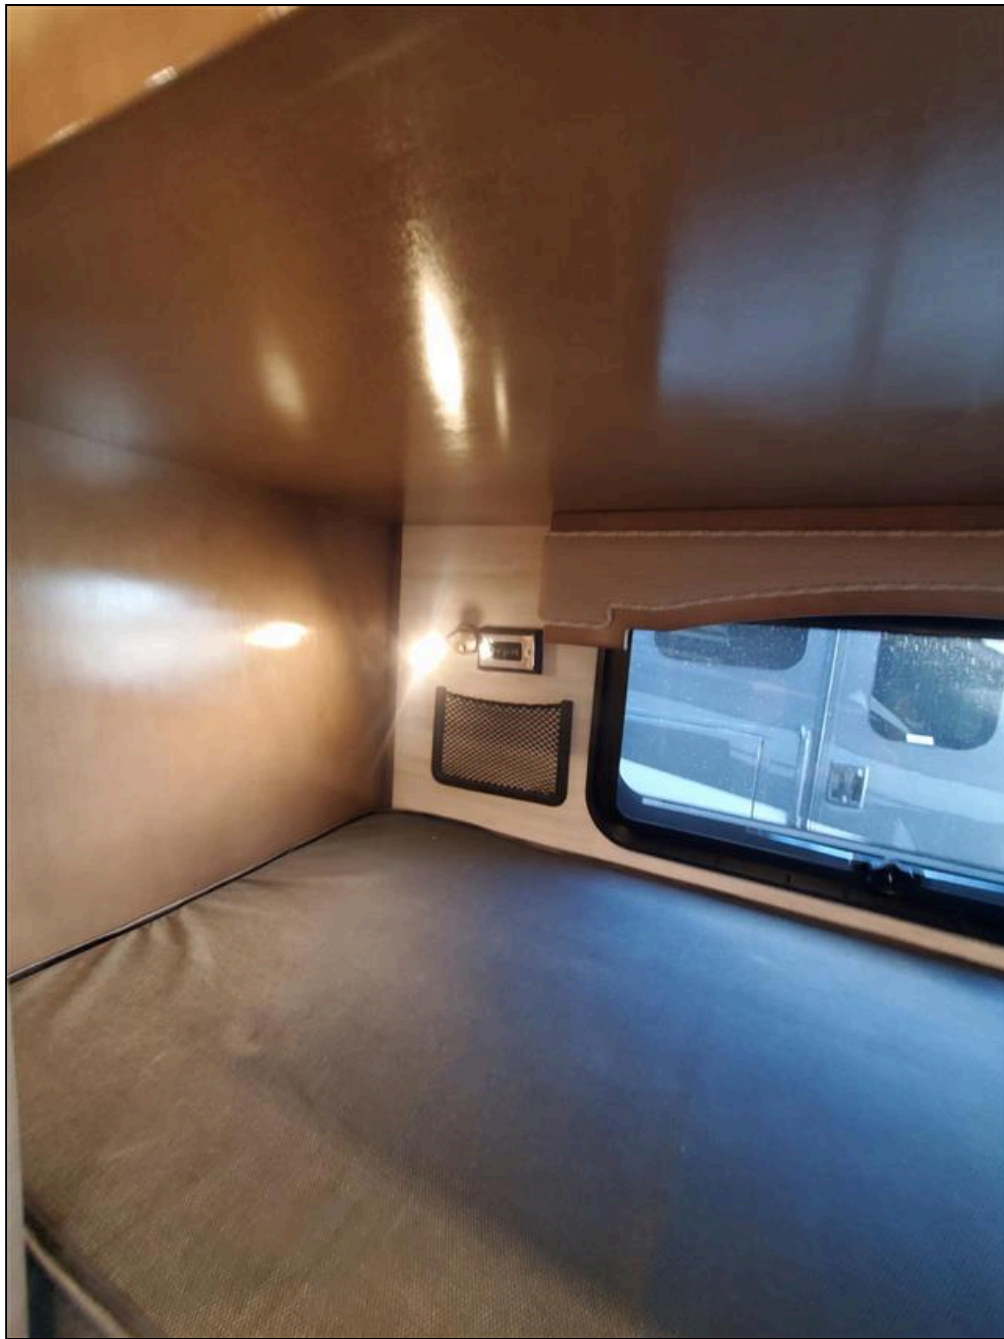
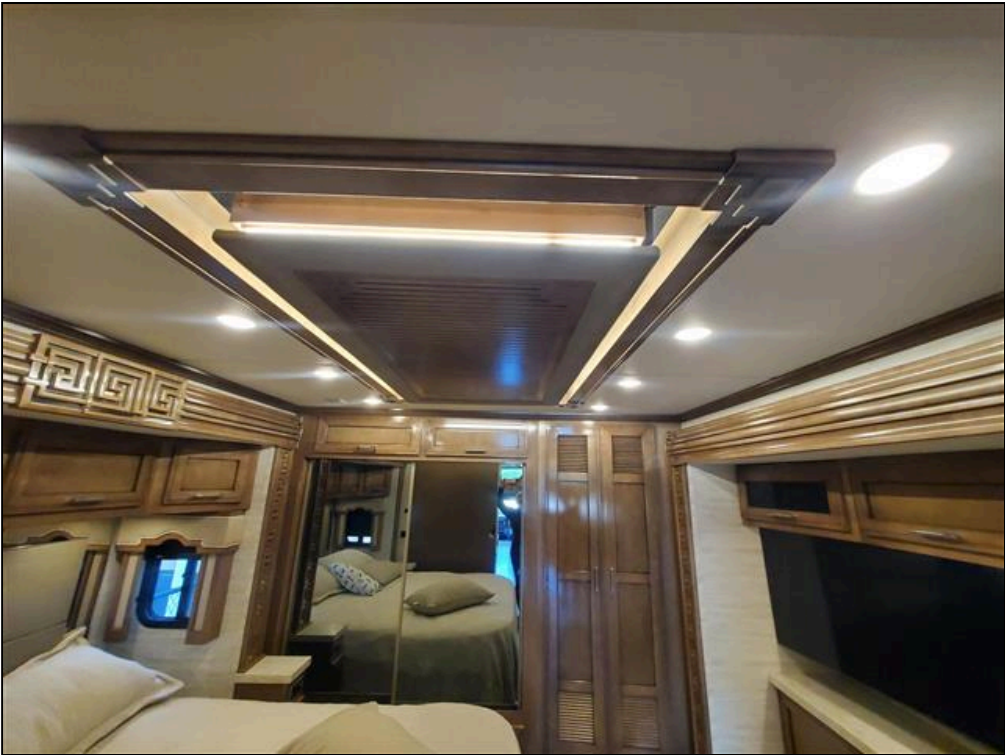
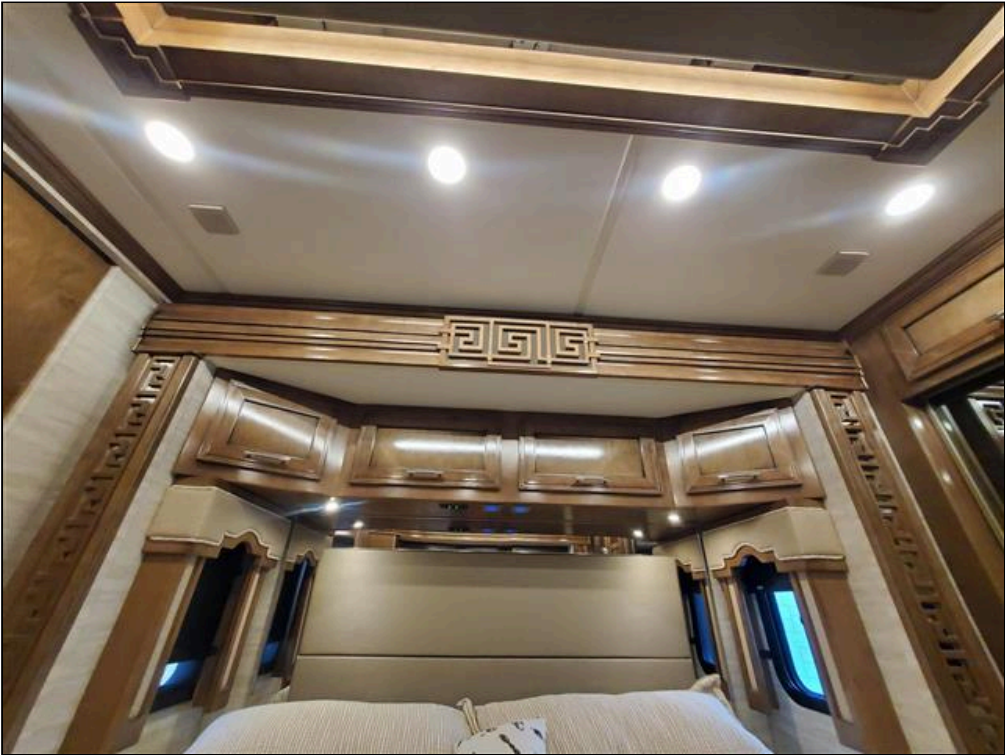
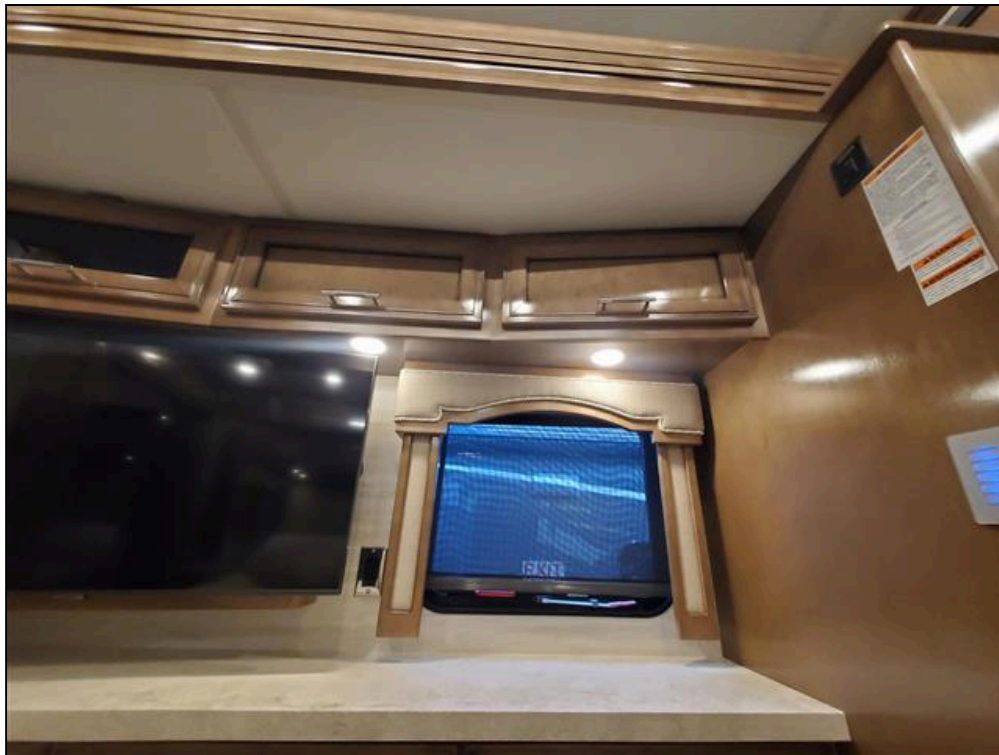
Lights All Operate as Intended
