RV Inspection Report

**Inspection Date / RV Model:
Newmar Superstar 4065 2023**

**Pierre Fortin
5753 Highway 85 N Lot 8511
Crestview, Florida, 32536**

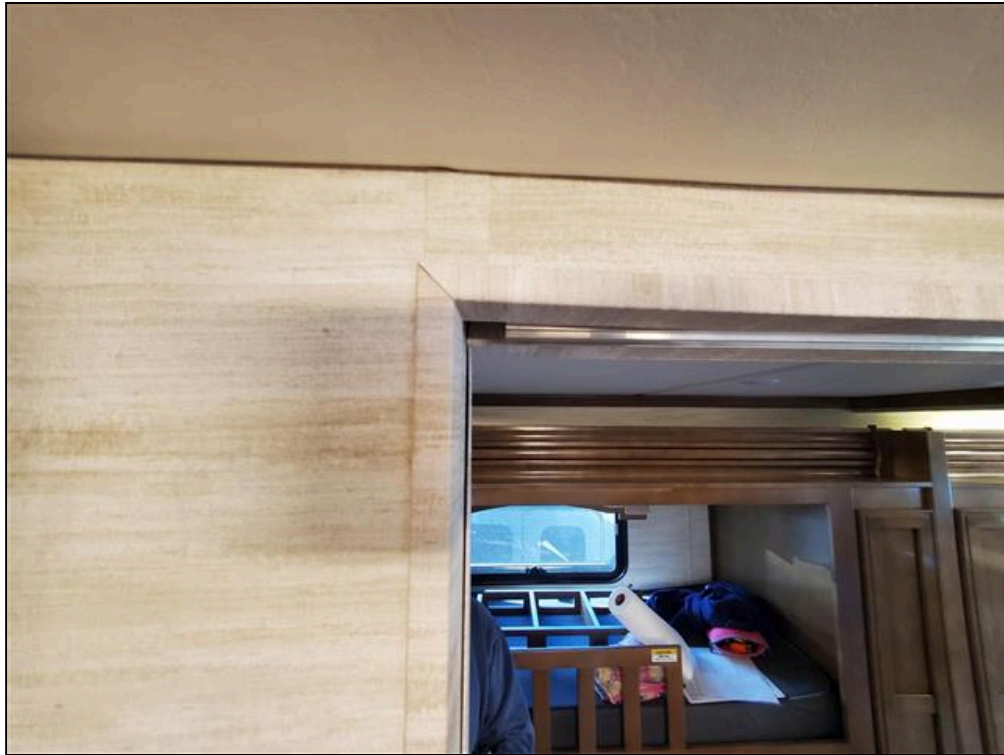
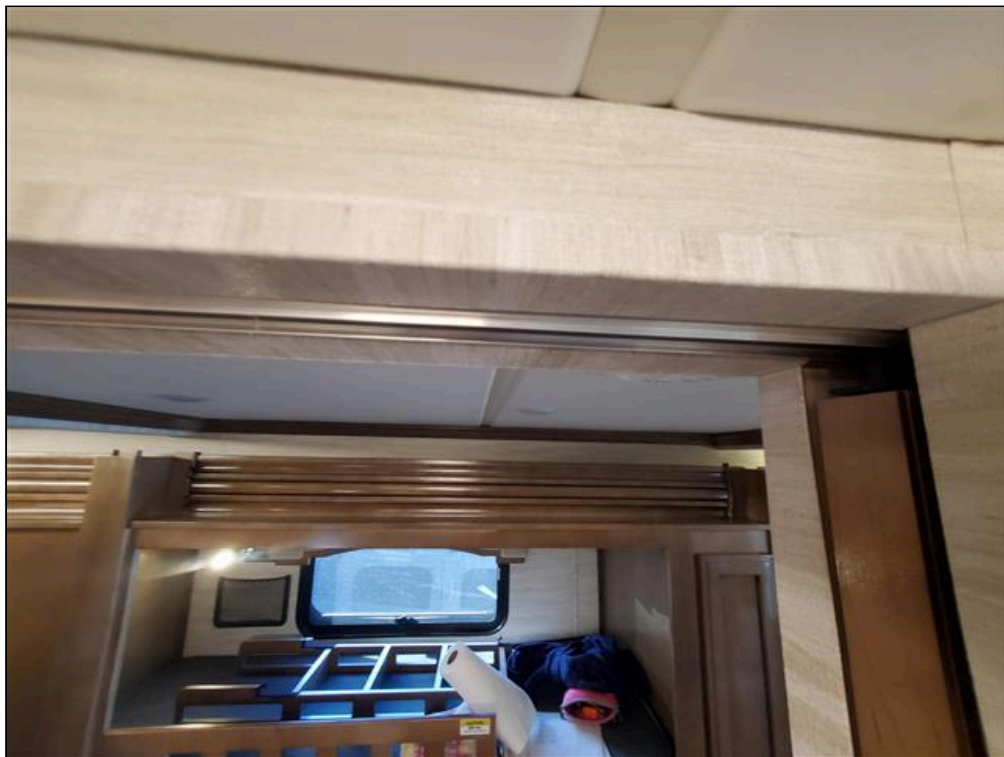
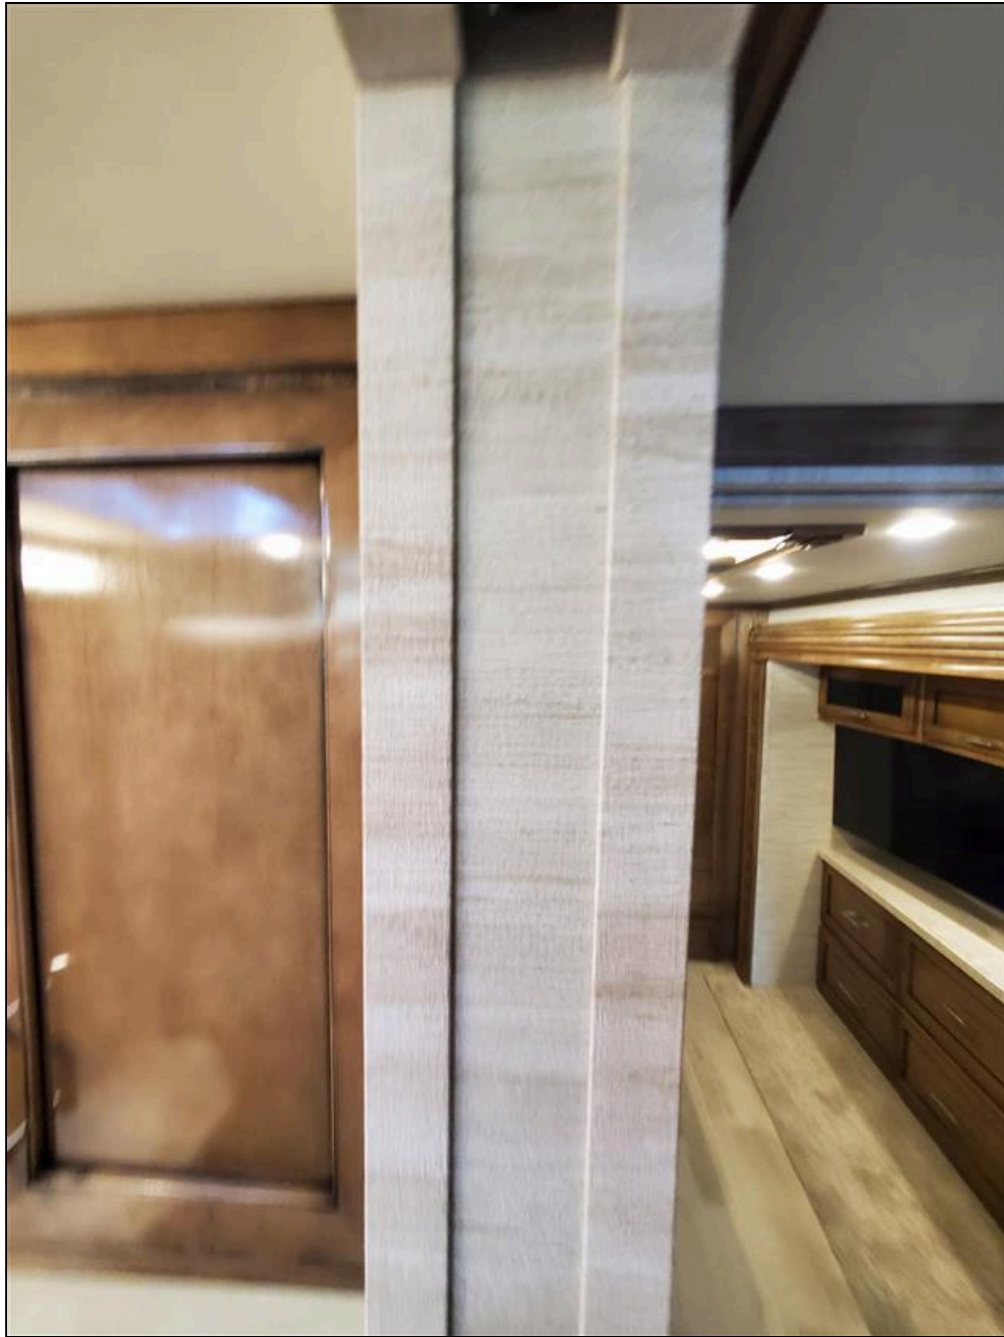
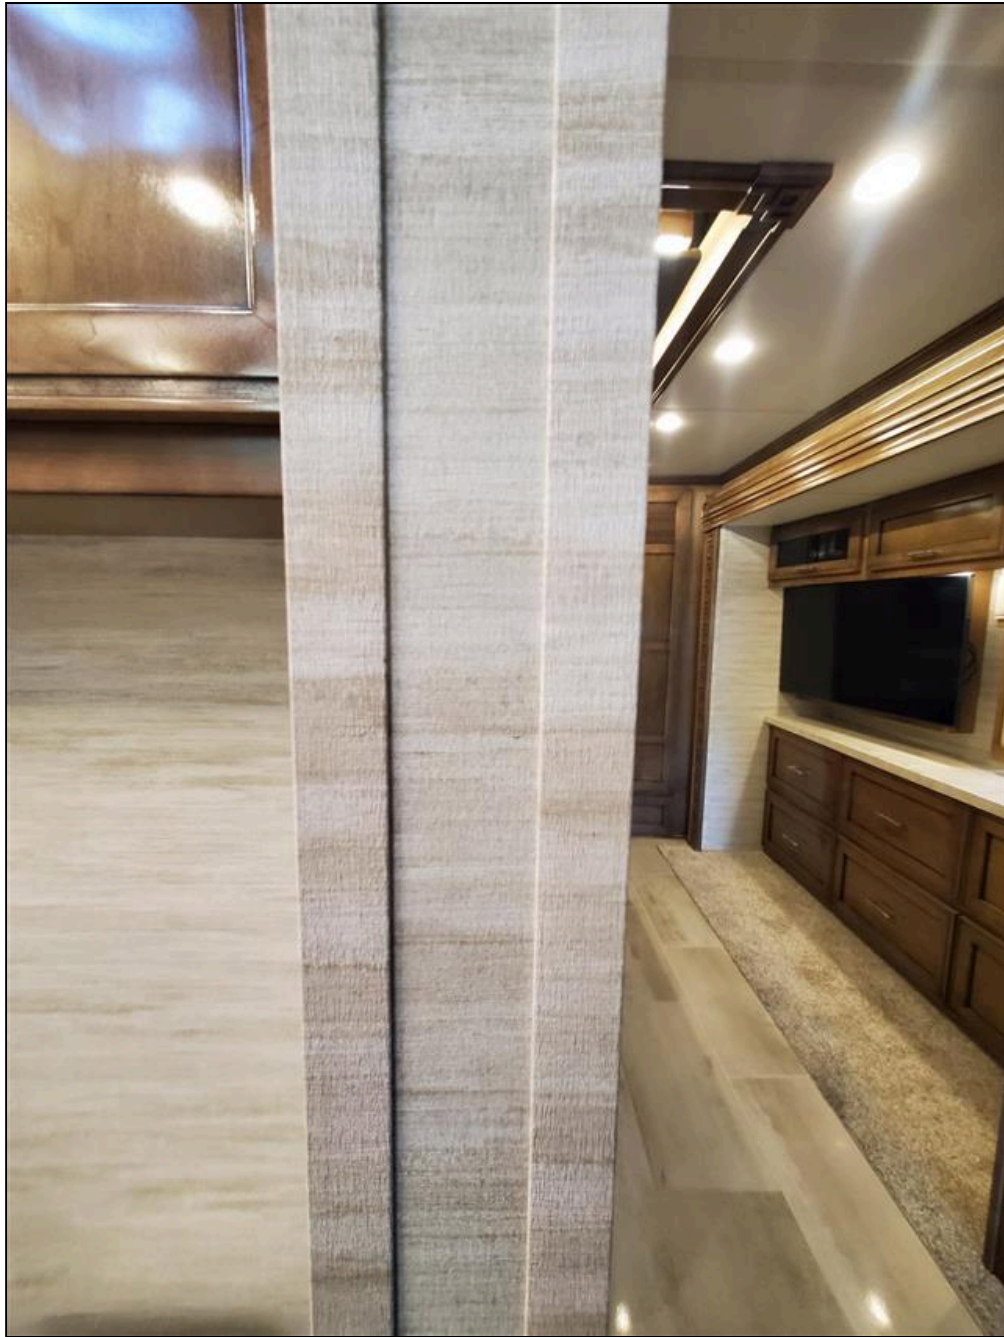
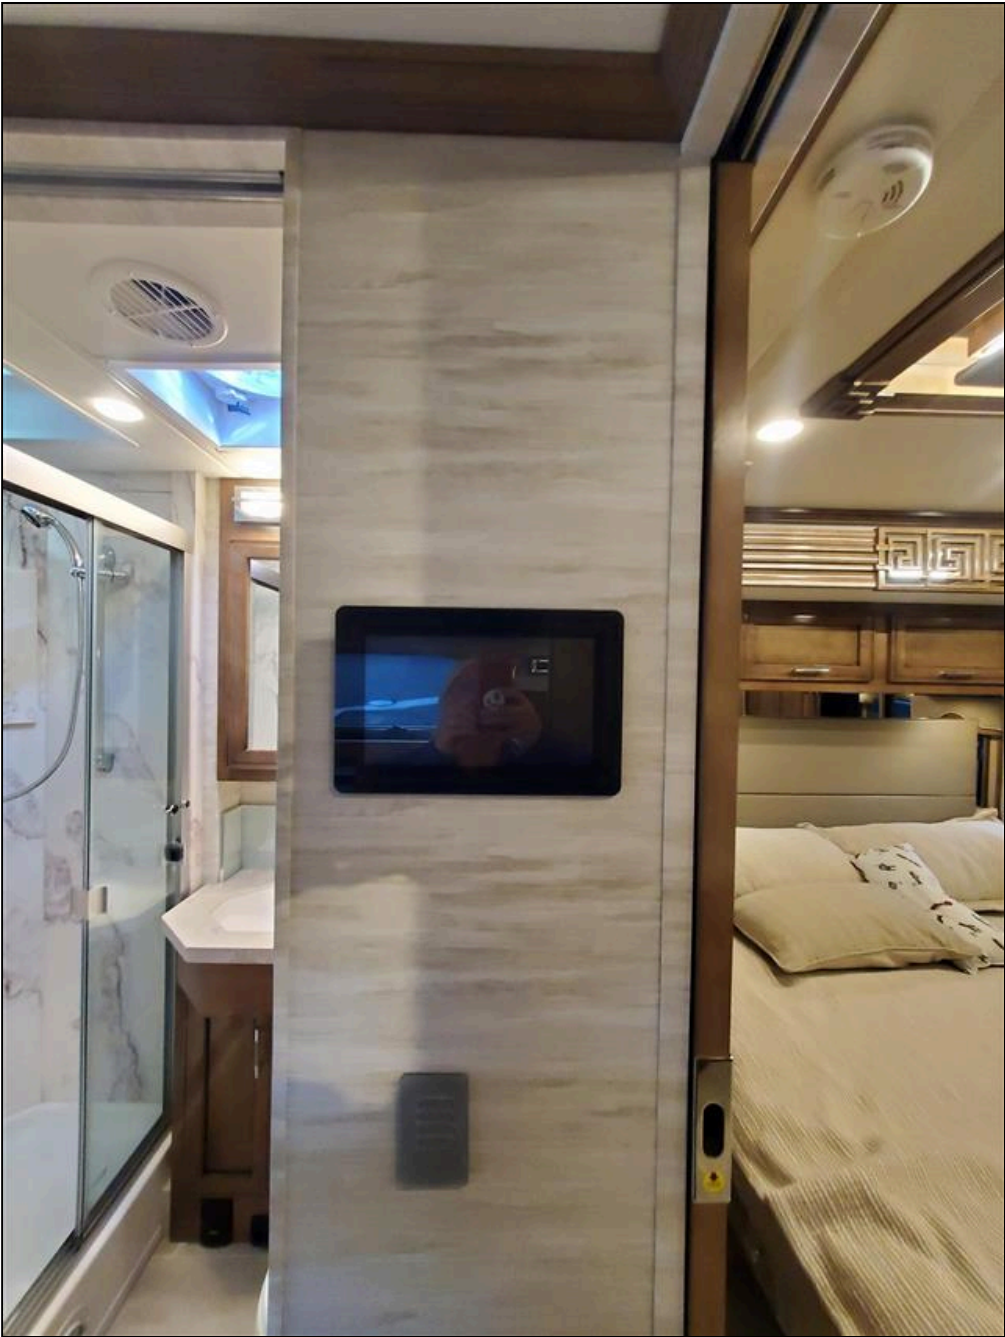
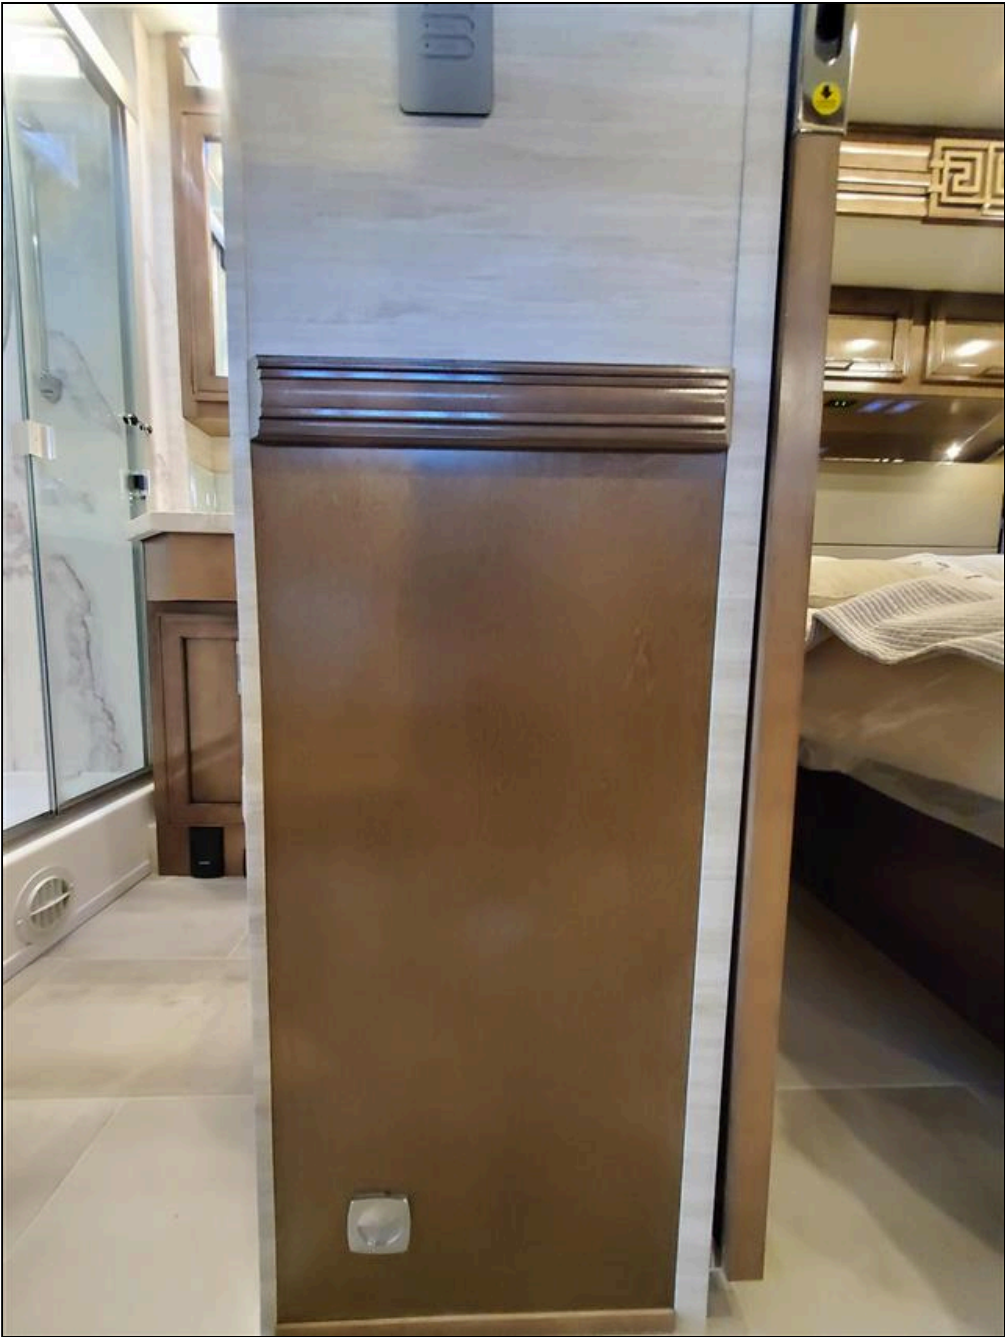
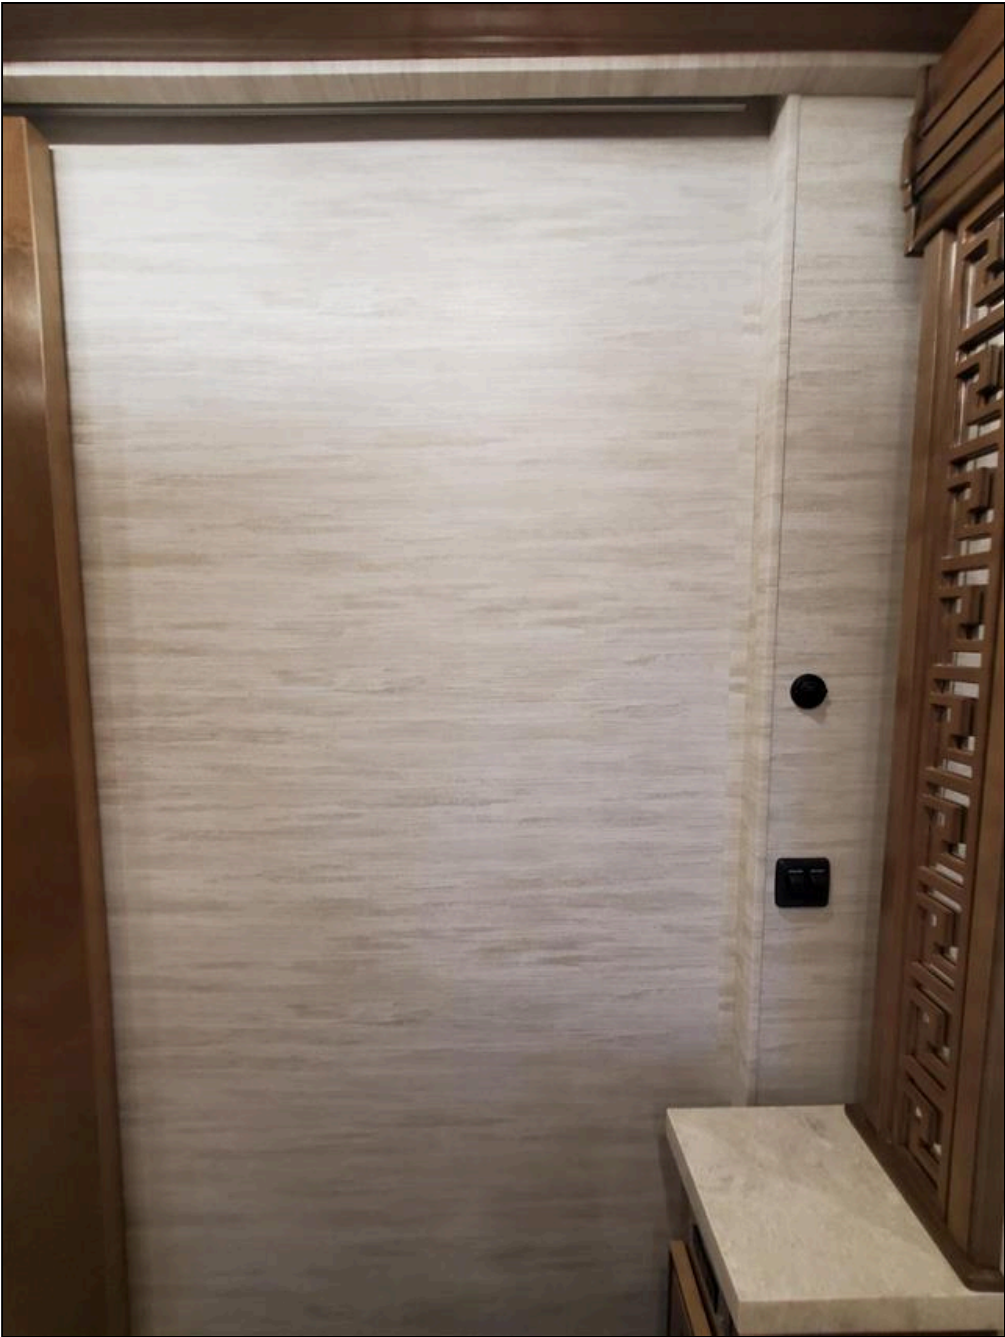
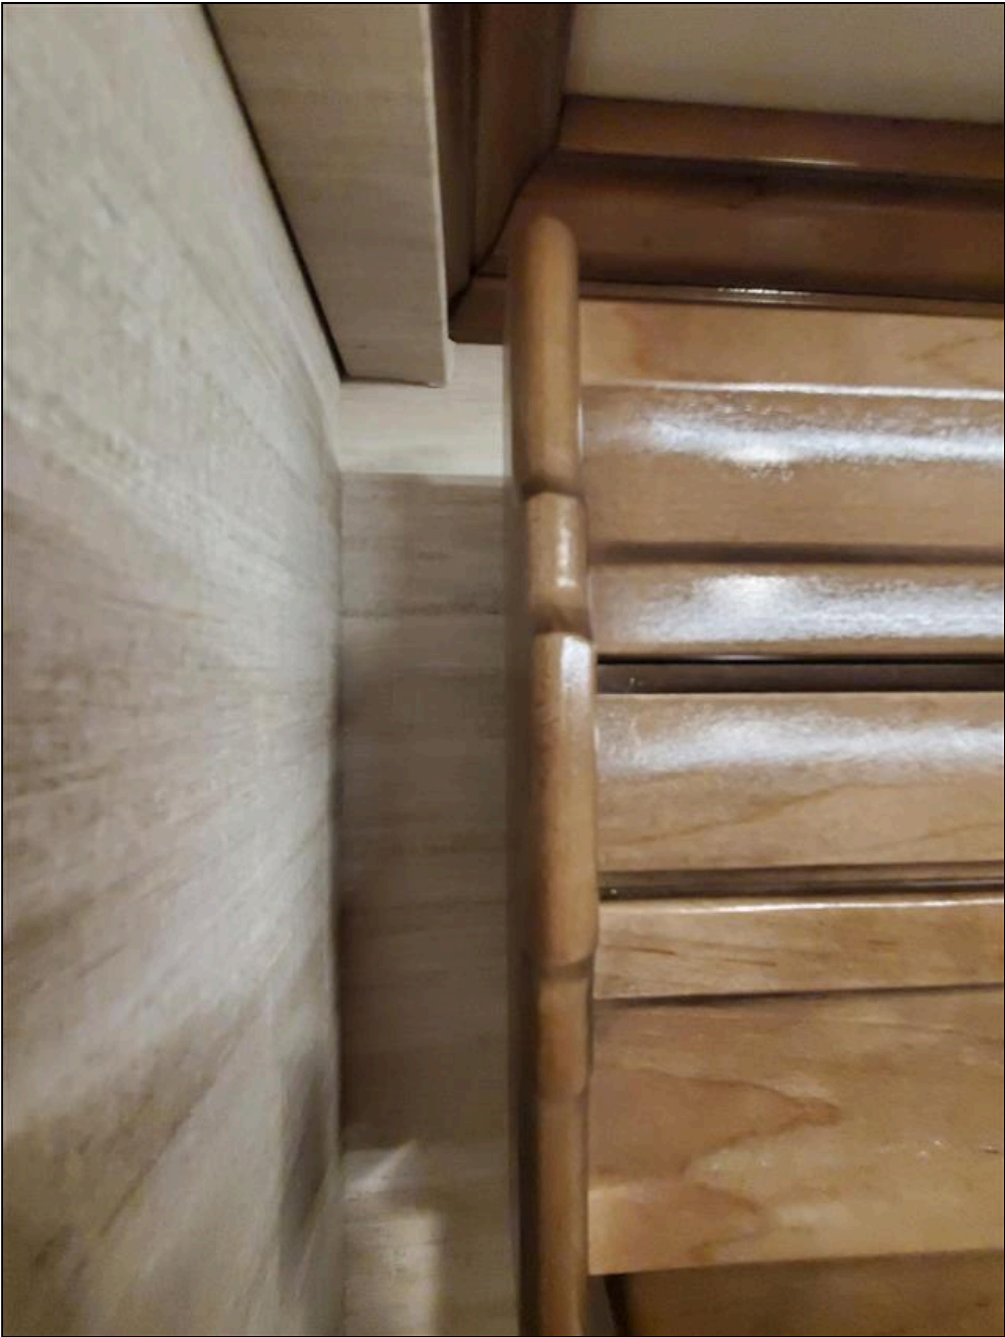
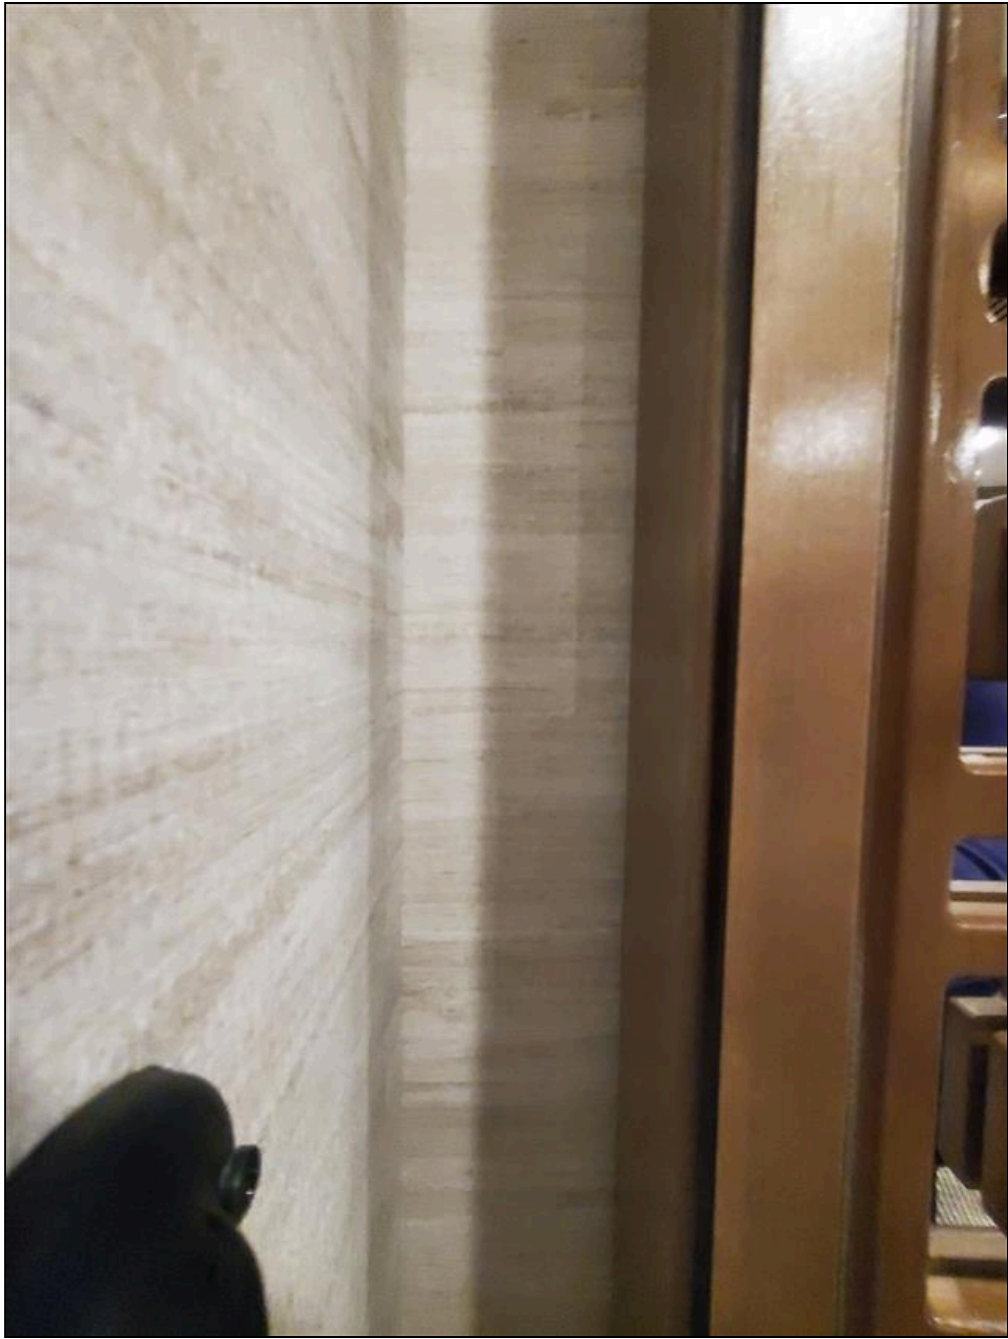
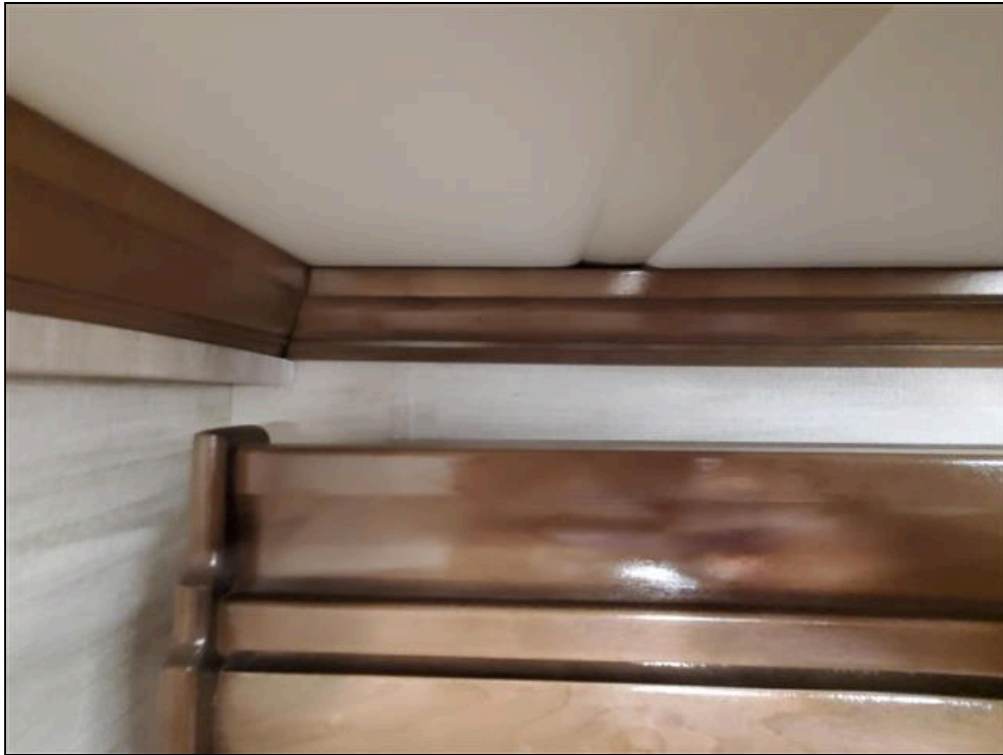
19.20 Walls - Wallpaper Wrinkles, Residue or Damage

(1) Wallpaper Tear(s) were Observed

(2) Wallpaper Wrinkles were Observed

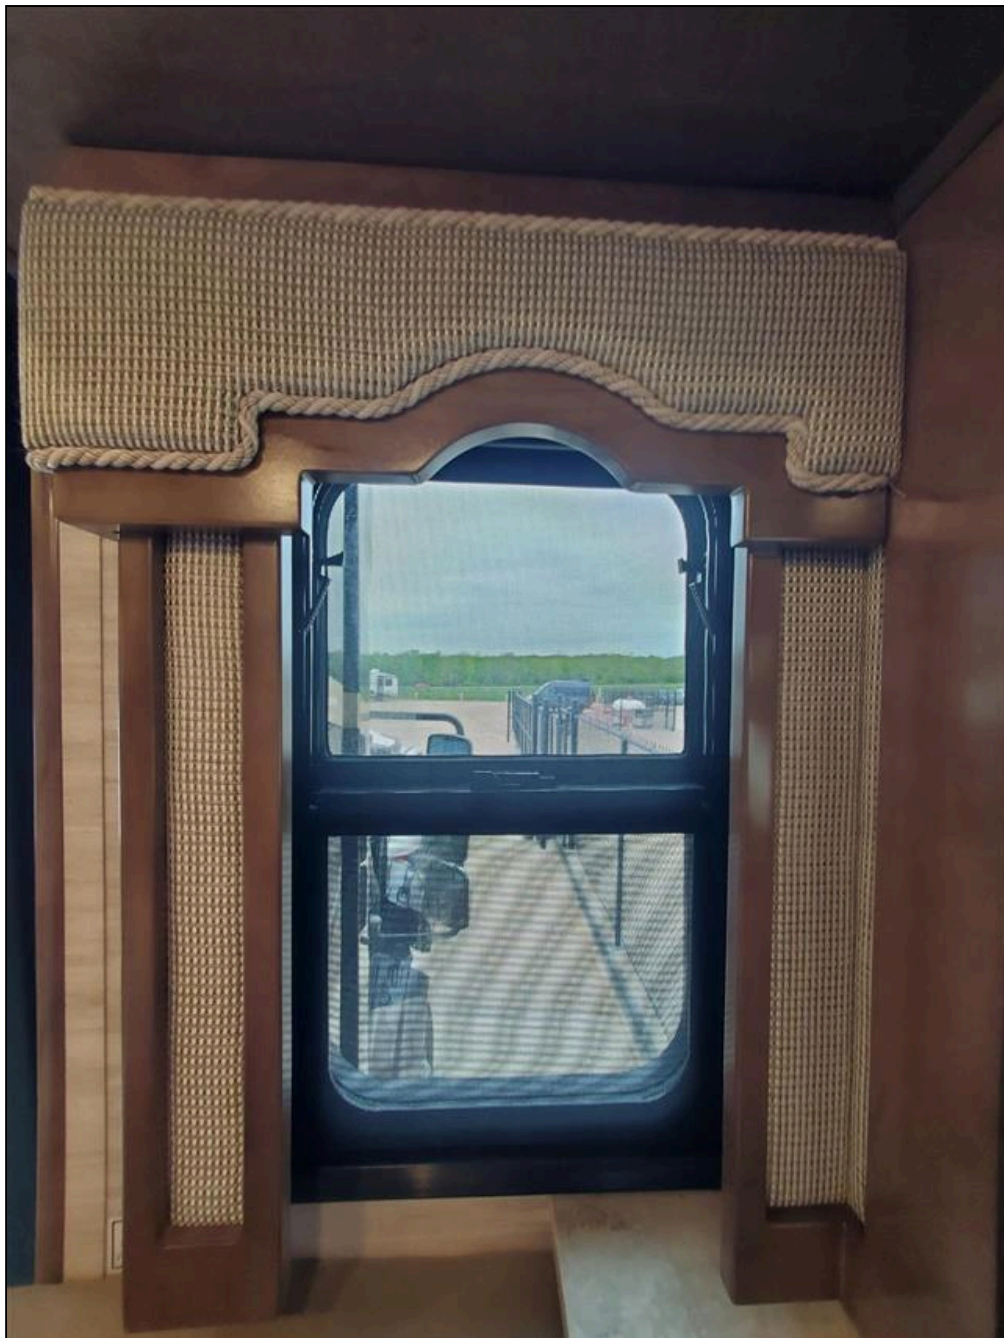
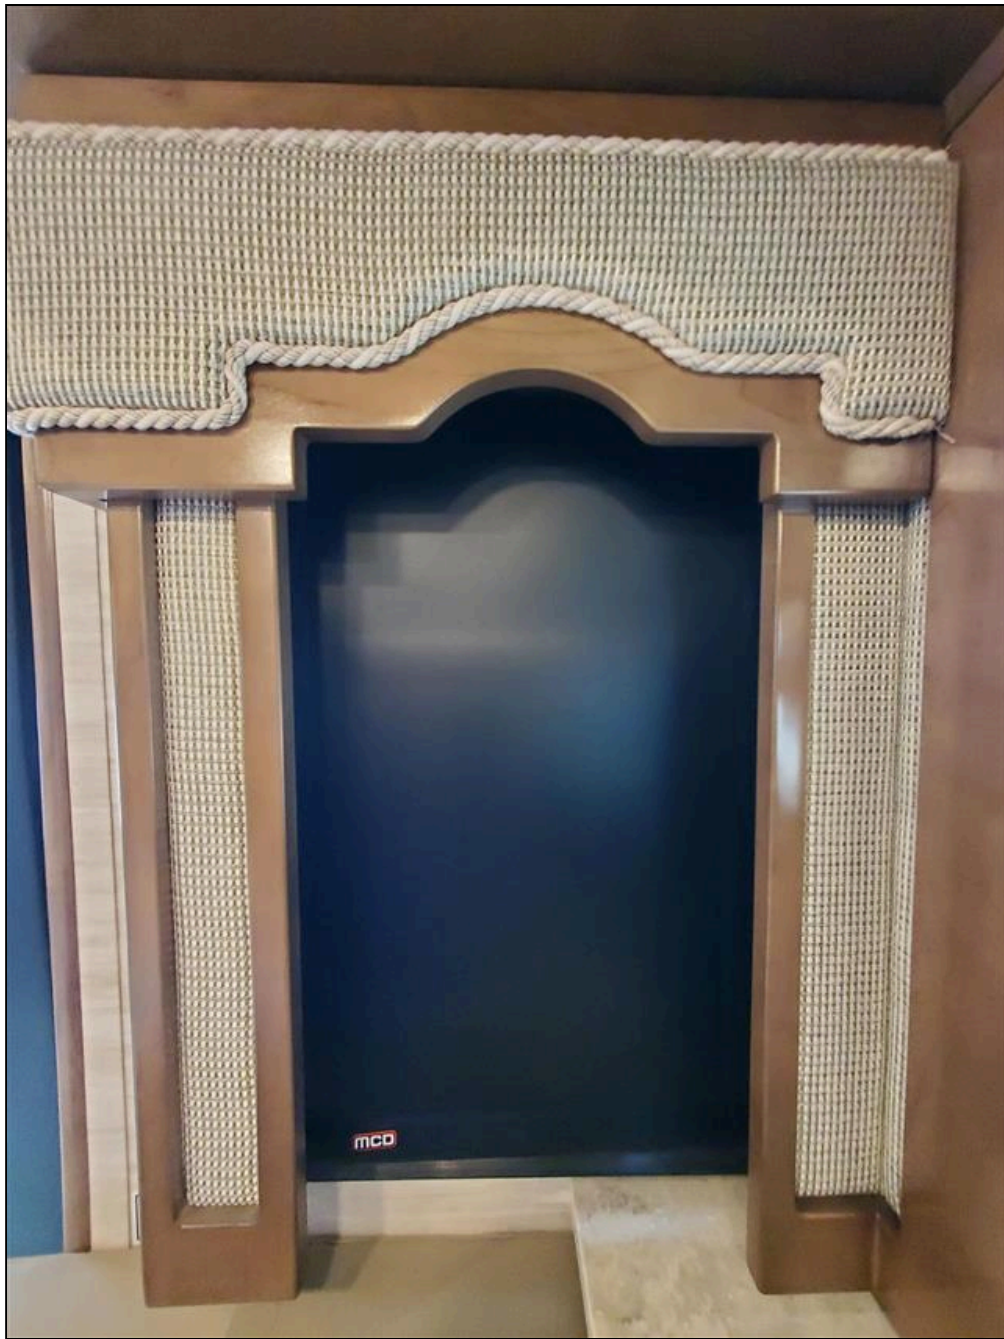
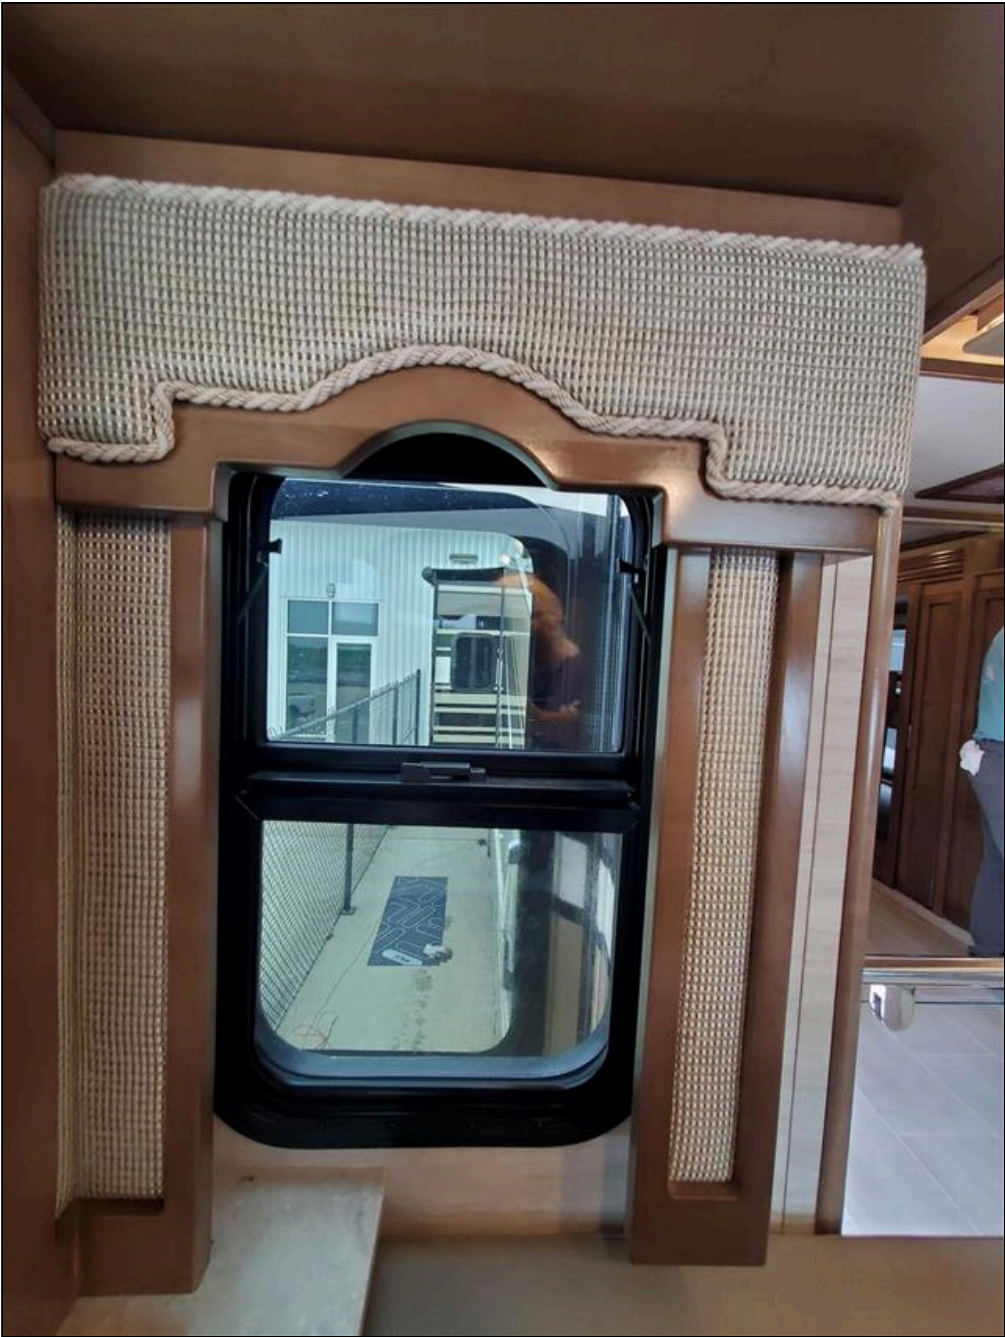
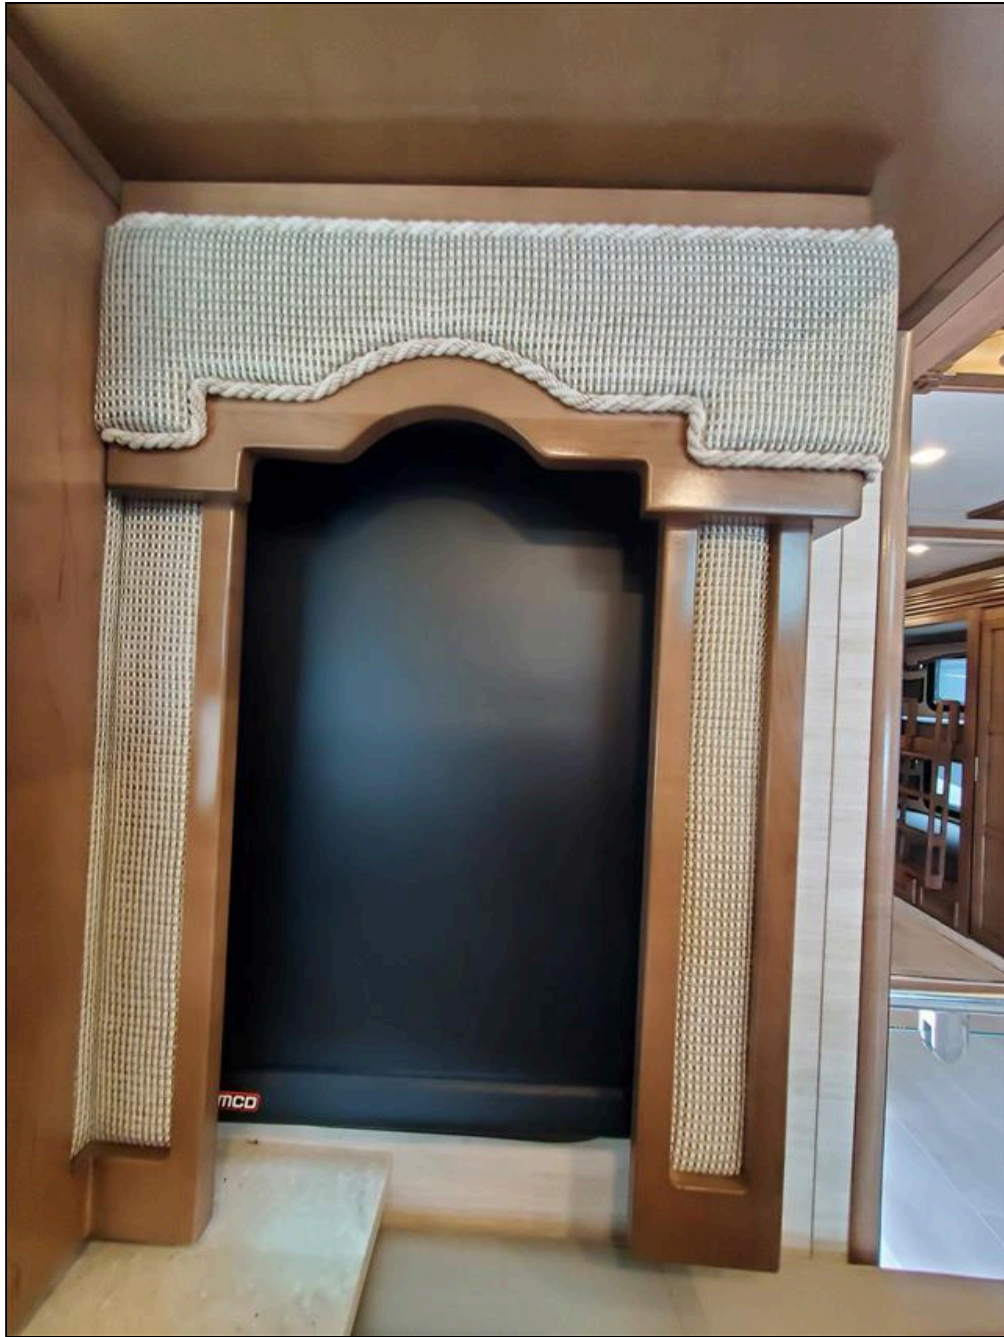
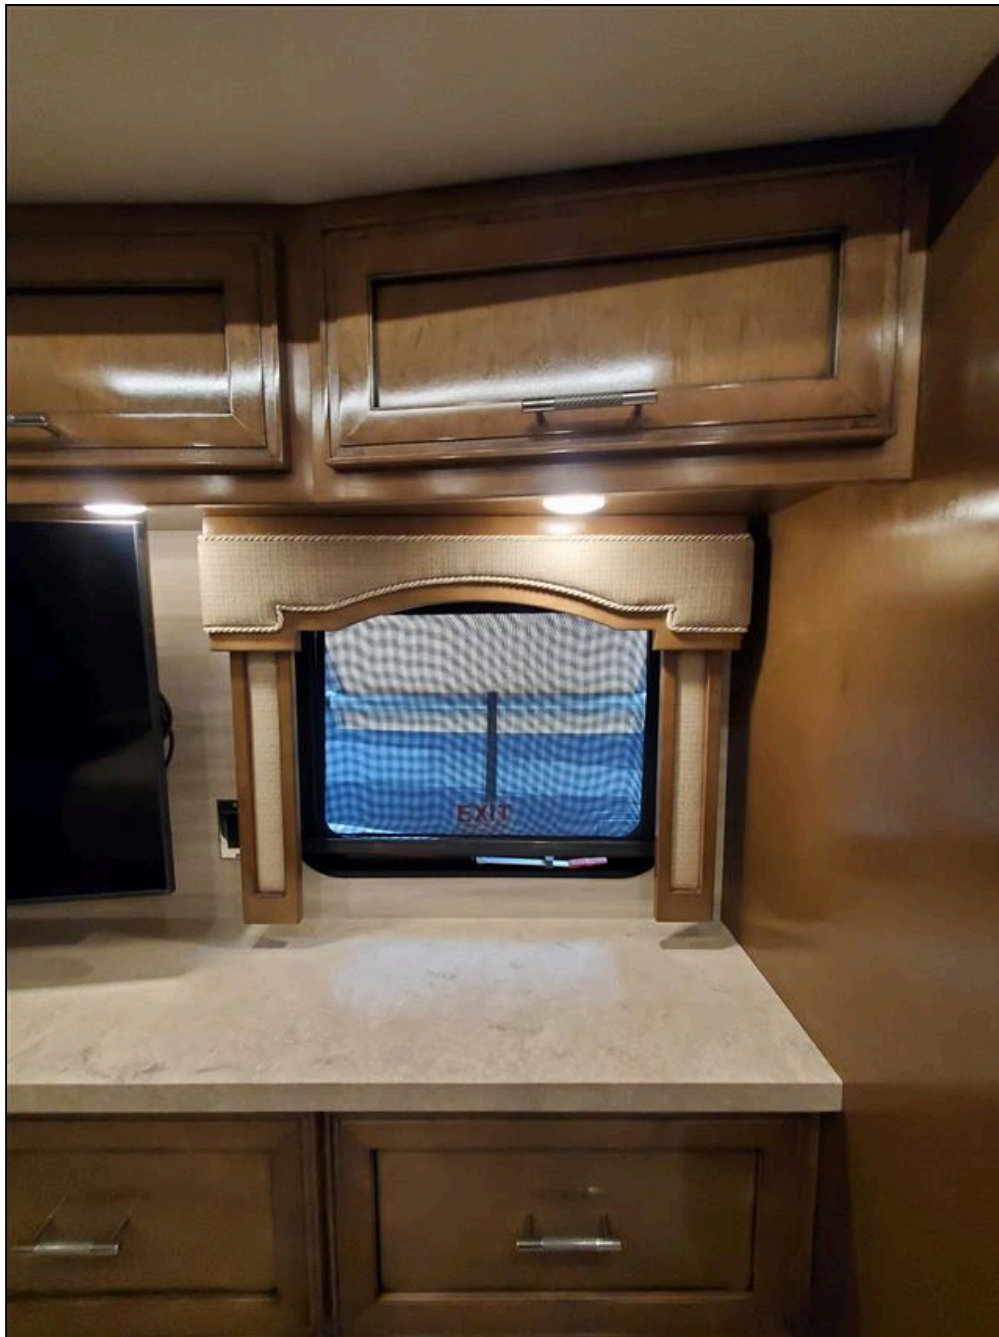
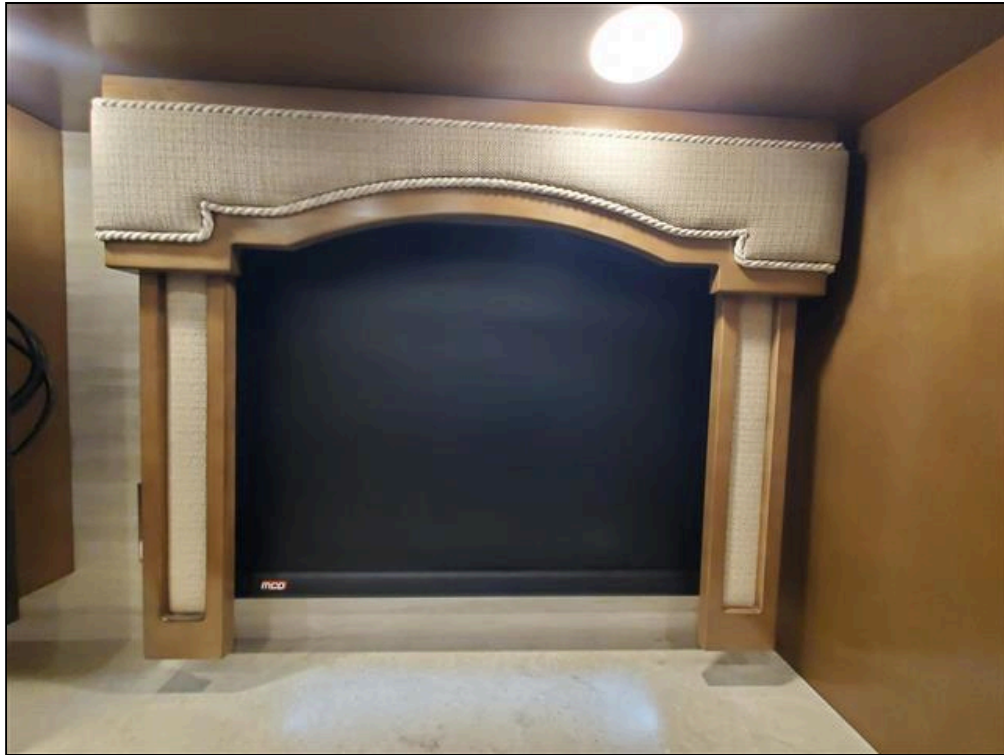
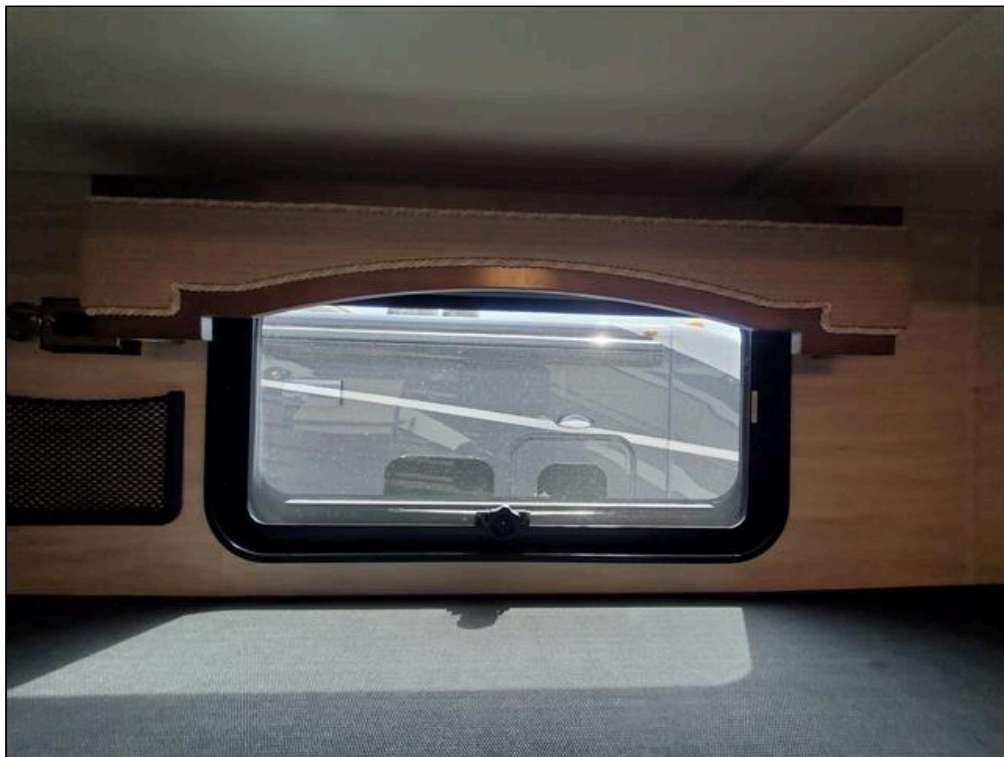
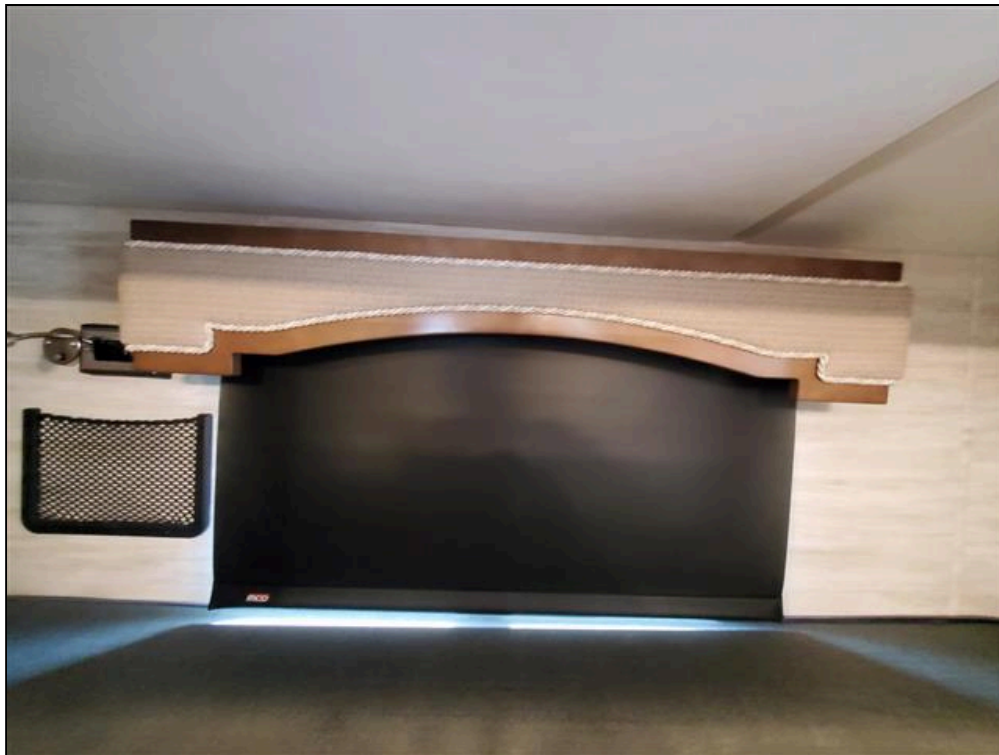
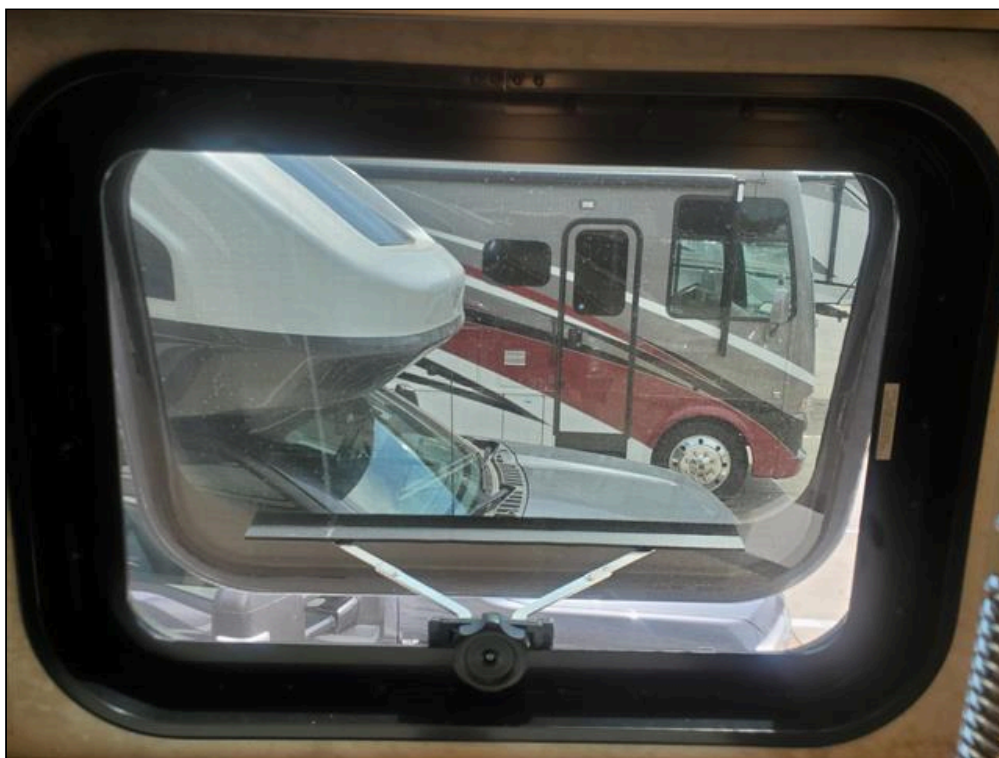
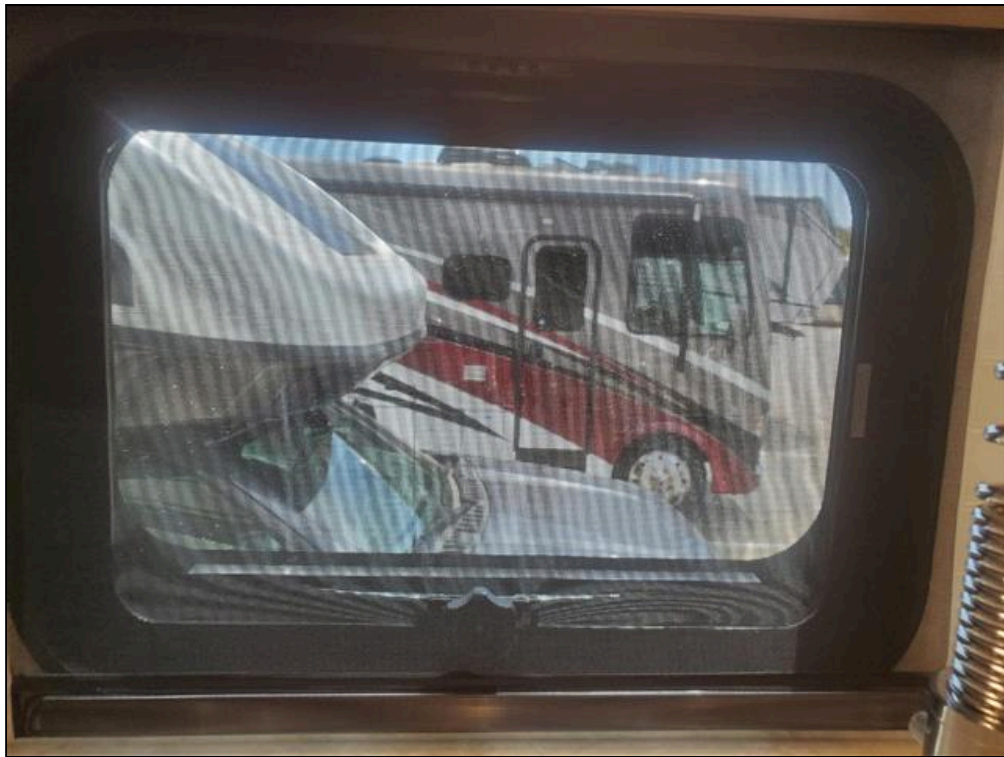
Window Coverings:

19.33 Windows - Window Coverings in Good Condition

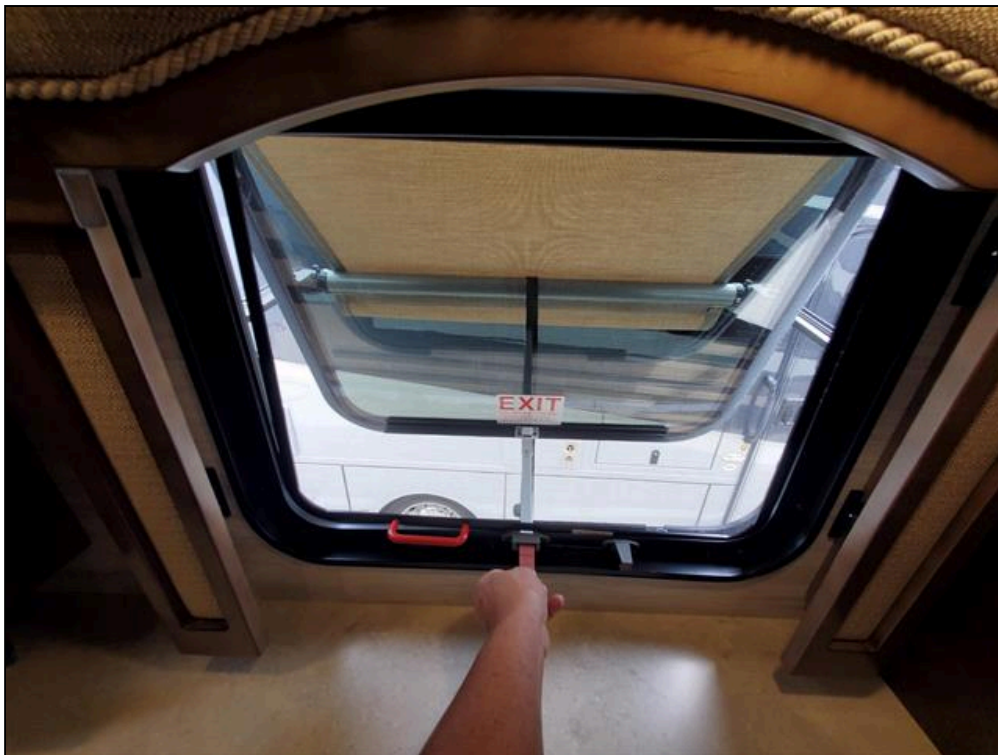
Emergency Windows: operational
