RV Inspection Report

**Inspection Date / RV Model:
Newmar Superstar 4065 2023**

**Pierre Fortin
5753 Highway 85 N Lot 8511
Crestview, Florida, 32536**

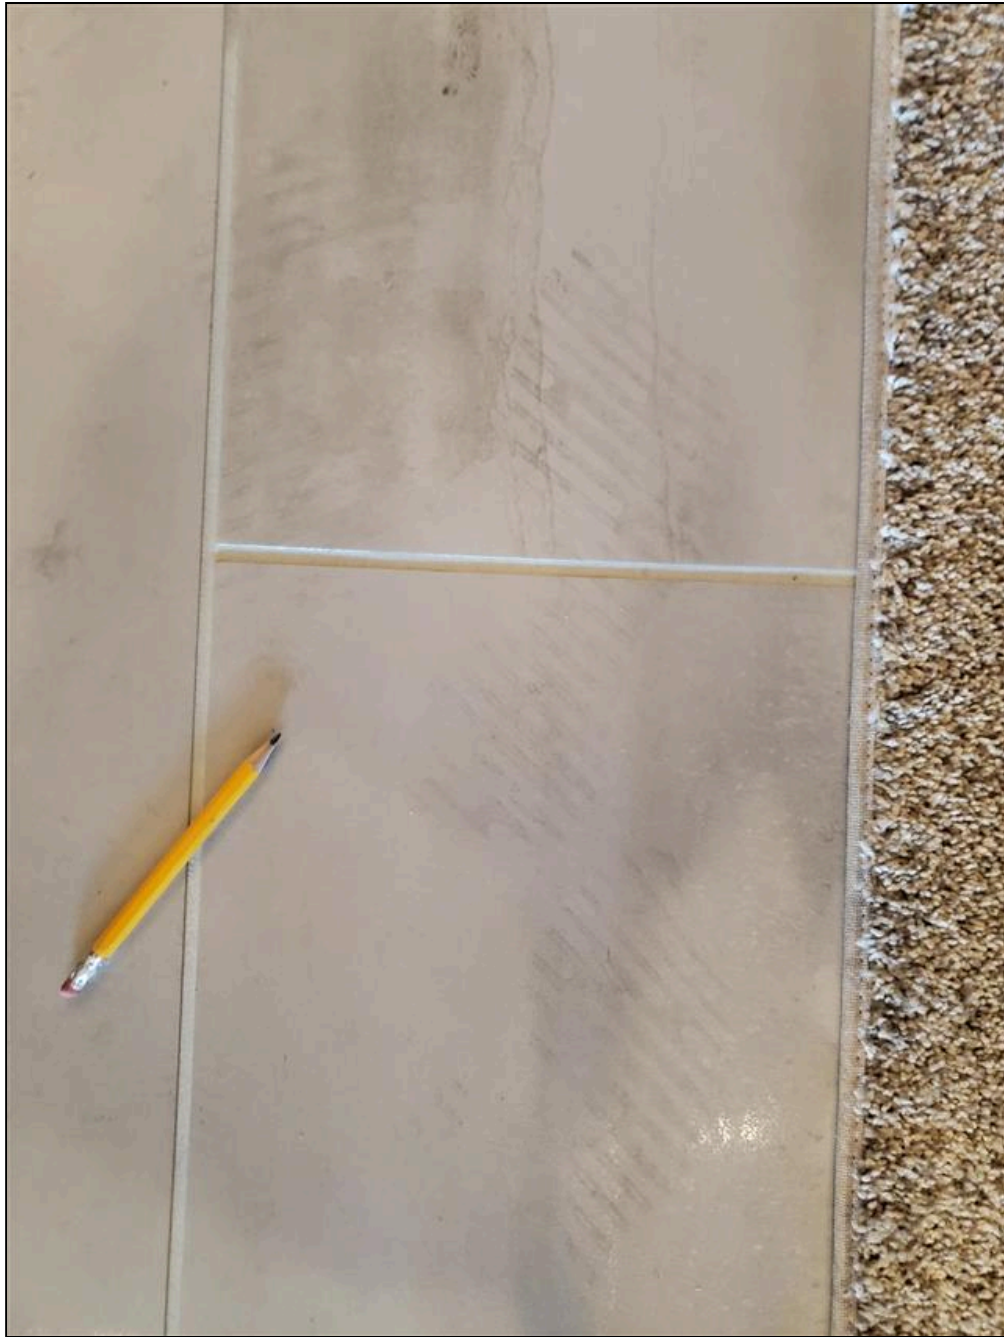
19.41 Flooring - Floor Covering Discolored, Stained or Residues

Residues were Observed on the Flooring Material.

We cannot State if it is Stained or Dirt.

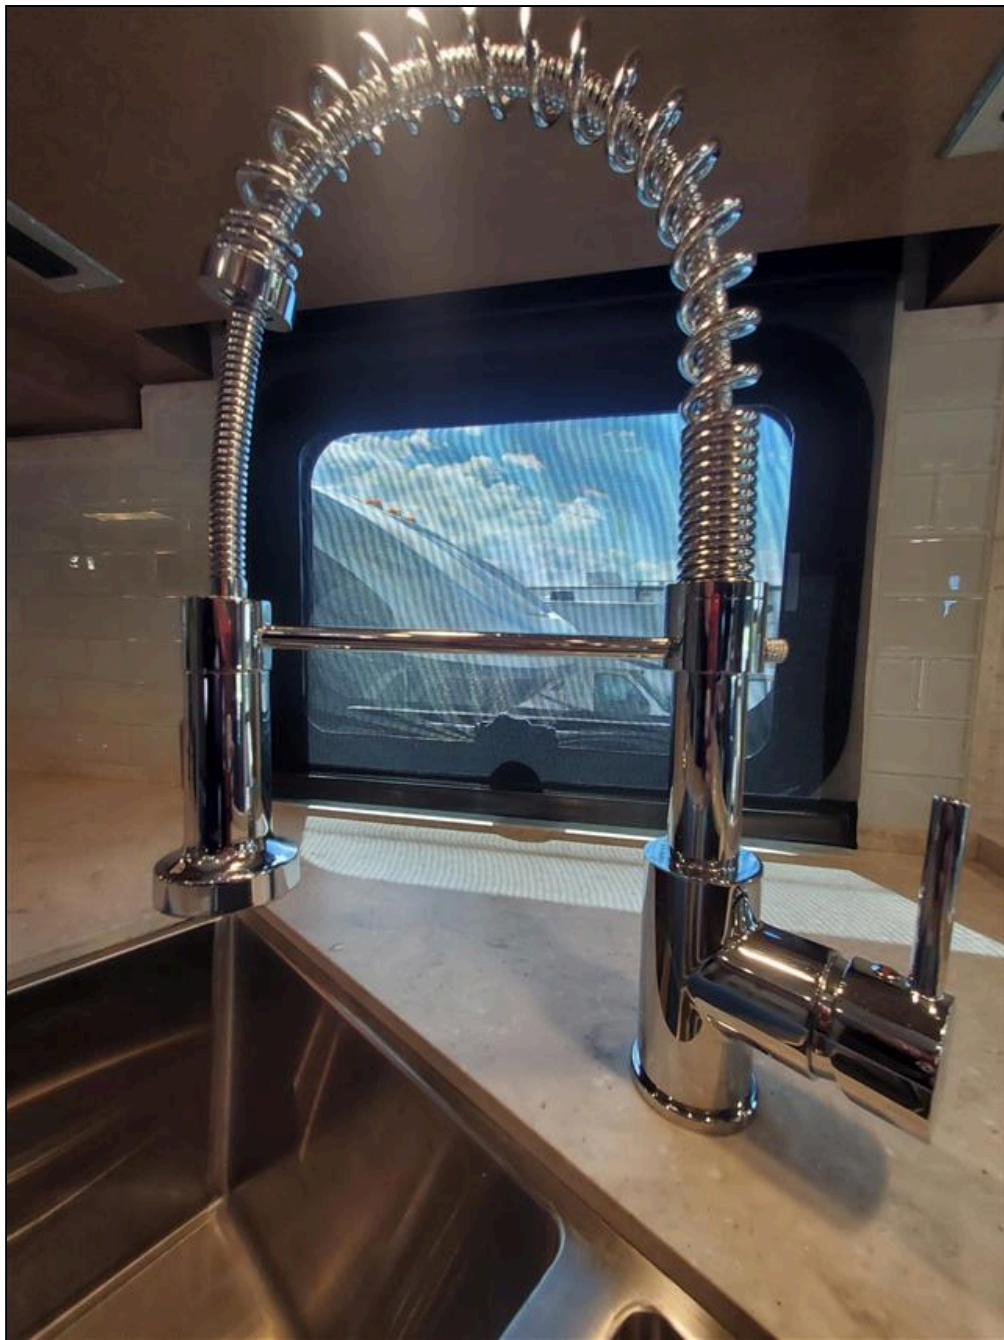
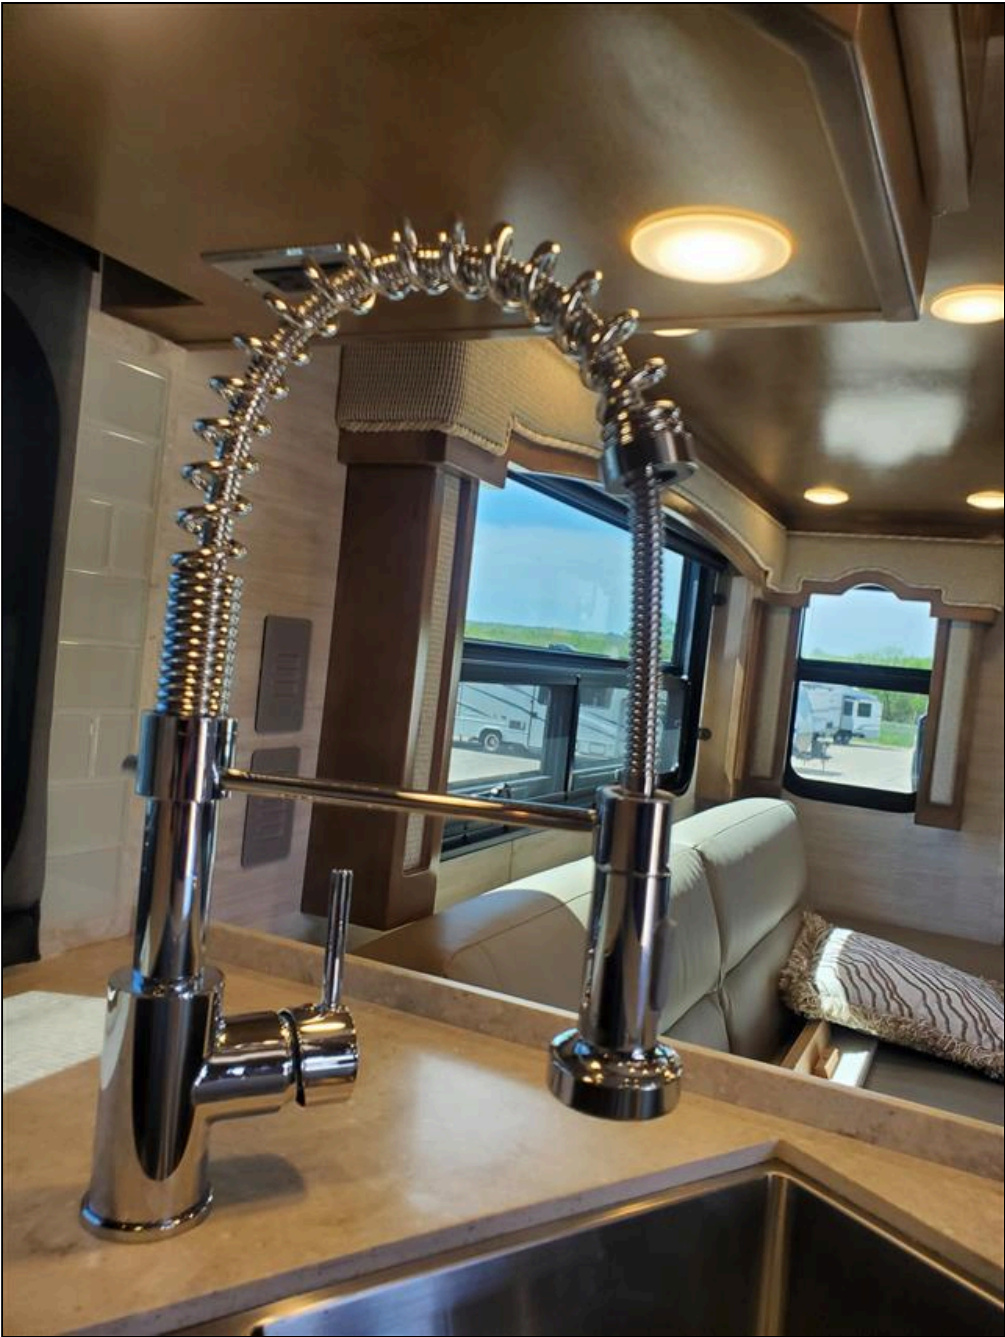
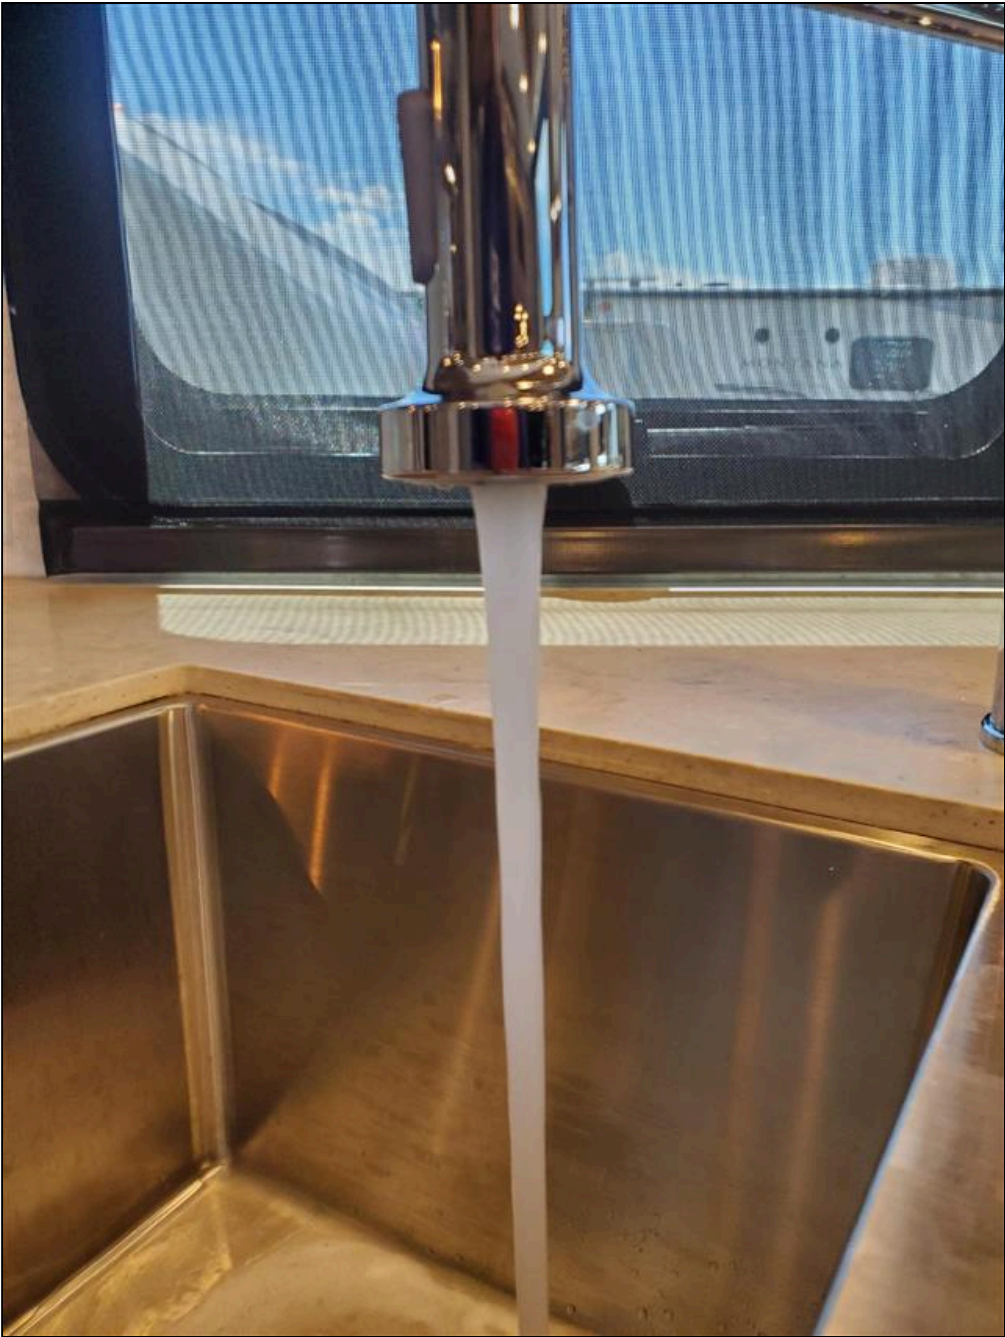
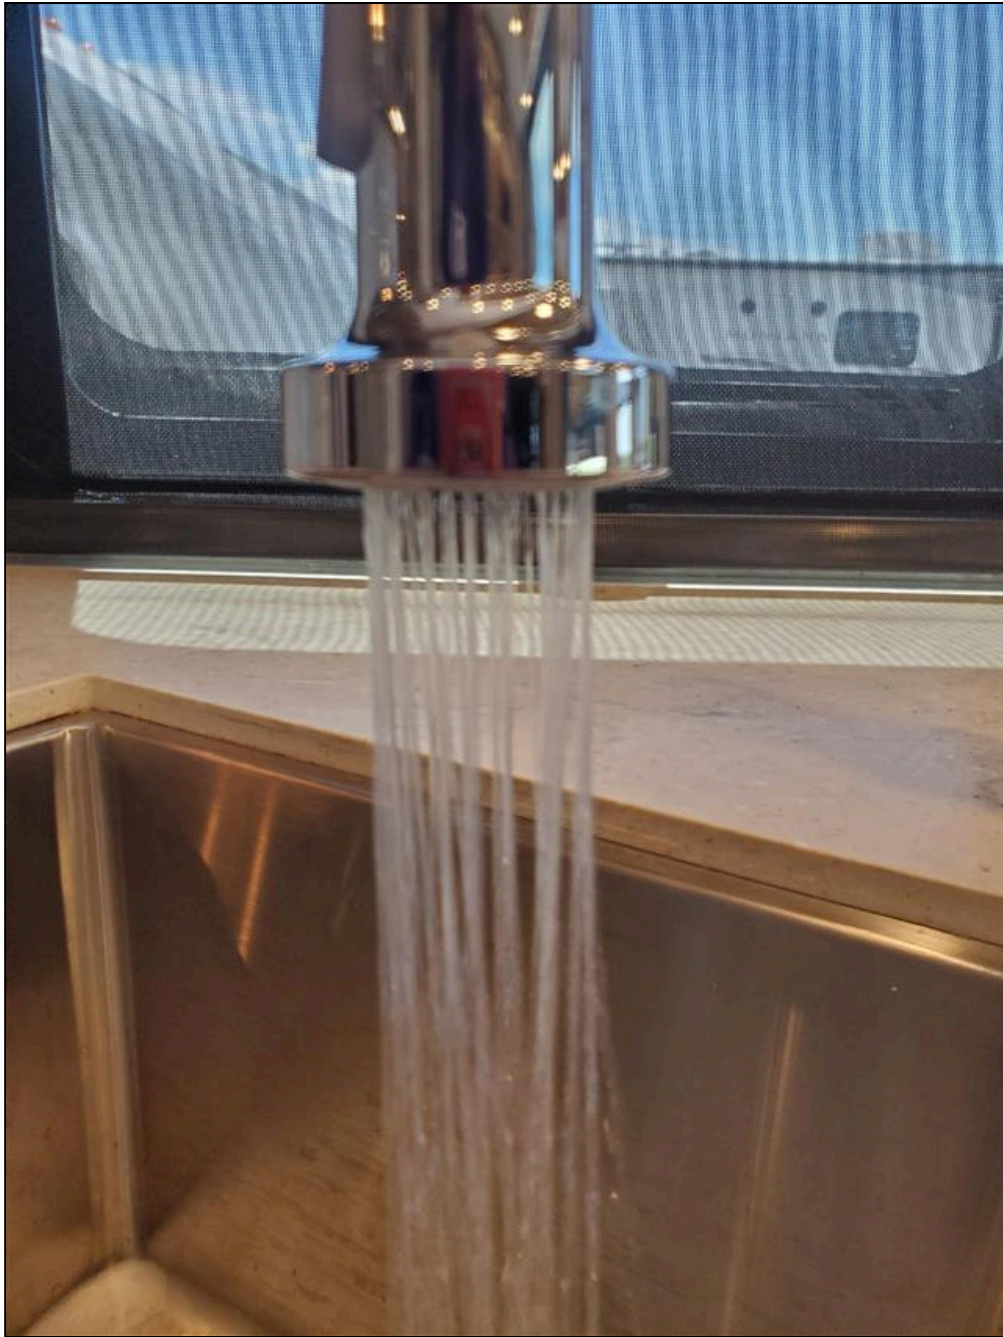
19.46 Operation and Condition of Kitchen Faucet

Kitchen Faucet Works as Intended

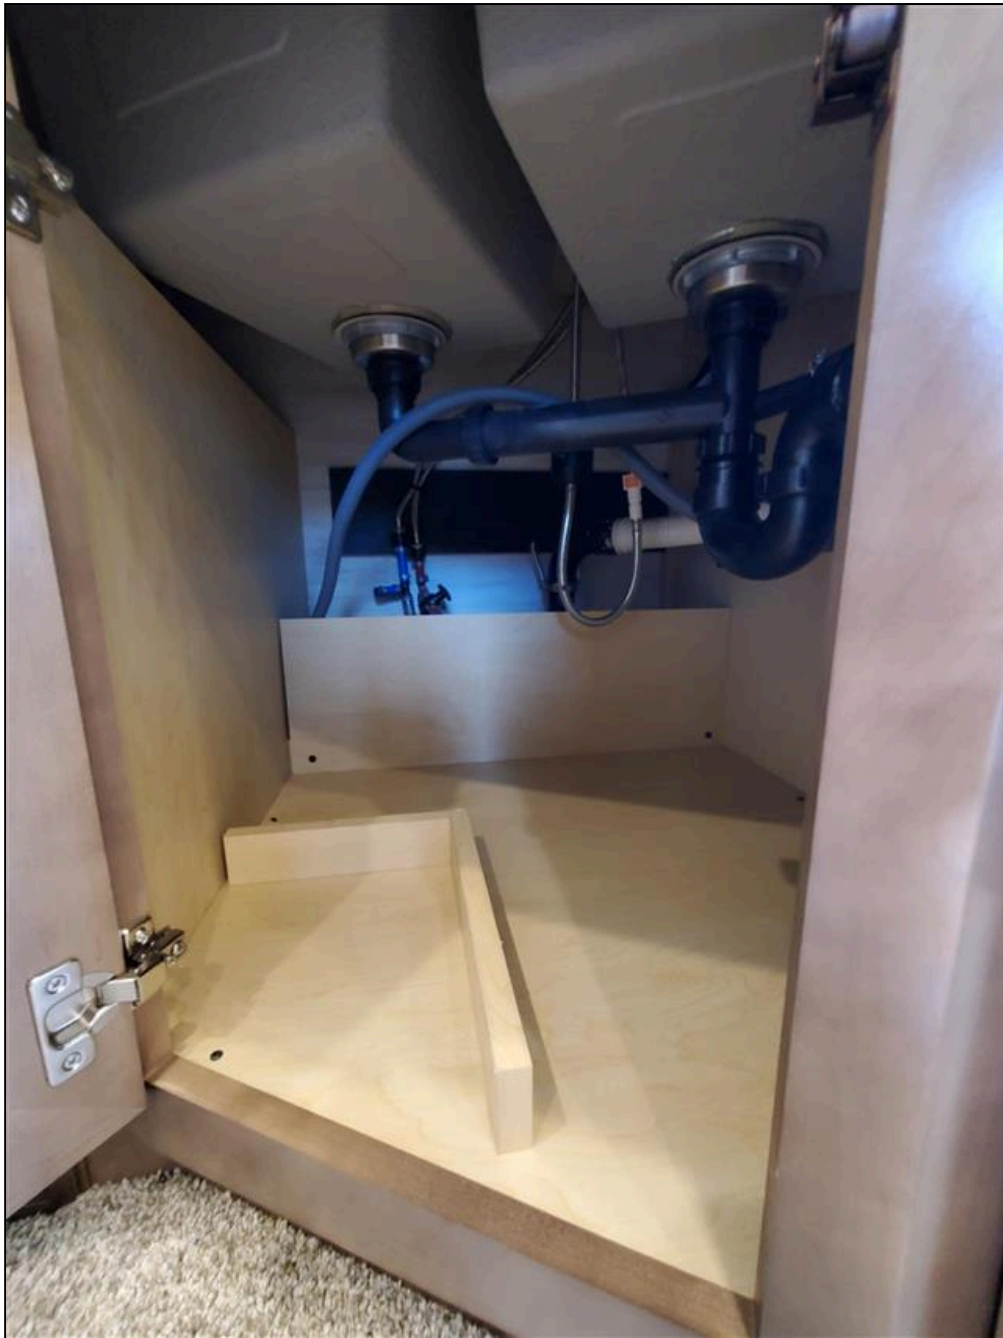
P-Trap holds water

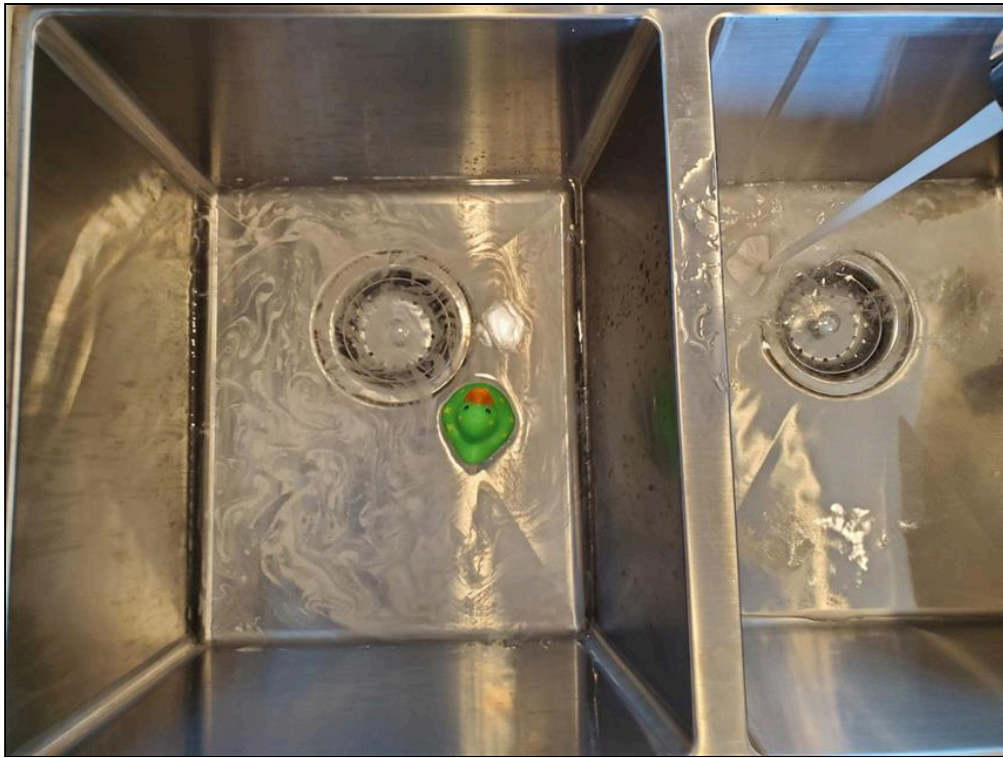
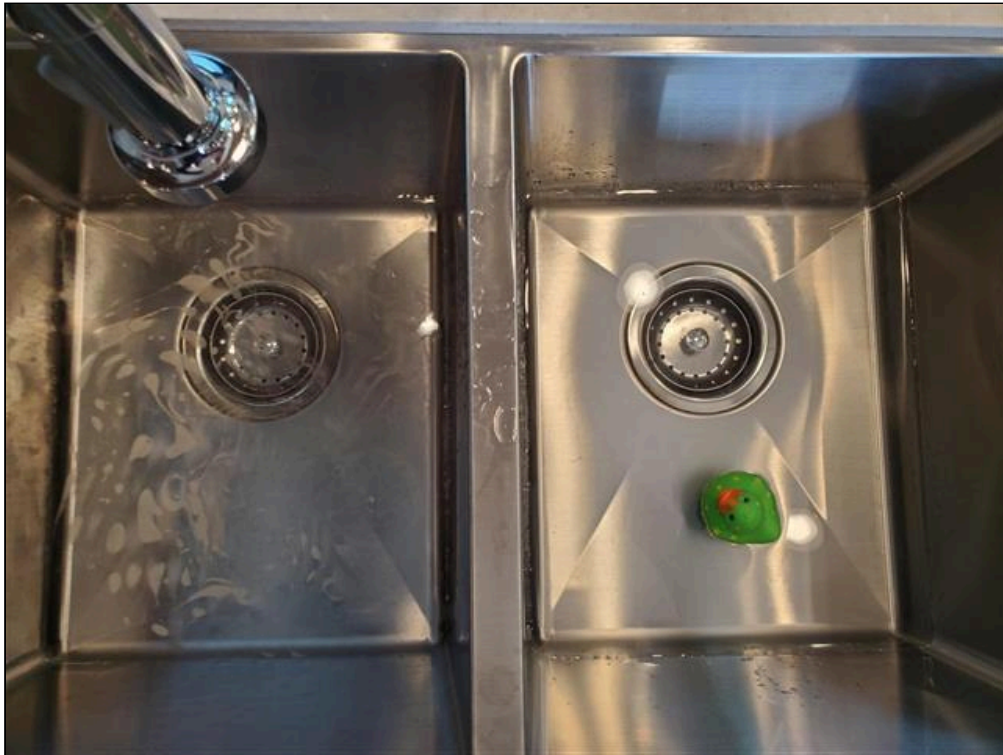
19.51 Kitchen Sink - Sink(s) Holds Water

Sink(s) Holds Water

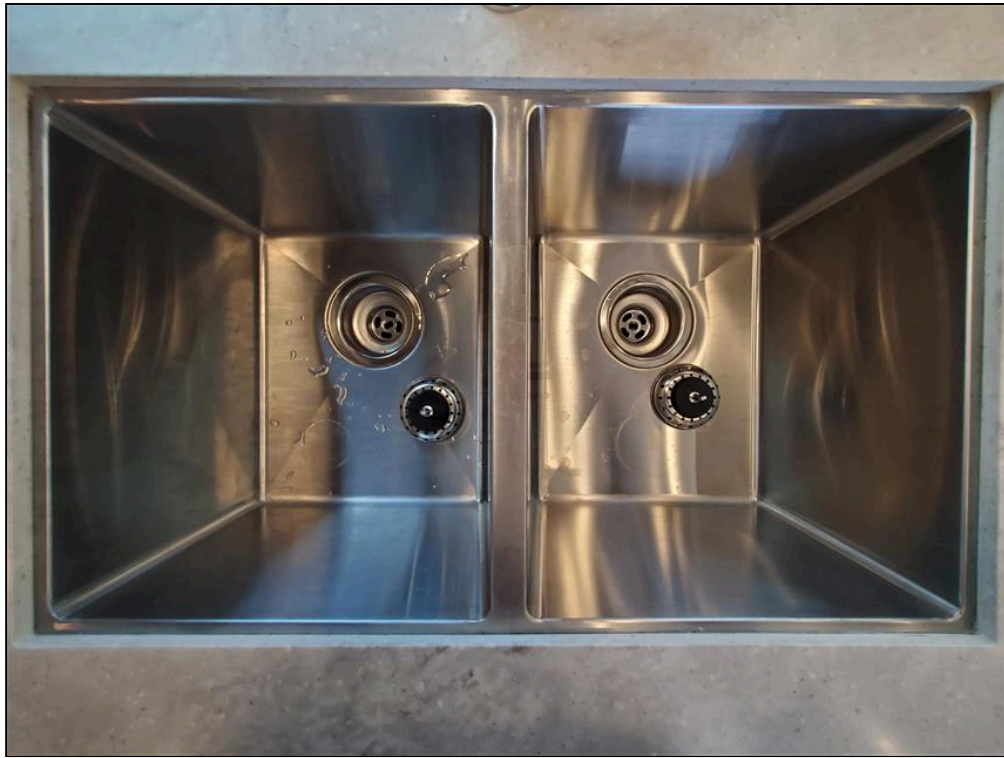
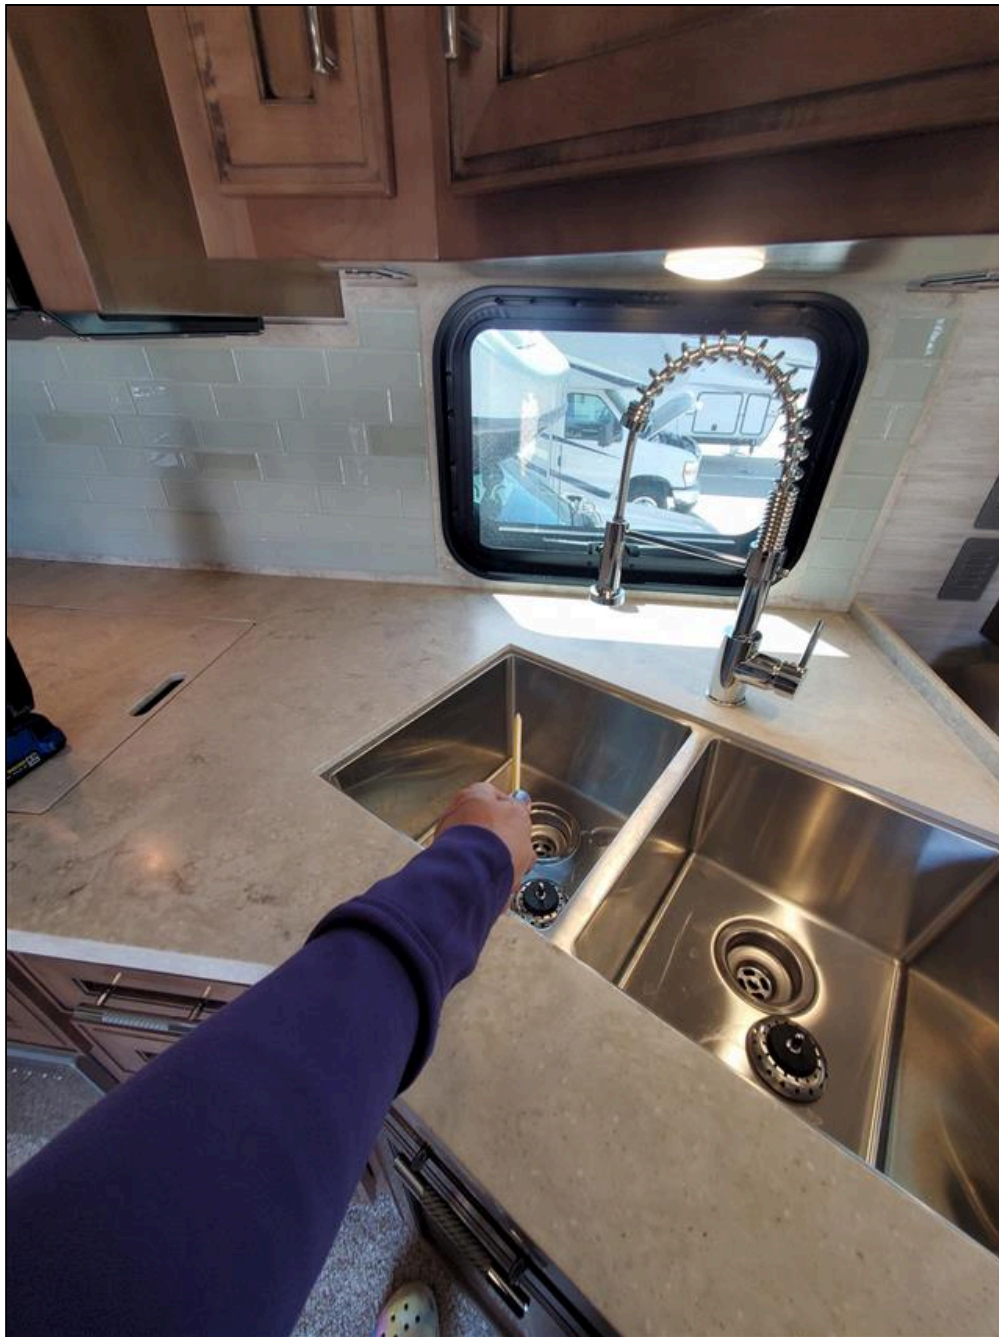
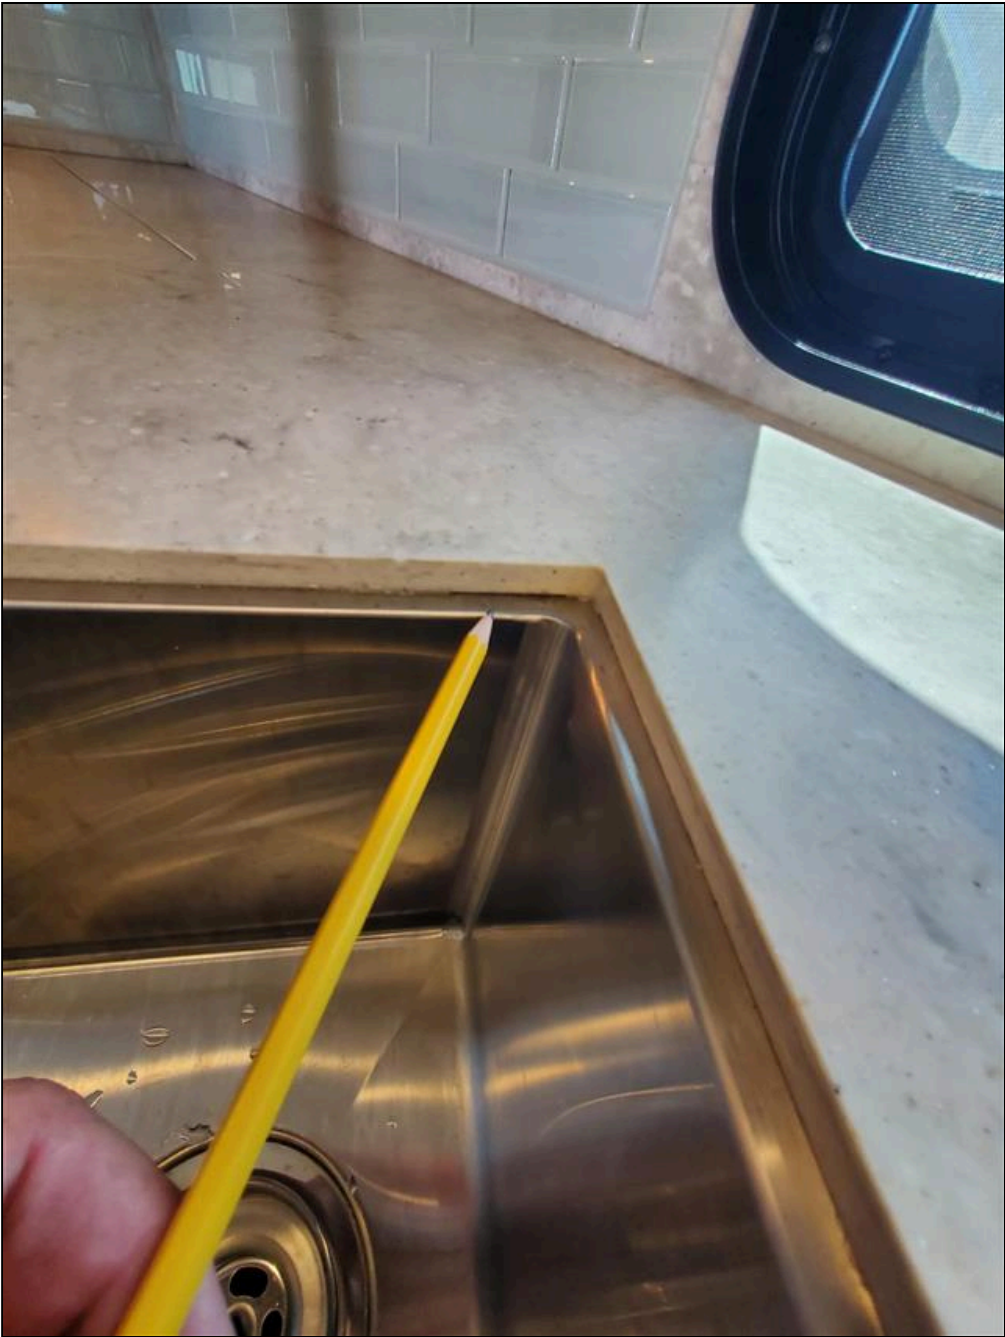
Kitchen Sink requires sealant

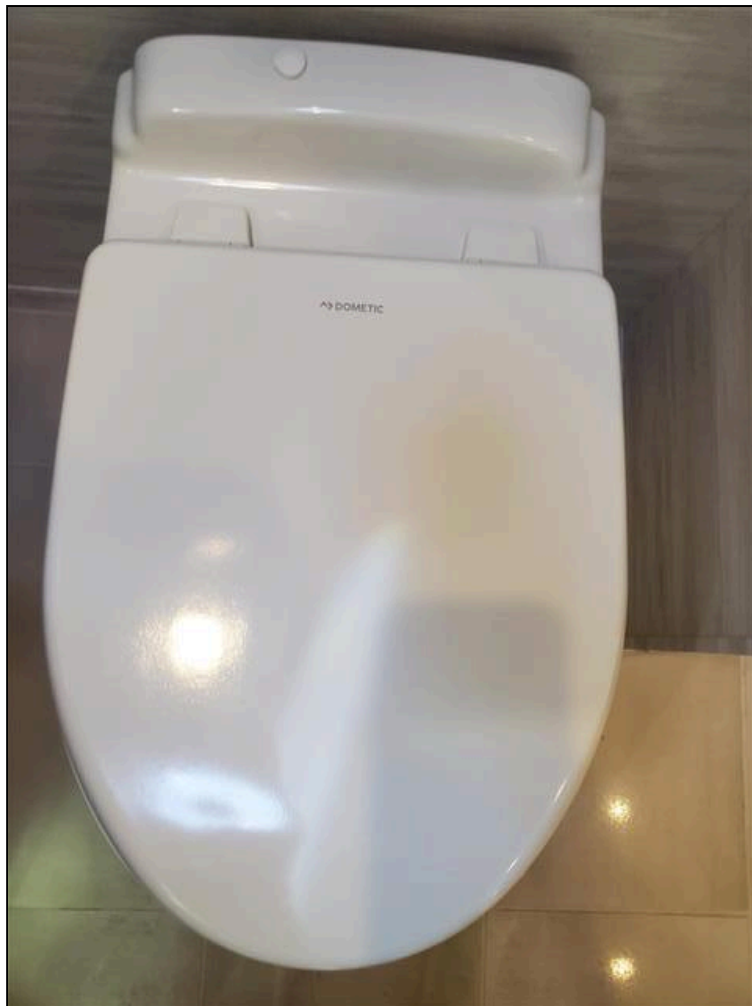
19.55 Operation and Condition of Toilet

Operation of Toilet as Intended

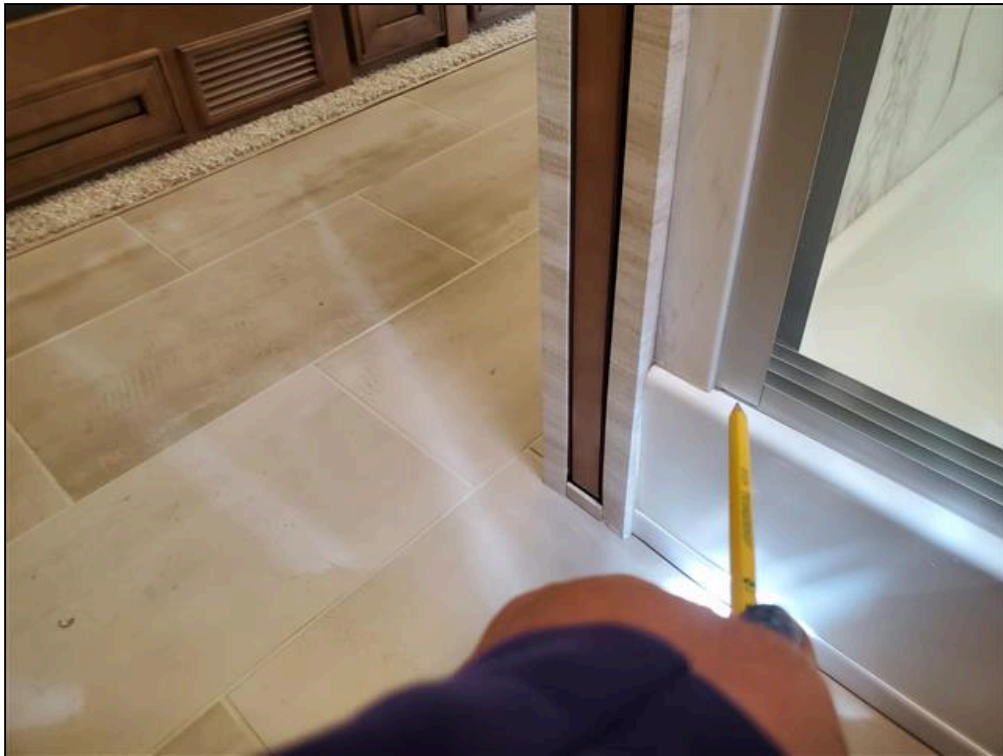
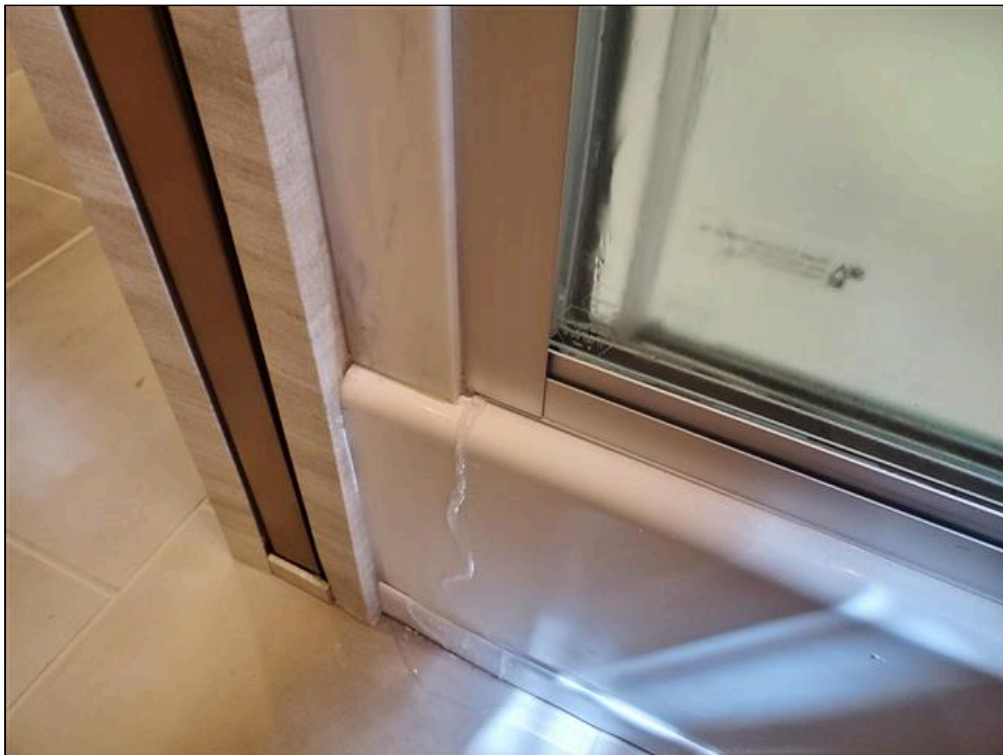
19.64 Shower / Tub - Water Damage or Leaks

Shower Leaks are Observed at Moment of Inspection. Inspector recommends to have the Issue fixed before water Damages occur

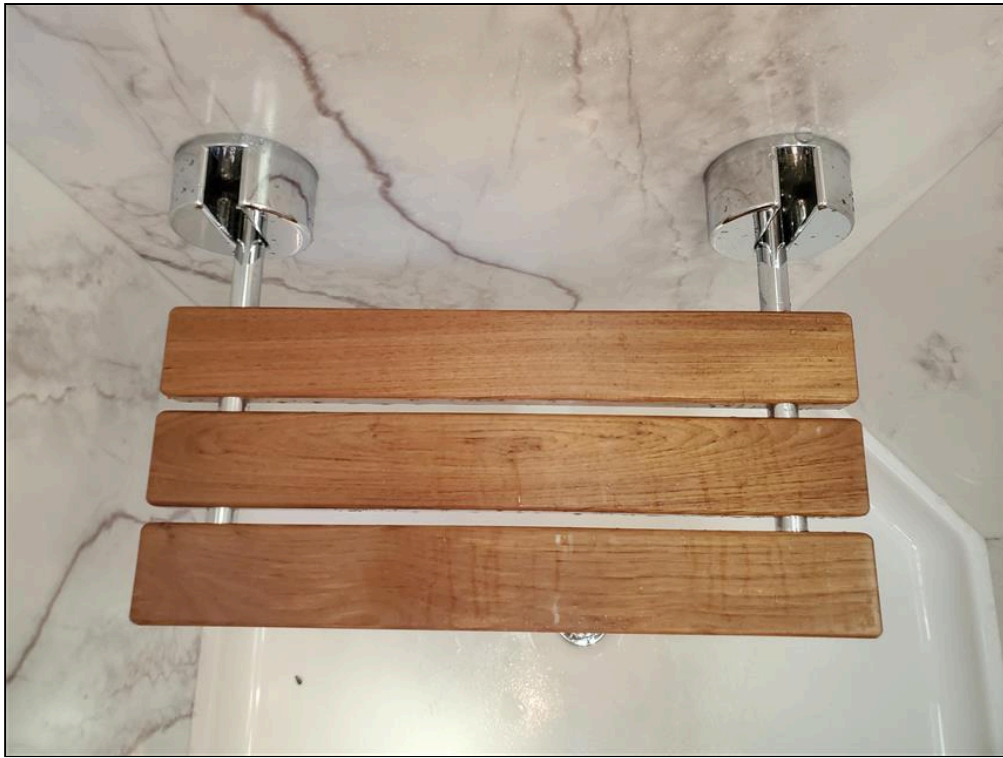
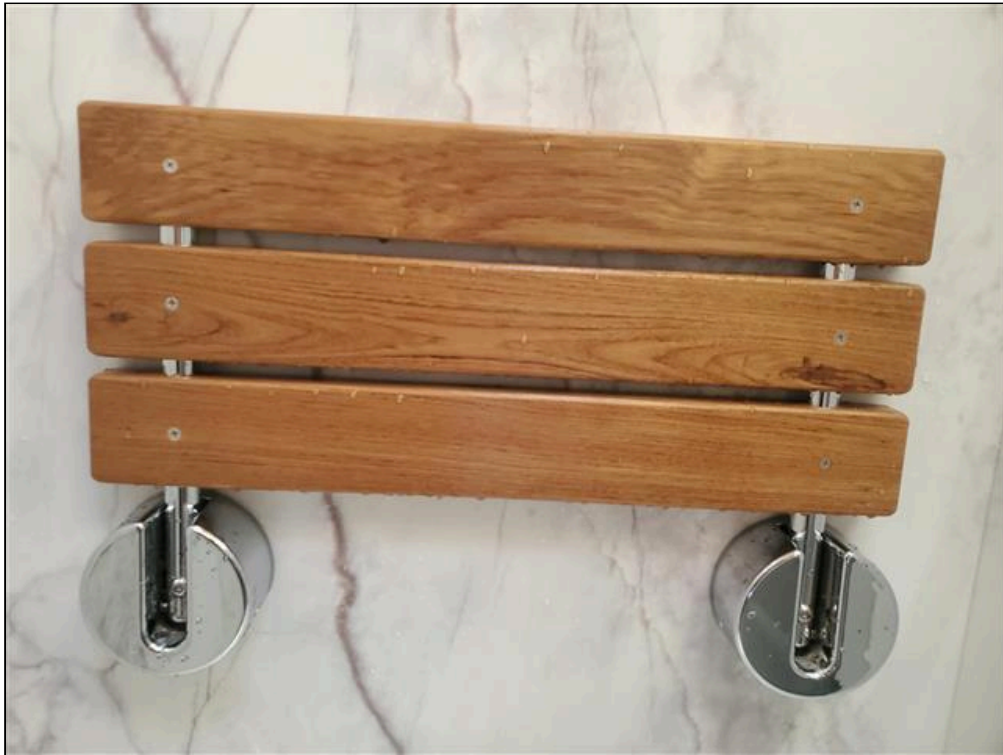
19.66 Shower / Tub - Seating in Good Condition

Shower Seating in Good Condition

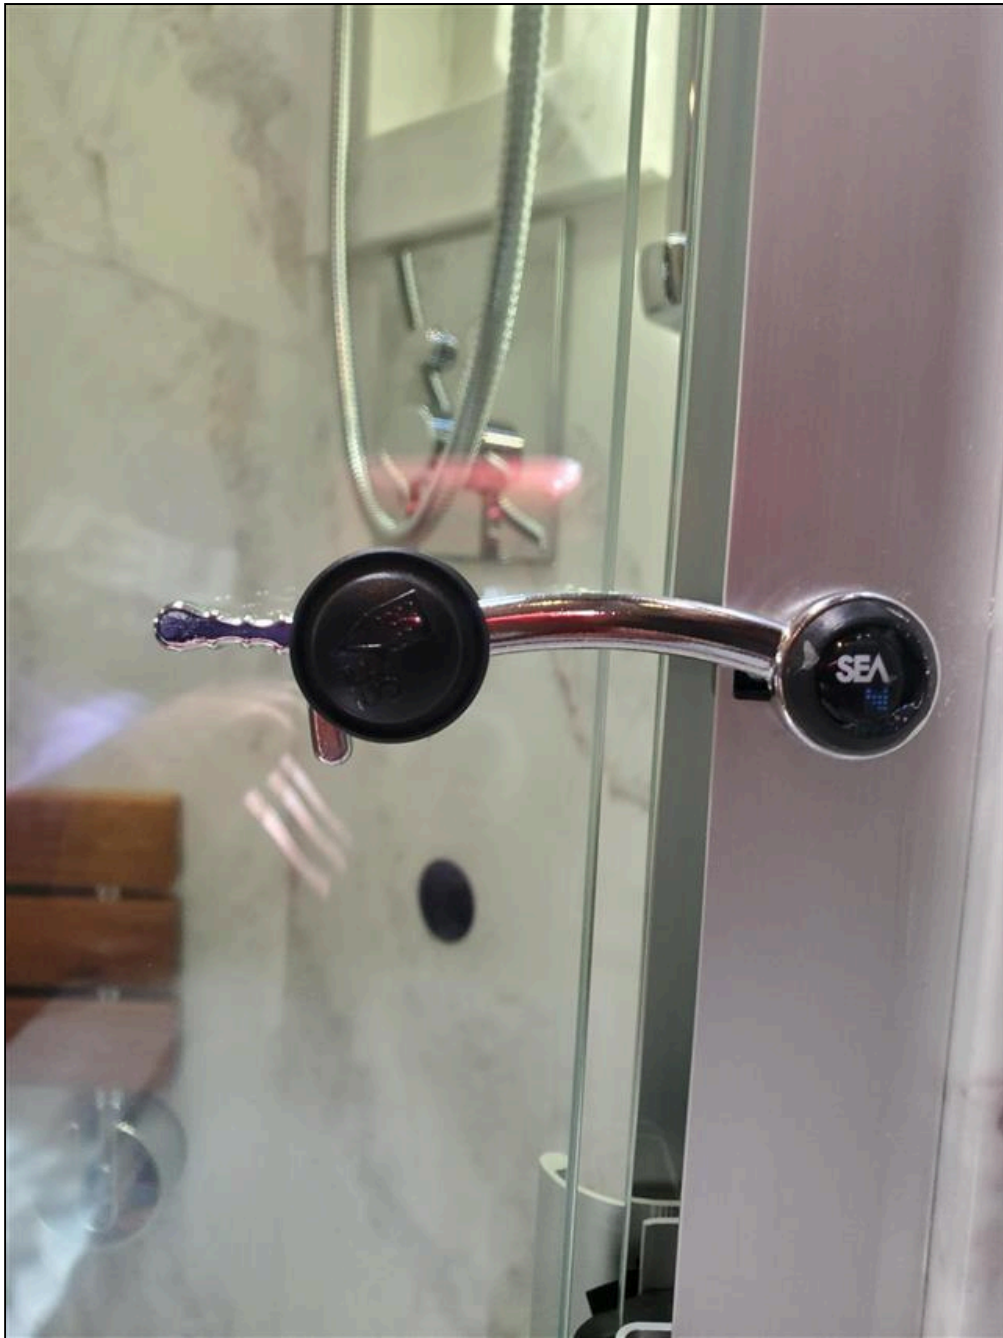
Shower - Tub: Latch functioning

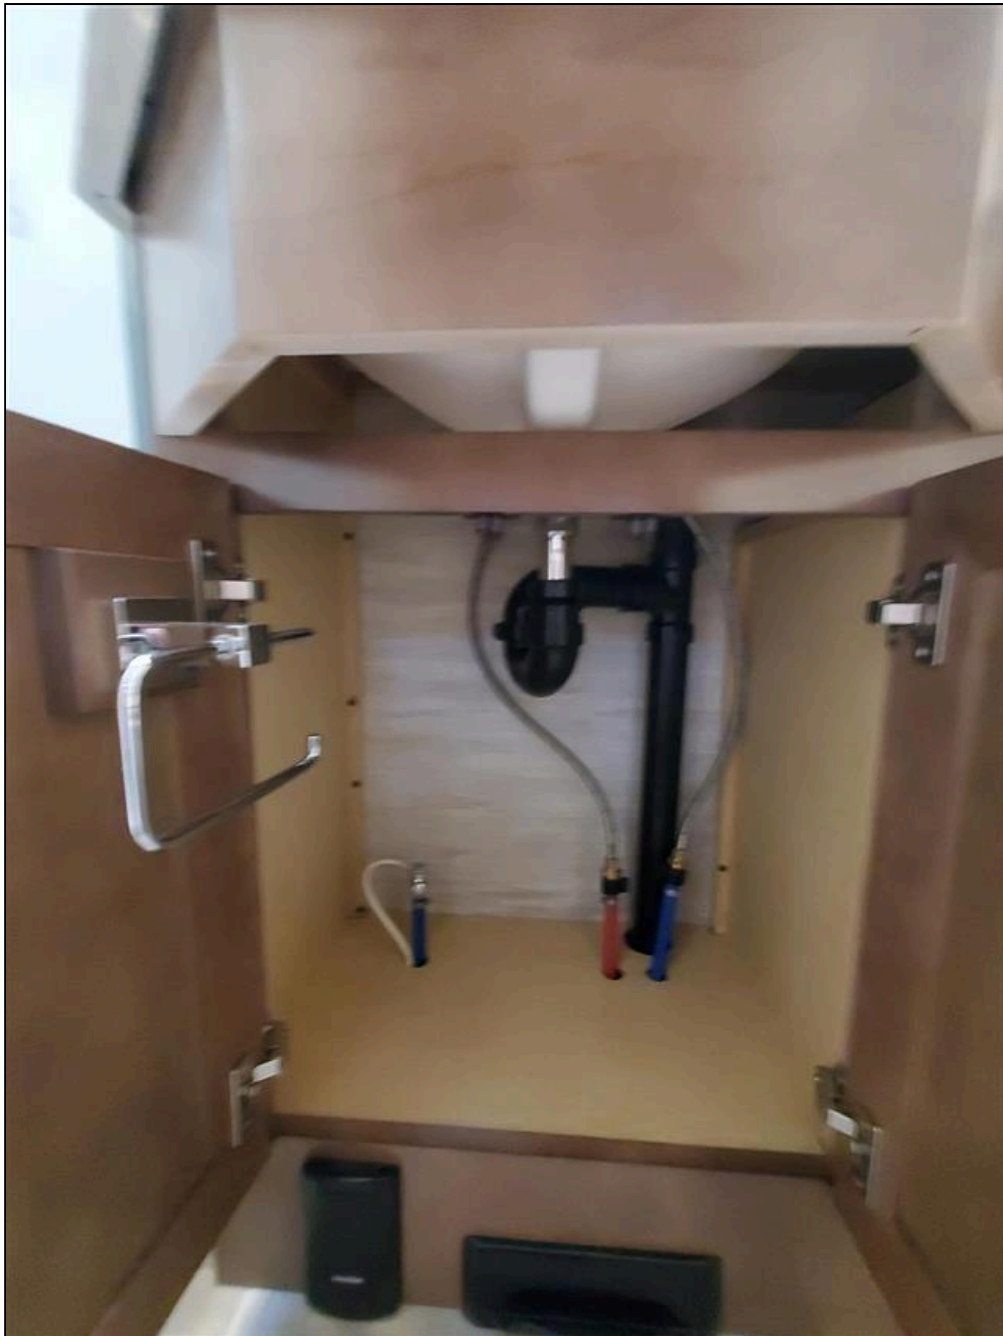
P-Trap holds water

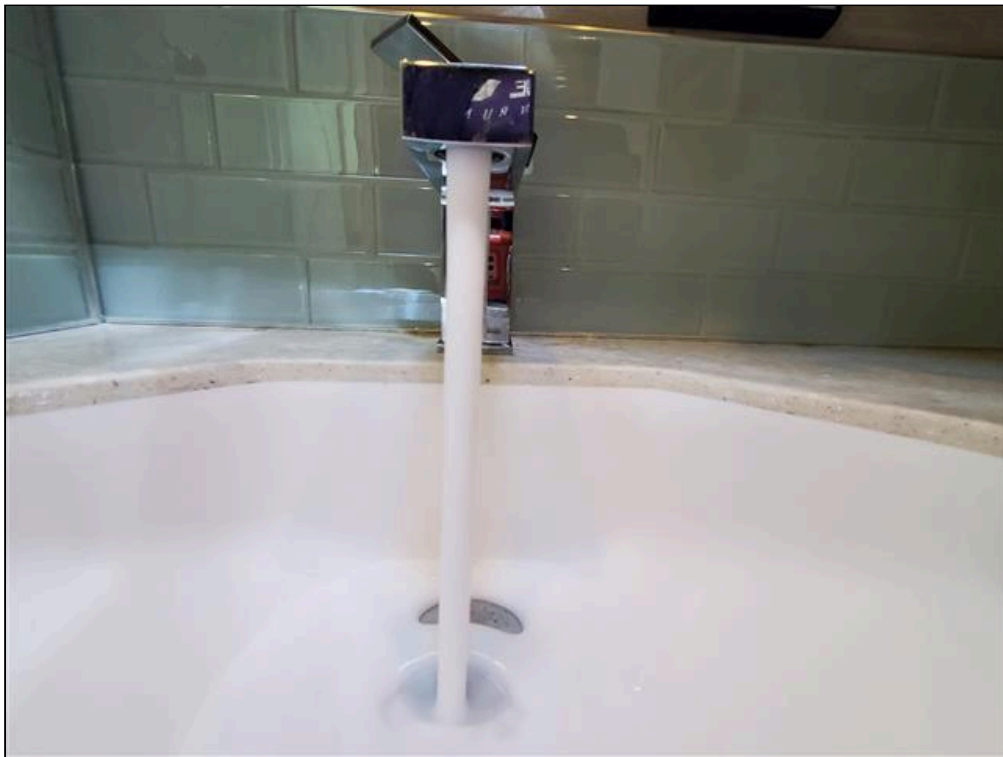
19.72 Bathroom Sink - Faucet Working

Bathroom Faucet Operating

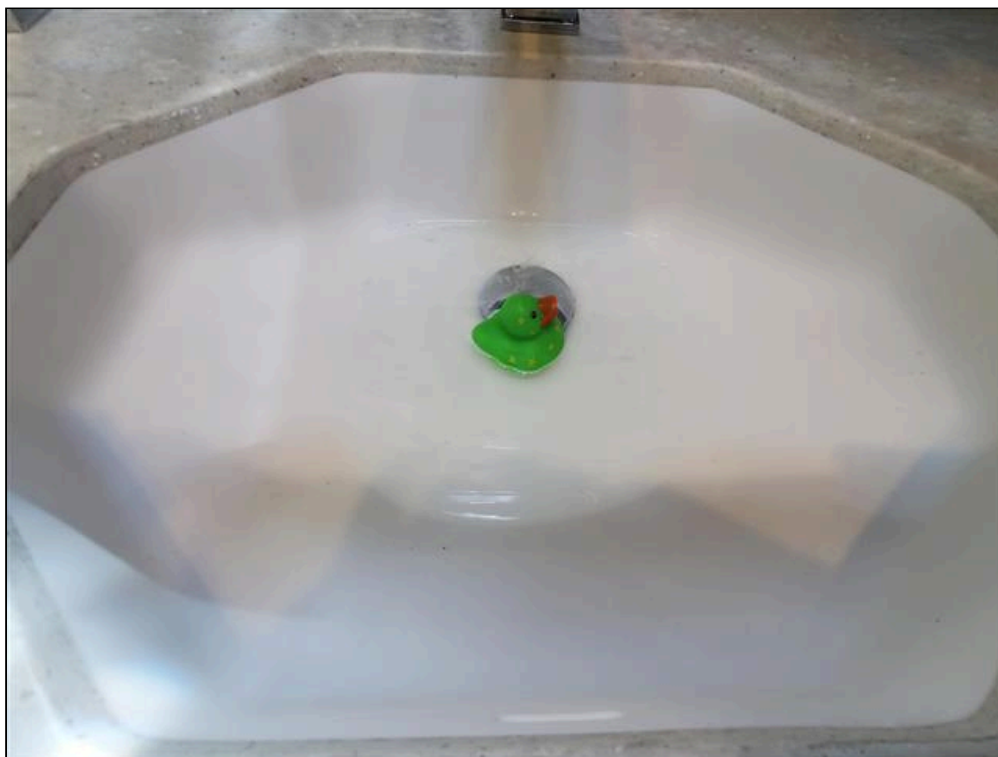
Bathroom Sink Holds Water

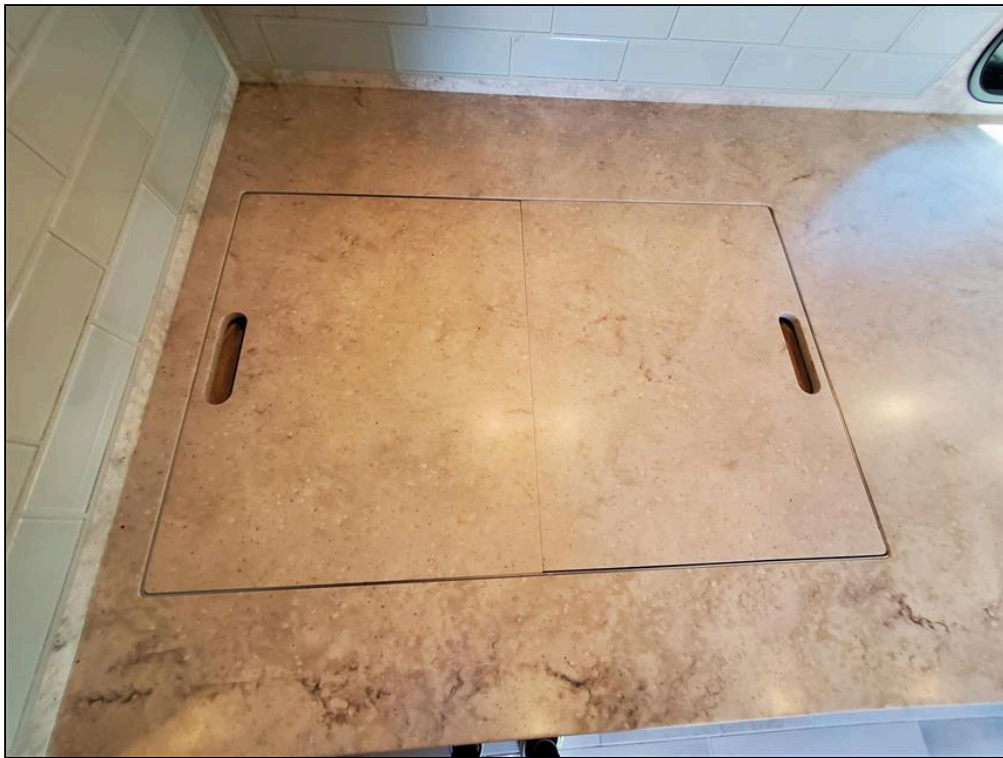
19.78 Counters - In Good Condition

Counters Are in Good Condition

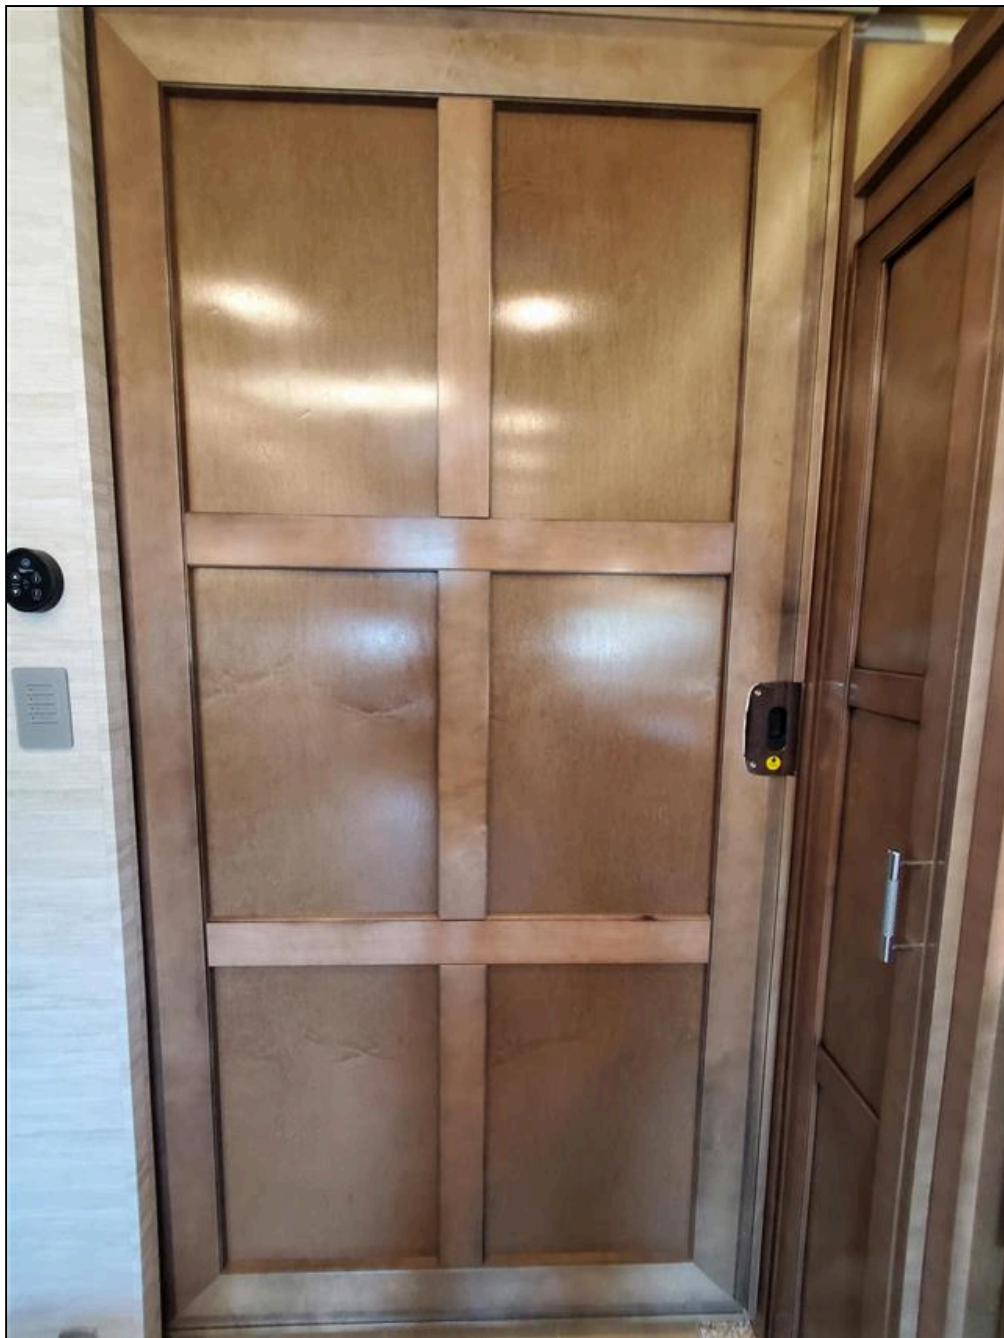
19.79 Doors / Pocket Doors - In Good Condition

Condition of Door(s) is Acceptable at Moment of Inspection
