RV Inspection Report

**Inspection Date / RV Model:
Newmar Superstar 4065 2023**

**Pierre Fortin
5753 Highway 85 N Lot 8511
Crestview, Florida, 32536**

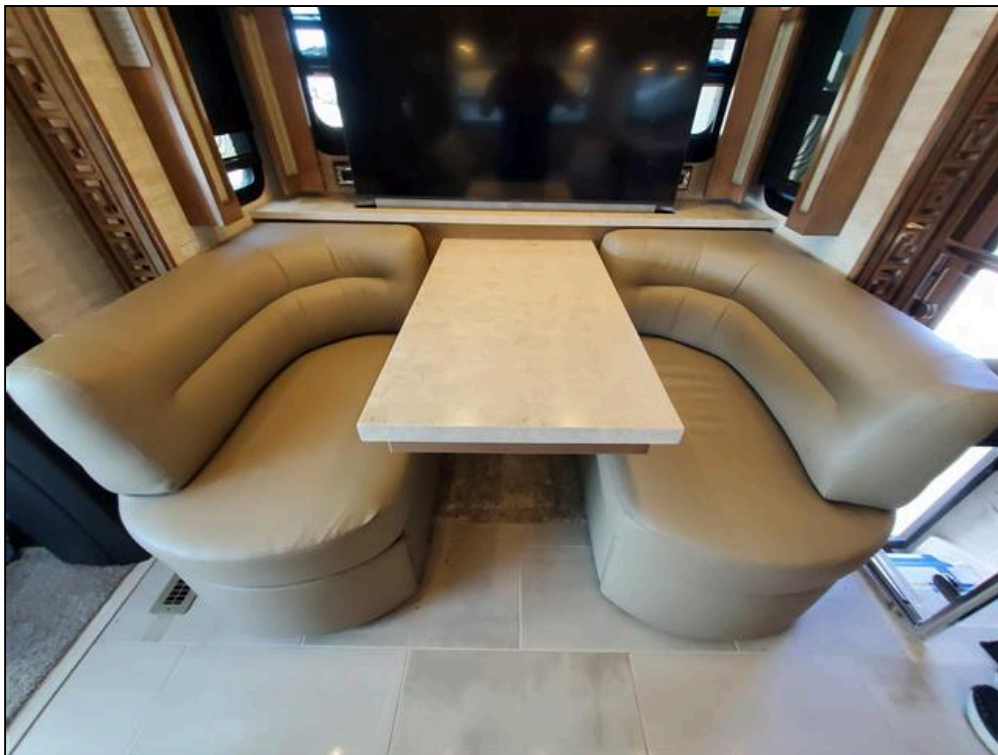
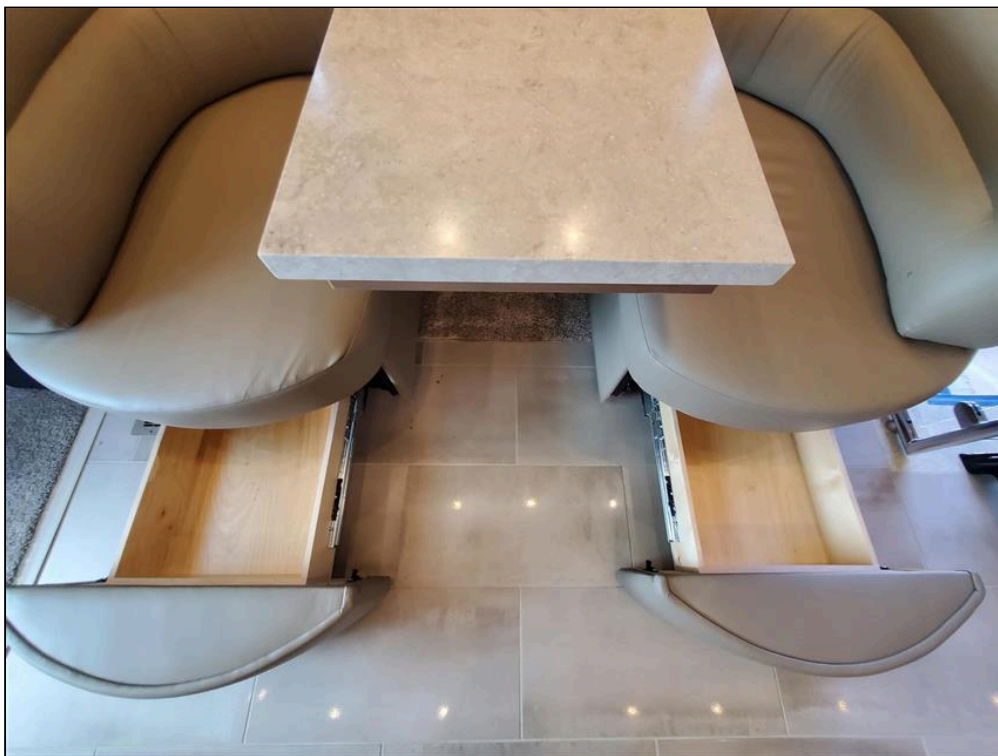
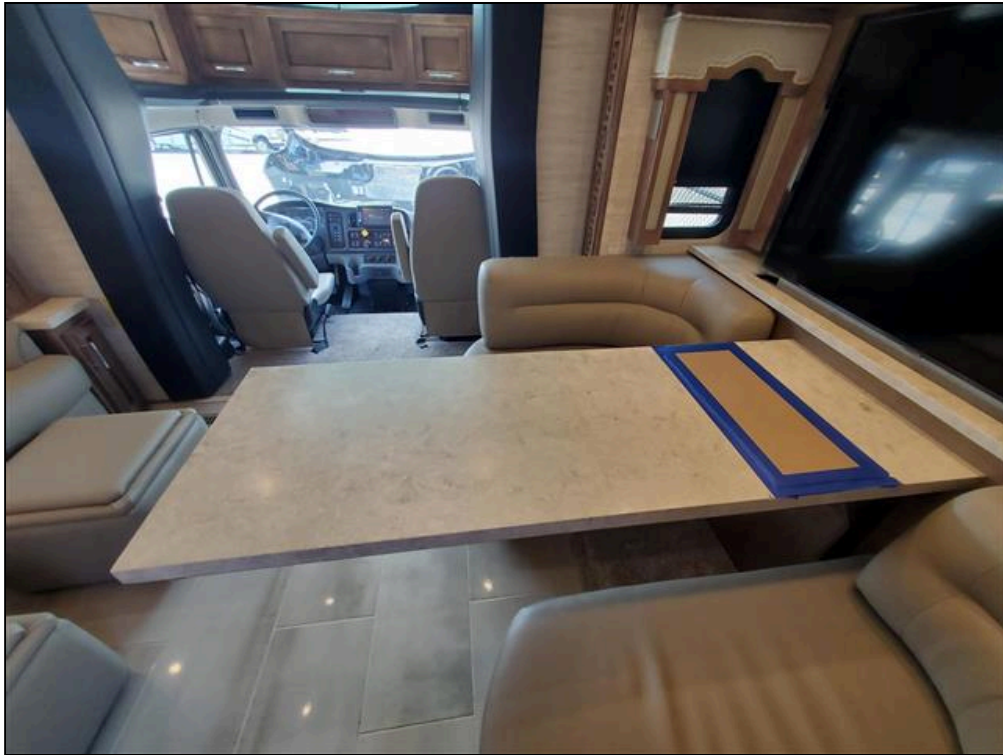
(1) Dinette Doesn't Turn into a Bed

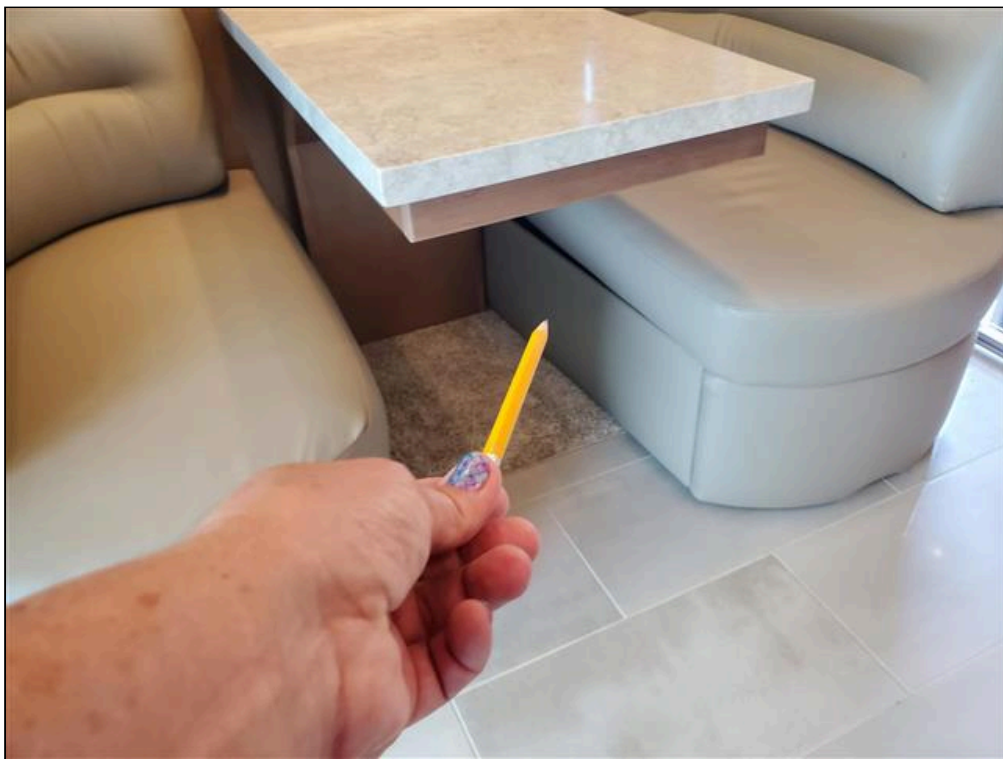
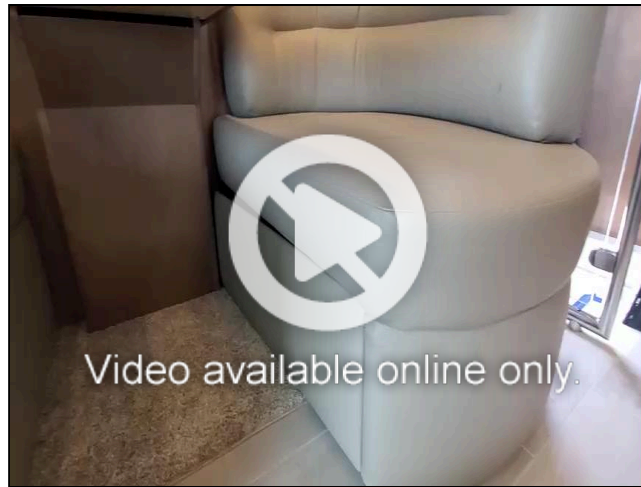
(2) Dinette Foot Backing is Loose

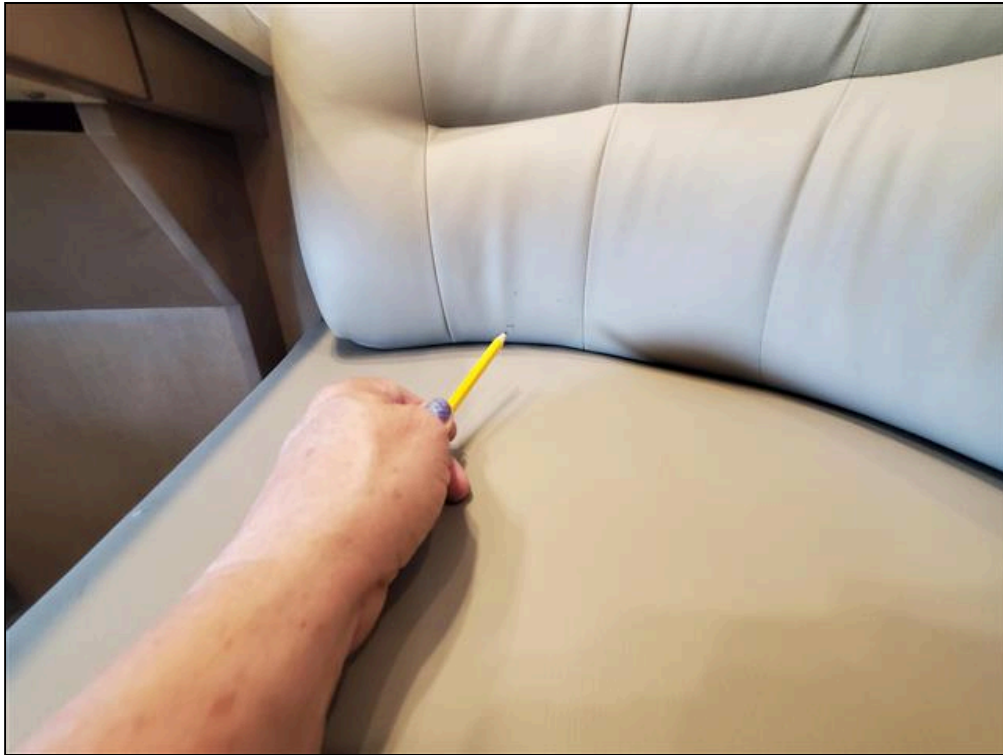
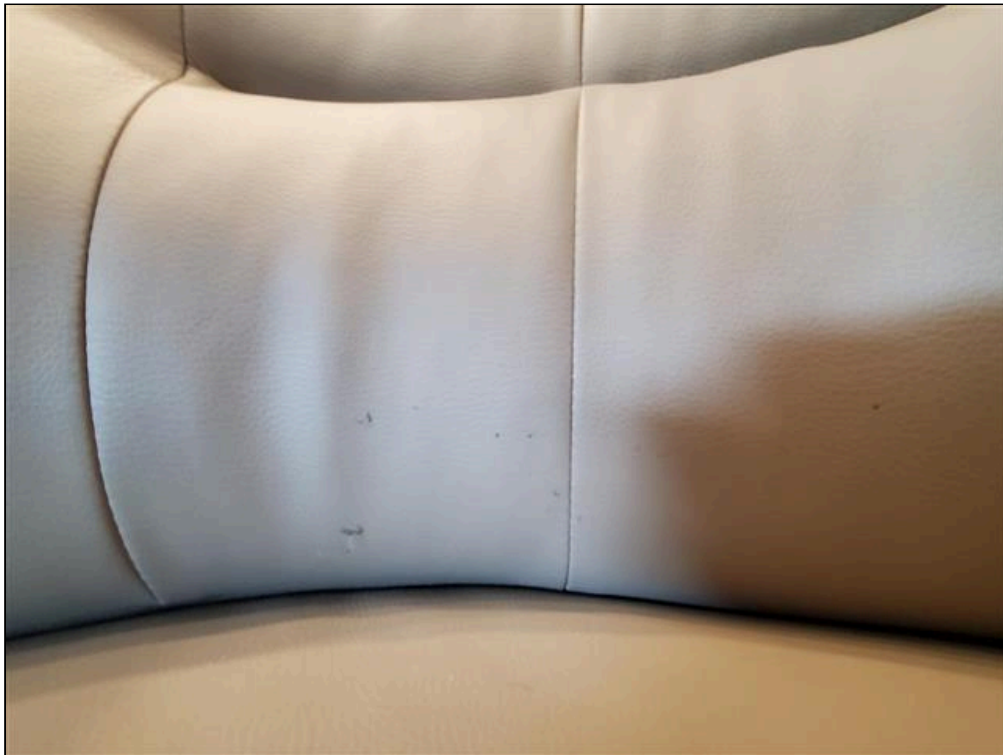
(2) Residues or Stains were Observed on the Material

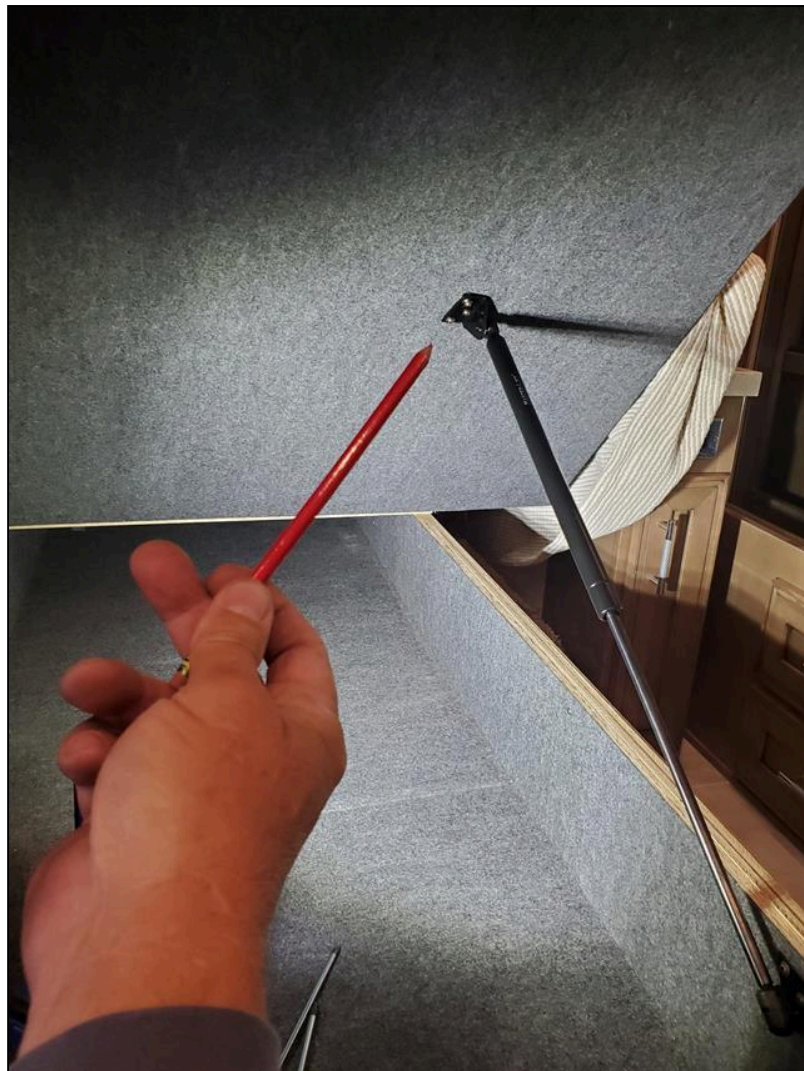
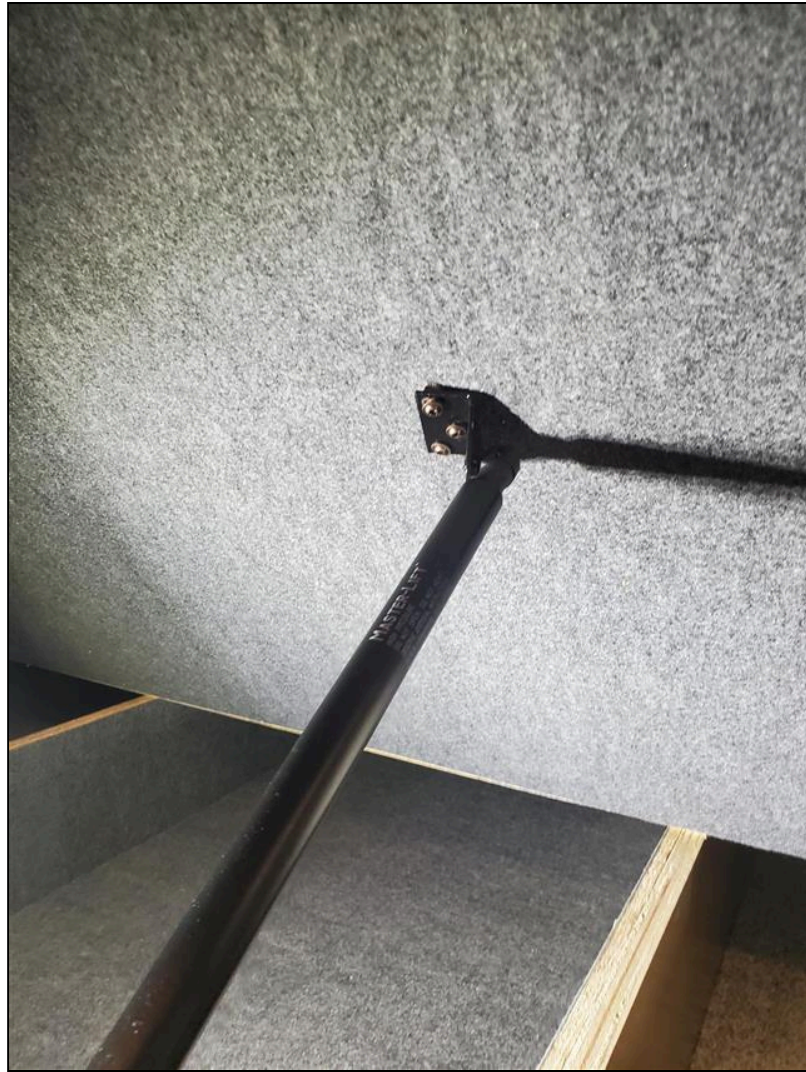
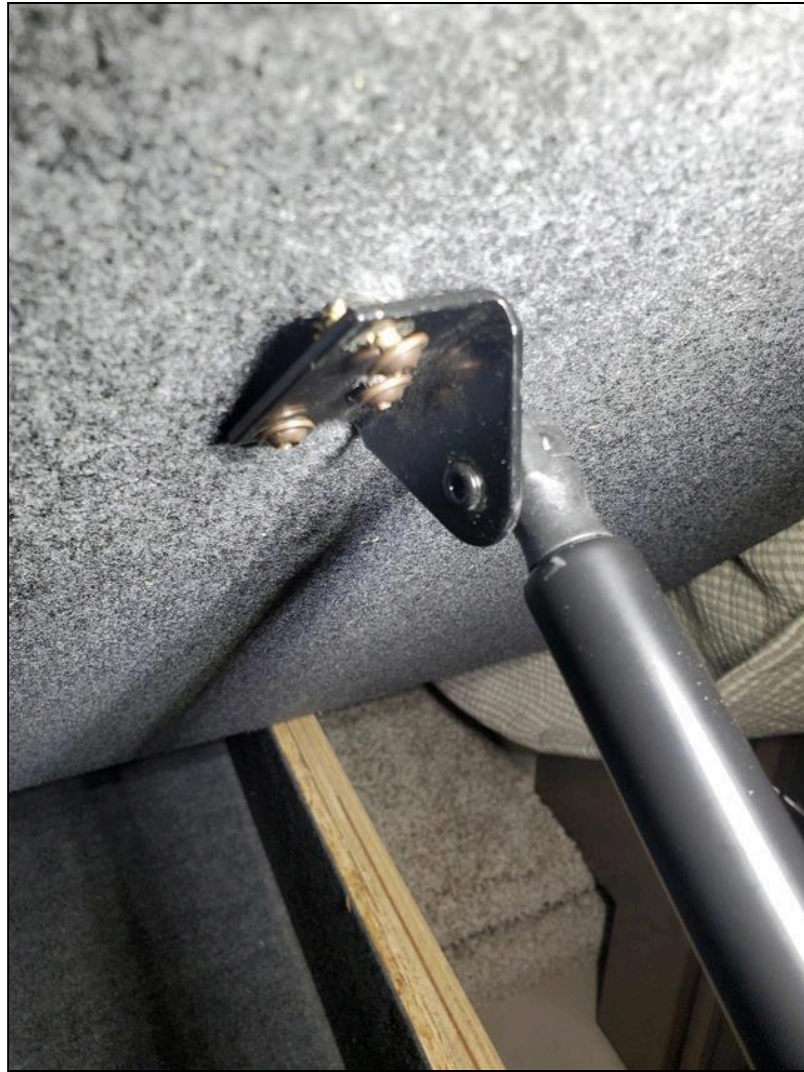
Upper bracket that holds the strut to open the bed is not attached as intended

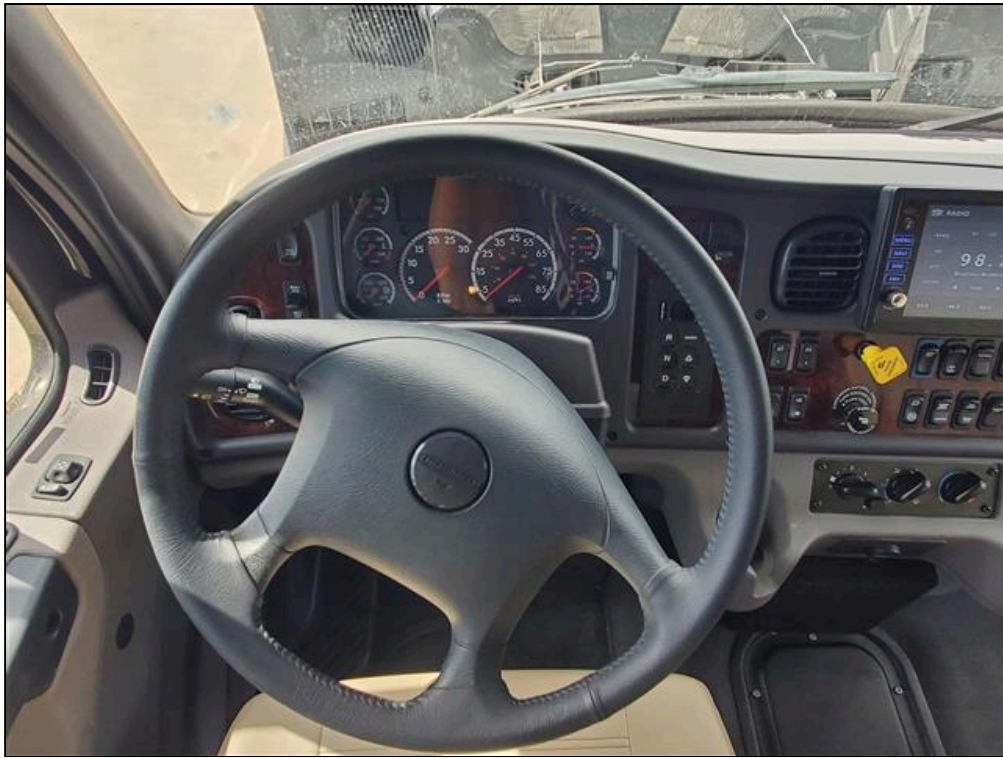
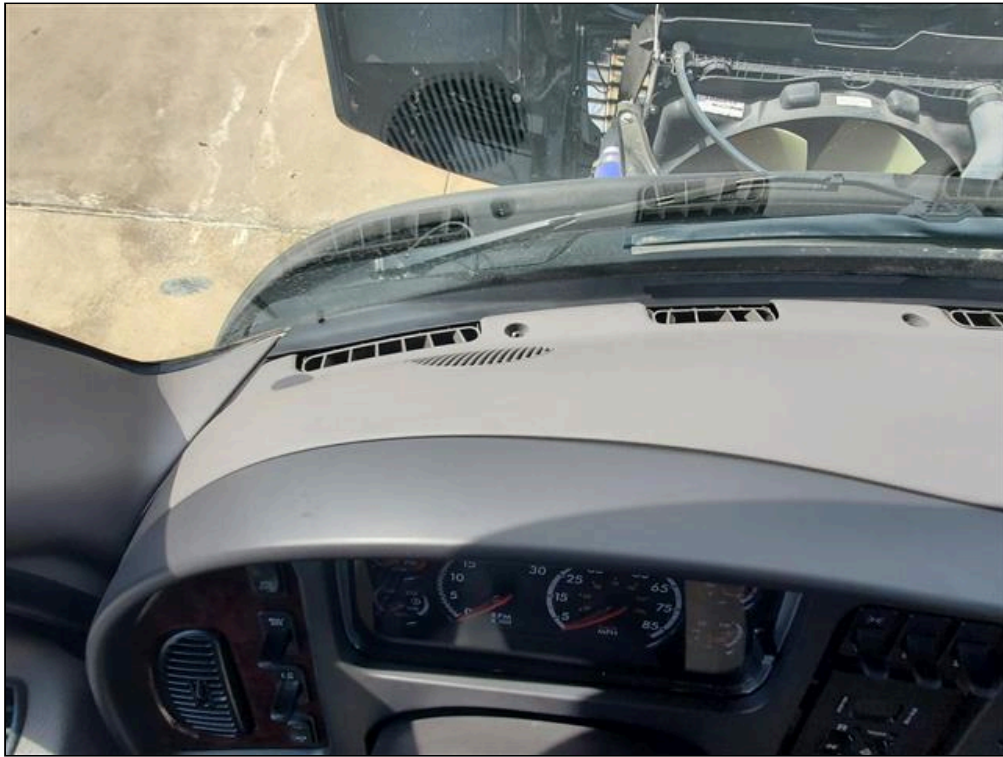
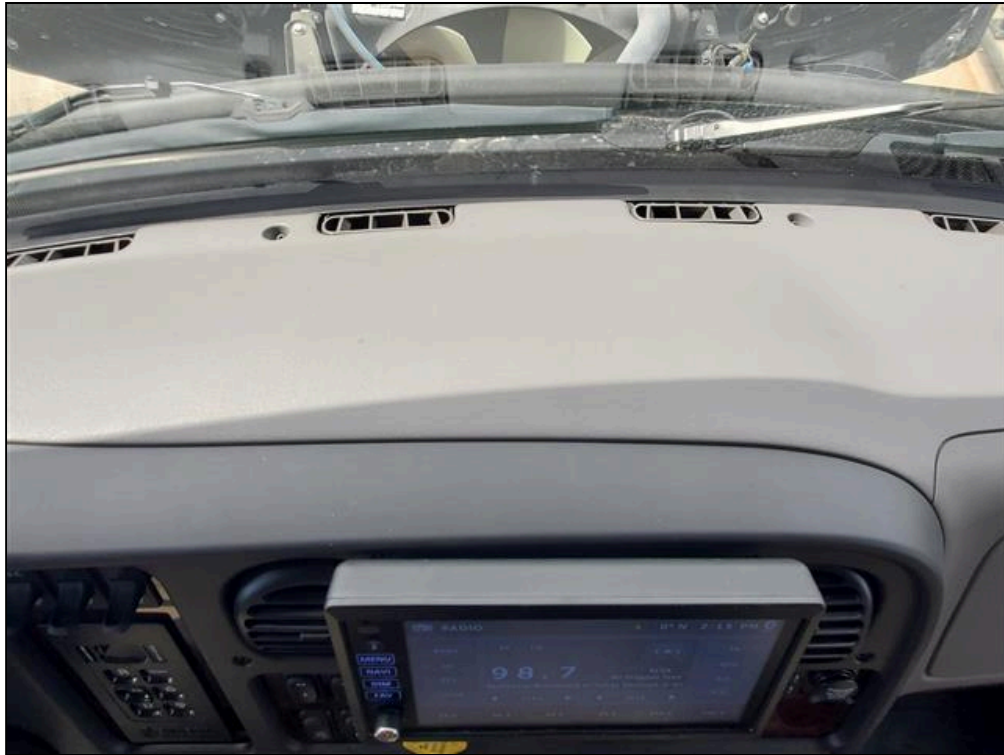
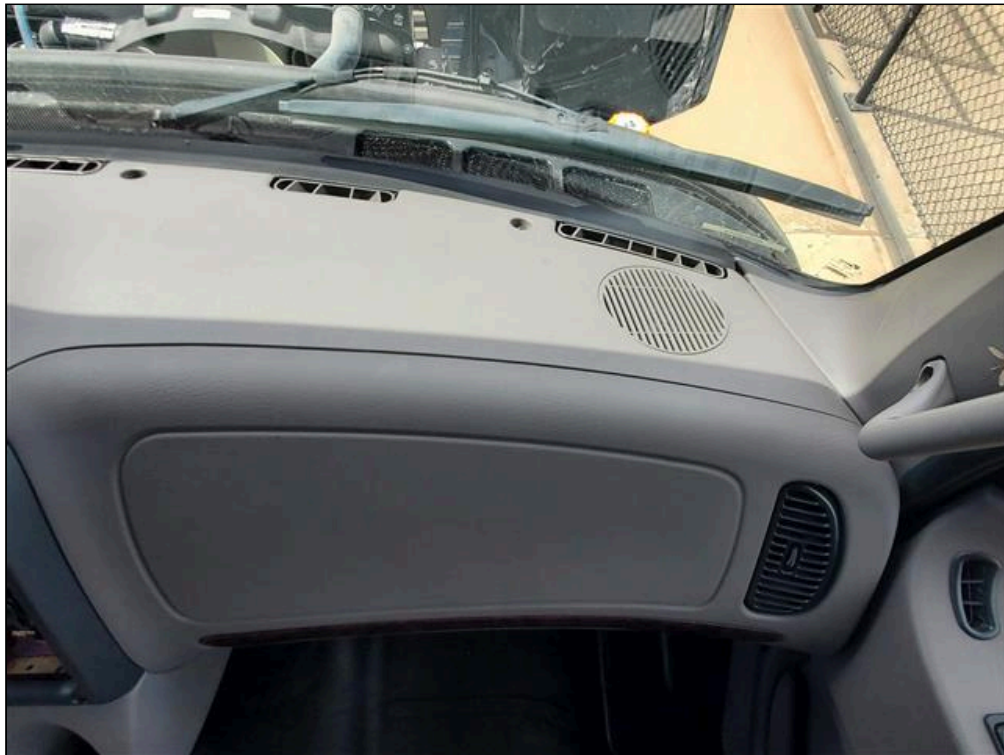
20.35 Cab Area in Good Condition

Cab Area in Good Condition

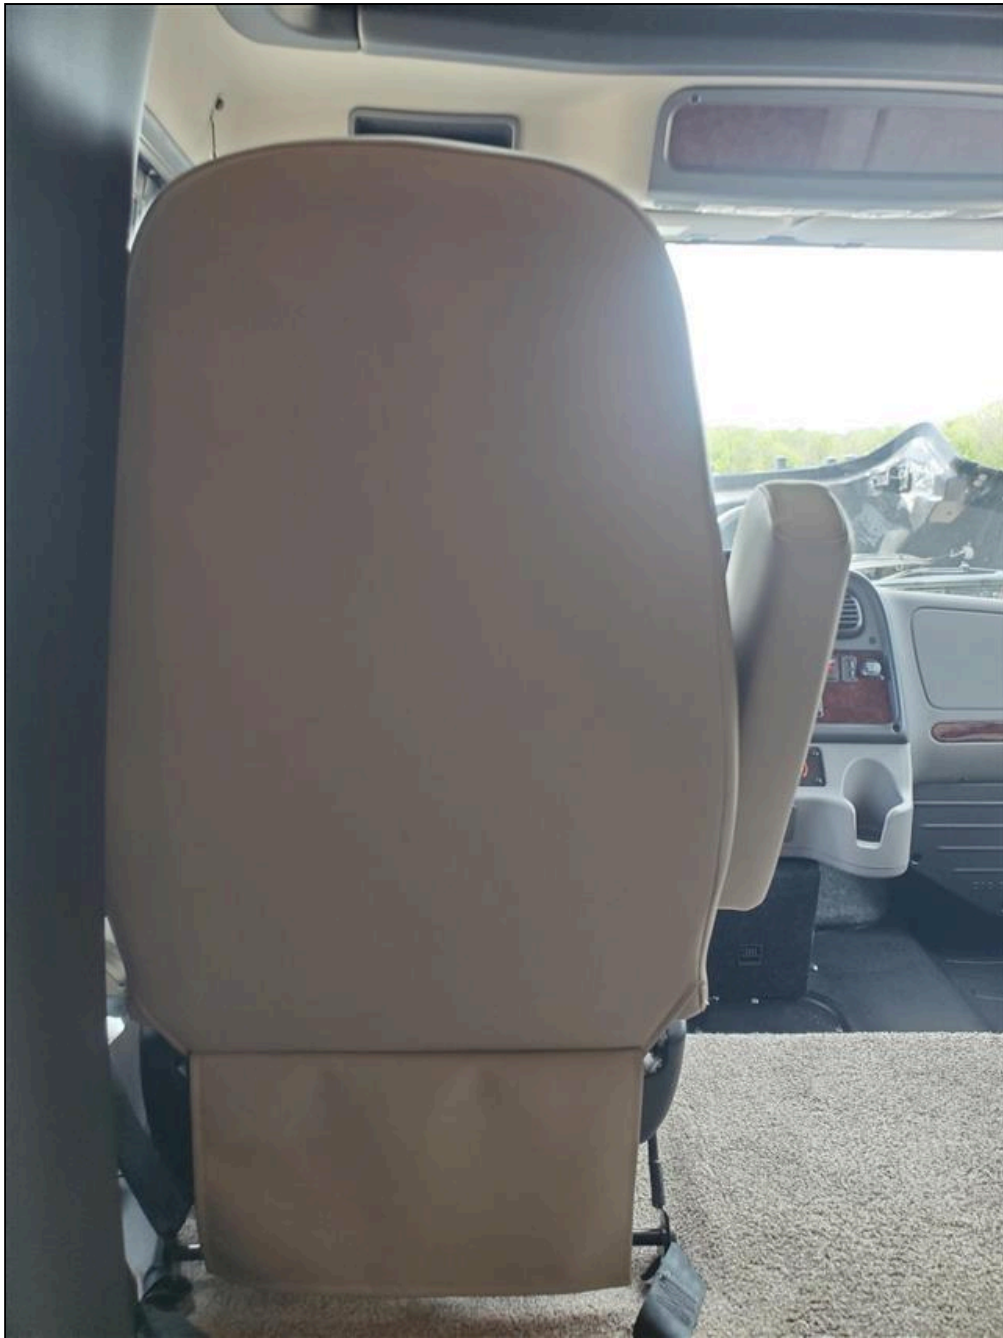
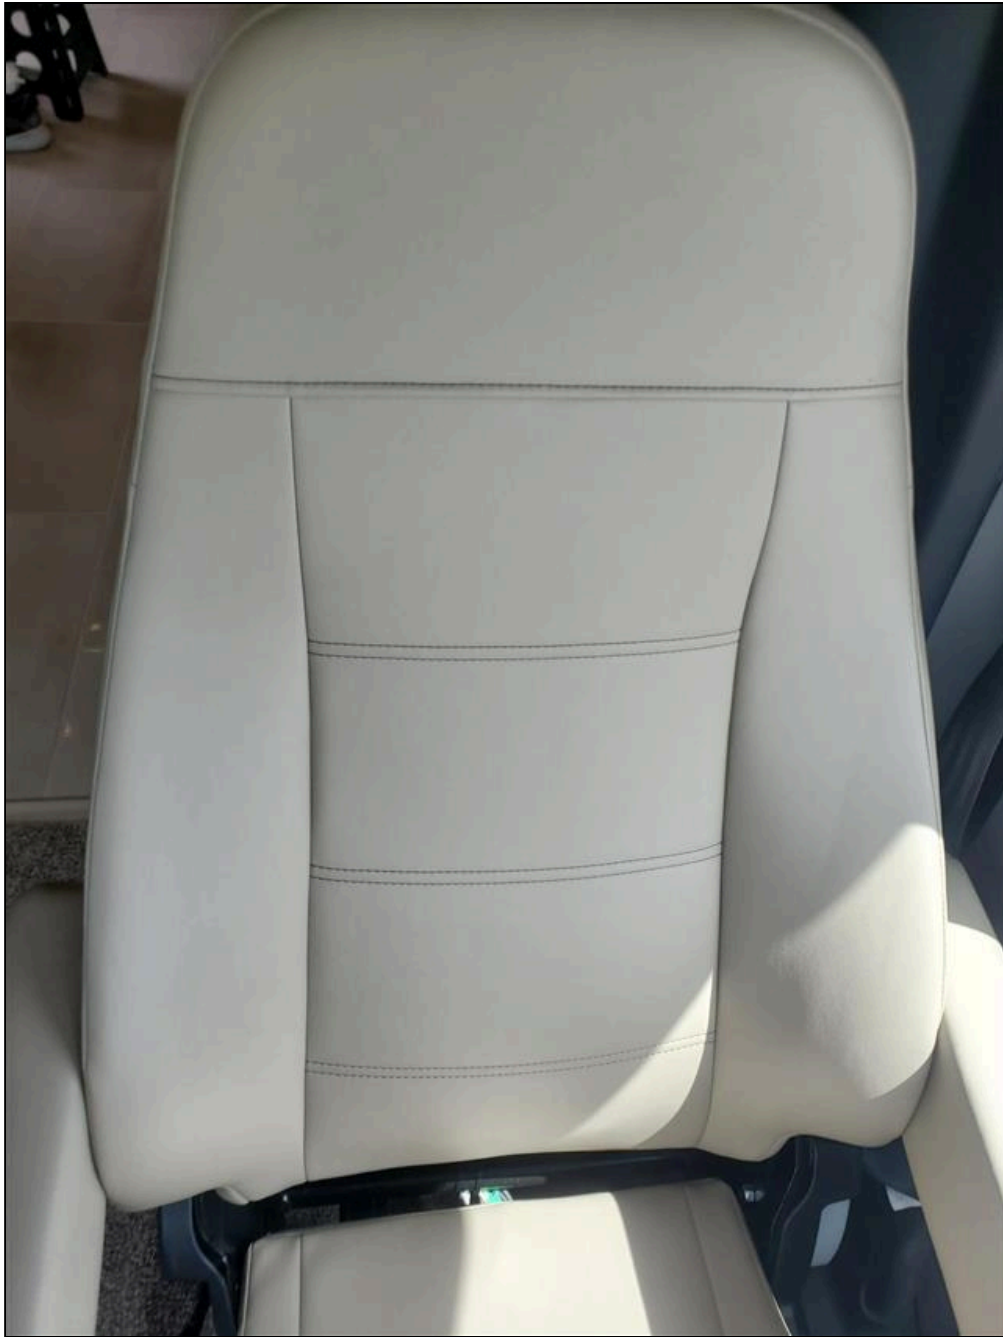
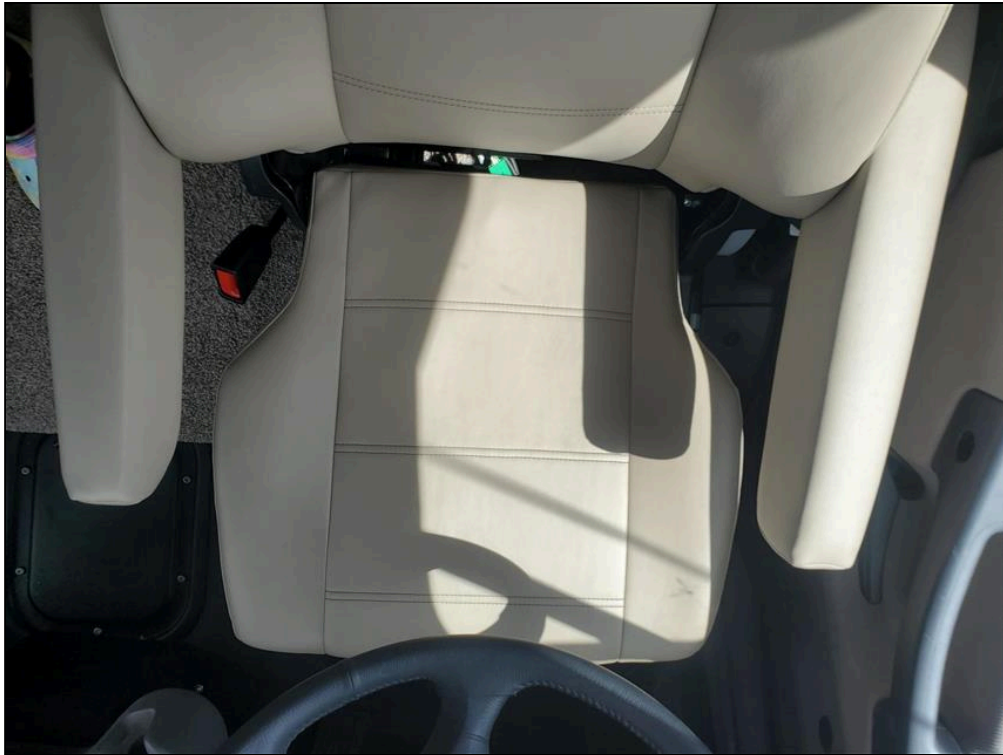
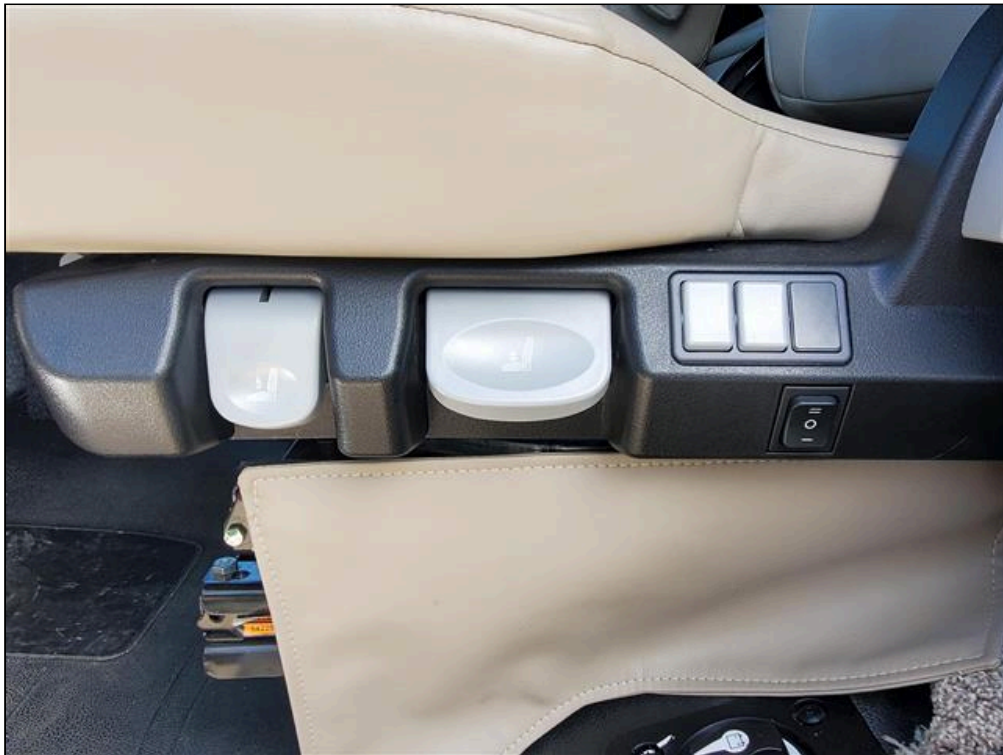
20.36 Driver's seat / does it operate as intended

Yes

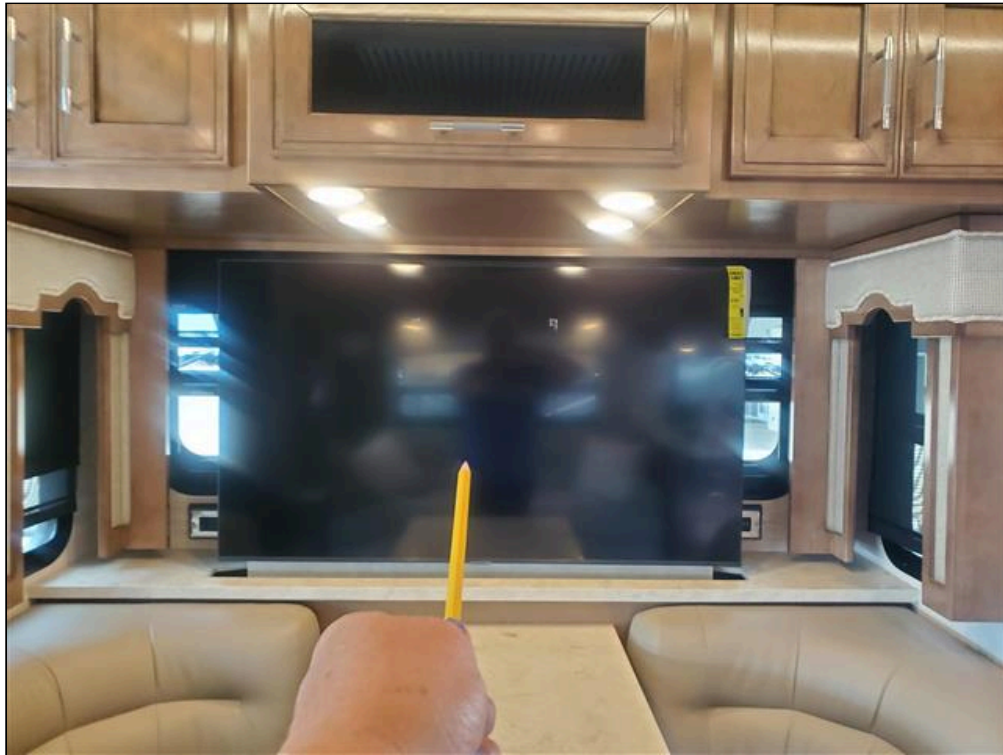
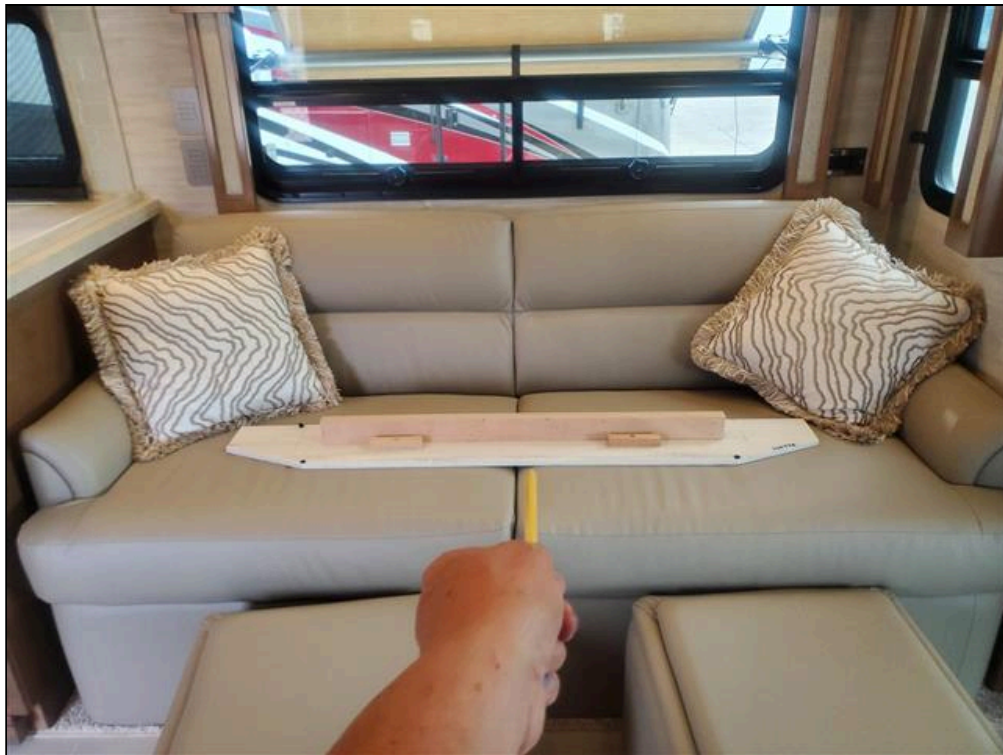
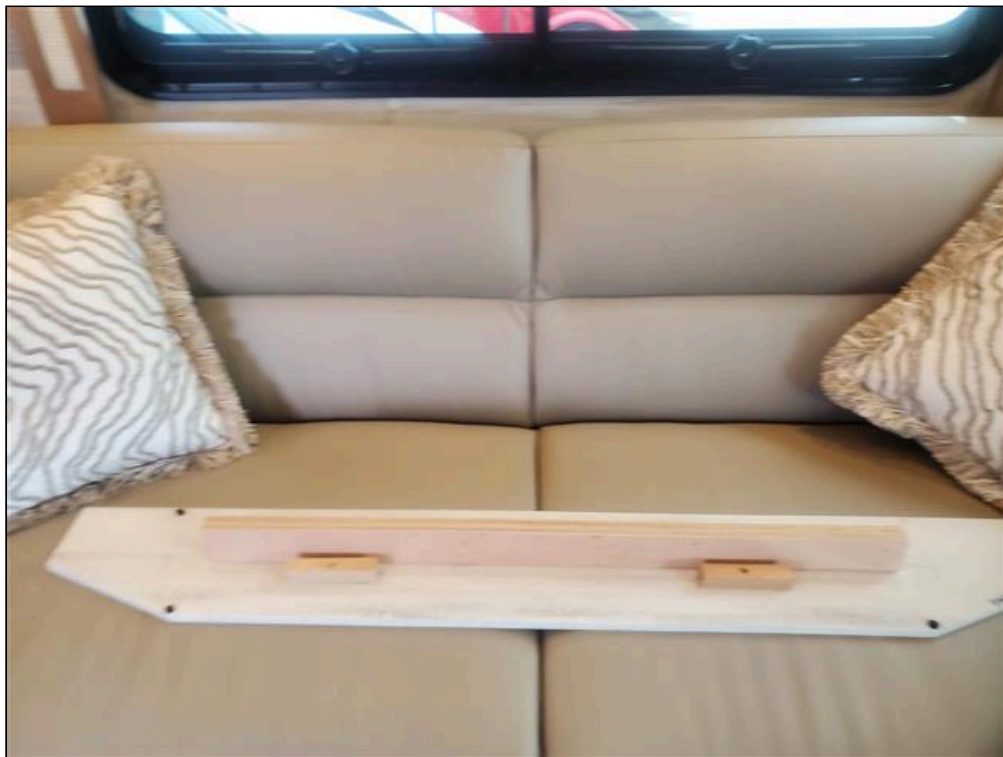
Technician was Changing the TV and Installing a new Mechanism.

Make sure to Test the Unit and Functions Before Leaving the Premises.
